# Oman Transport Safety Bureau (OTSB)

## Final Report

### TCAS Resolution Advisory between Etihad Airways - Airbus 320-232 and Boeing 787-9 Dreamliner in Muscat FIR

**OTSB Case File No: AIFN001.02.2026**

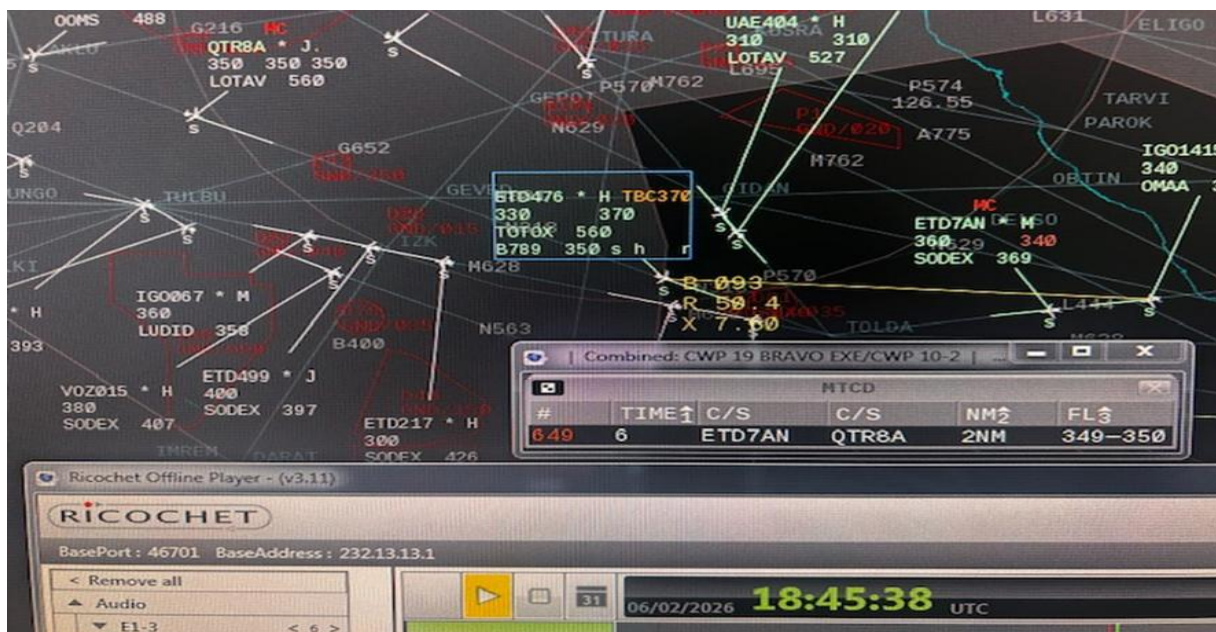
1.1.3 At 18:45:38 after Bravo ATCO entered the Cleared Flight Level (CFL), FL340 on the radar display for aircraft ETD7AN while still maintaining FL360 to descend to FL340, a safety net Medium Term Conflict Detection (MC) was activated between aircraft ETD7AN and aircraft QTR8A, which was still in Central sector maintaining FL350 as shown in the box in figure 1 below.

Figure1 shows MC between ETD7AN maintaining FL360 and QTR8A maintaining FL350 (Source: DGAN).

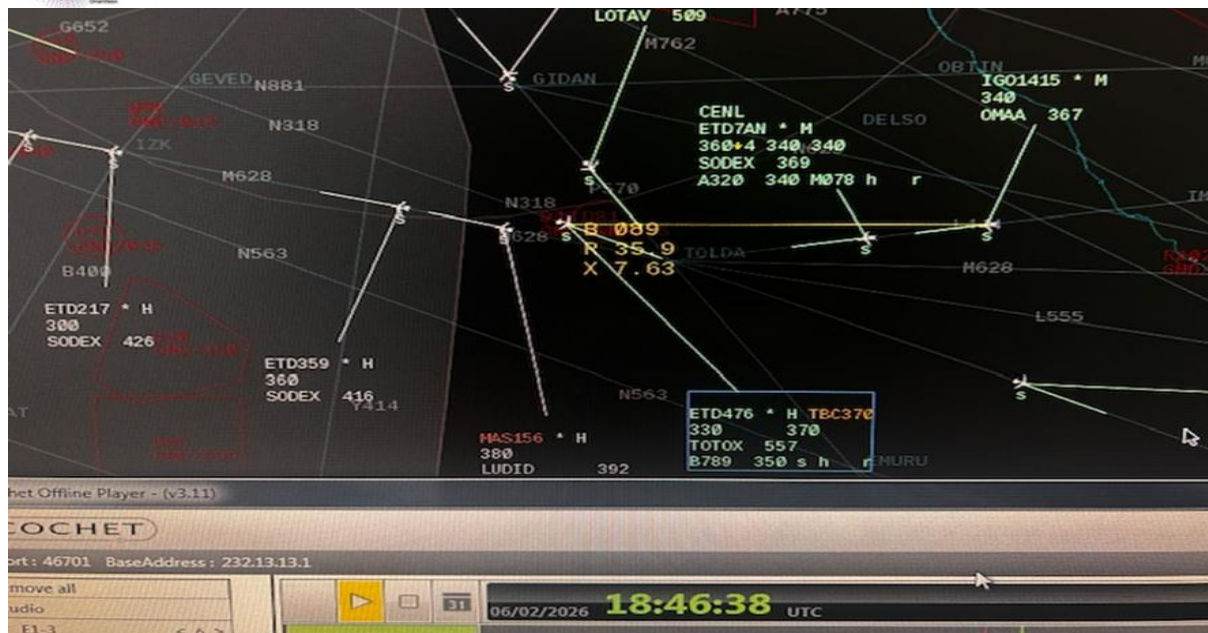
1.1.5 At 18:46:38 aircraft ETD7AN commenced the descent vacating FL360 at ROD of 400FPM as shown in figure 2 below.

Figure 2 shows ETD7AN started descending leaving FL360 with ROD of 400FPM (Source: DGAN).

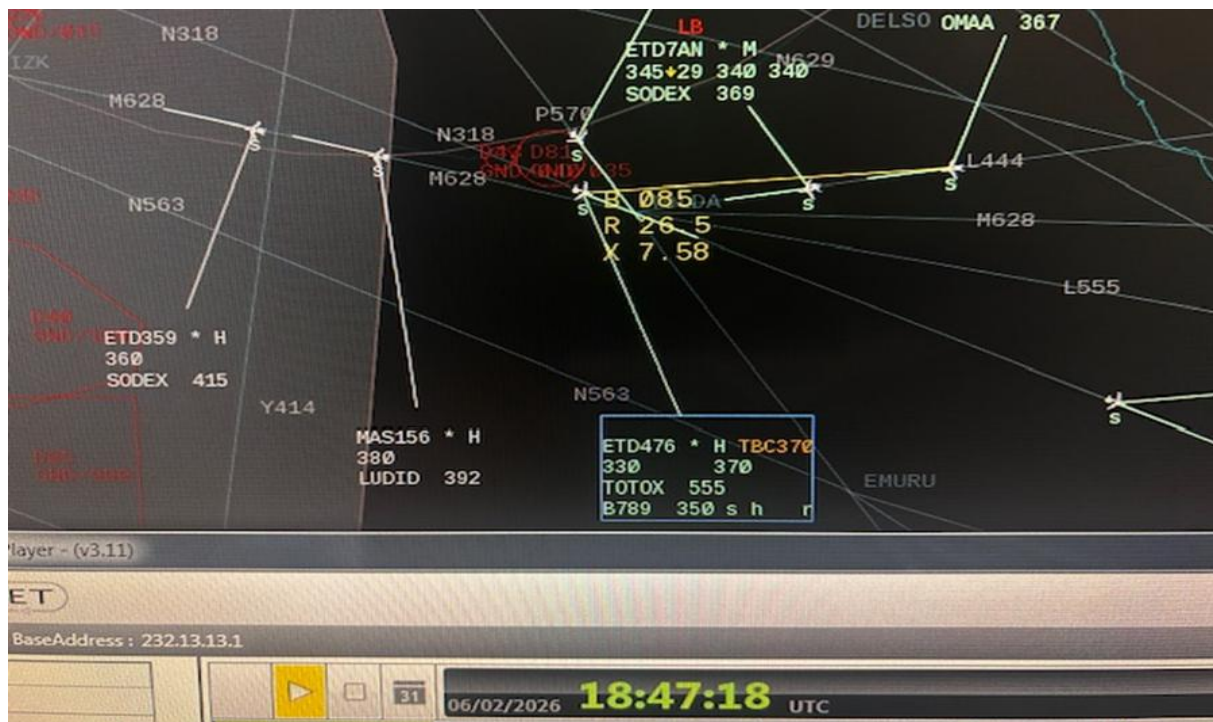
1.1.6 At 18:47:18 another safety net level bust (LB) was activated on aircraft ETD7AN while on descent passing through FL345 with ROD of 2900FPM meanwhile ETD476 was maintaining FL330 as shown in figure 3 below. The LB was activated due to discrepancy between the FL entered by the flight crew of ETD7AN on the aircraft FMS and the CFL entered by the ATCO on the radar display.

Figure 3 shows LB on ETD7AN while on descent to FL340 passing FL345 with ROD of 2900FPM (Source: DGAN).

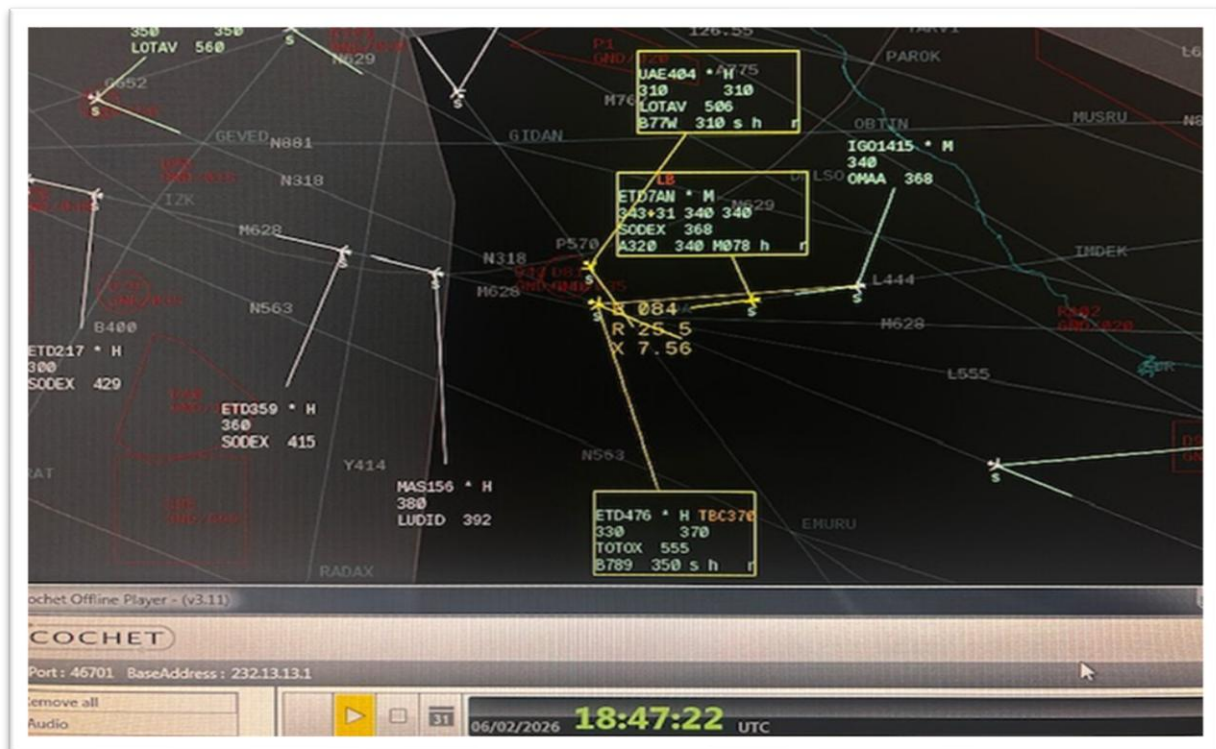
1.1.7 The Yellow STCA was activated on the radar display at 18:47:22 as aircraft ETD7AN was on descent passing through FL343 with a ROD of 3100FPM and aircraft ETD476 was maintaining FL330. At 18:47:24, the yellow STCA window indicated another conflict between UAE404

maintaining FL310 and ETD7AN descending to FL340 at 3100FPM as shown in figure 4 below. Then at 18:47:26, the yellow STCA between ETD7AN and ETD476 was deactivated.

Figure 4 shows yellow STCA on aircraft ETD7AN while on descent passing through FL343 with ROD 3100 FPM and ETD476 maintain FL330 and also between ETD7AN and UAE404 maintaining FL310 (Source: DGAN).

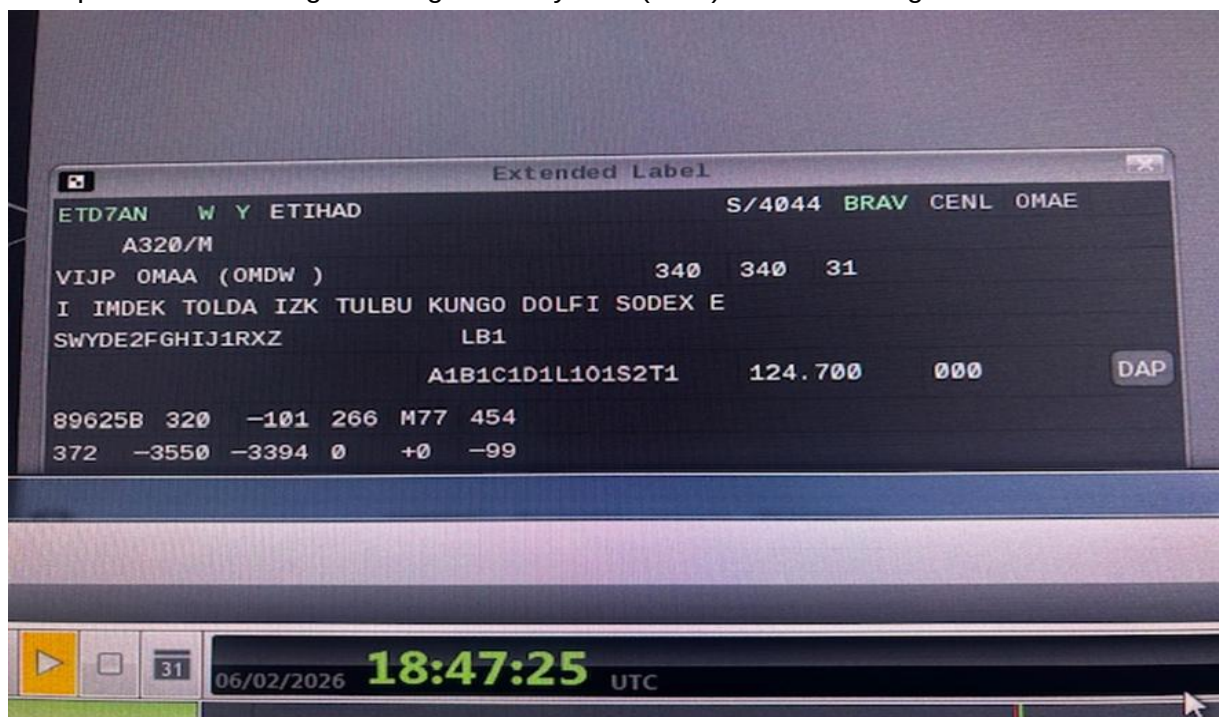
1.1.8 At 18:47:25, Mode S on the radar display indicated that ETD7AN was descending to FL320 as per the aircraft Flight Management System (FMS) as shown in figure 5 below.

Figure 5 shows aircraft ETD7AN Mode S indicating the aircraft descending to FL320 (Source: DGAN).

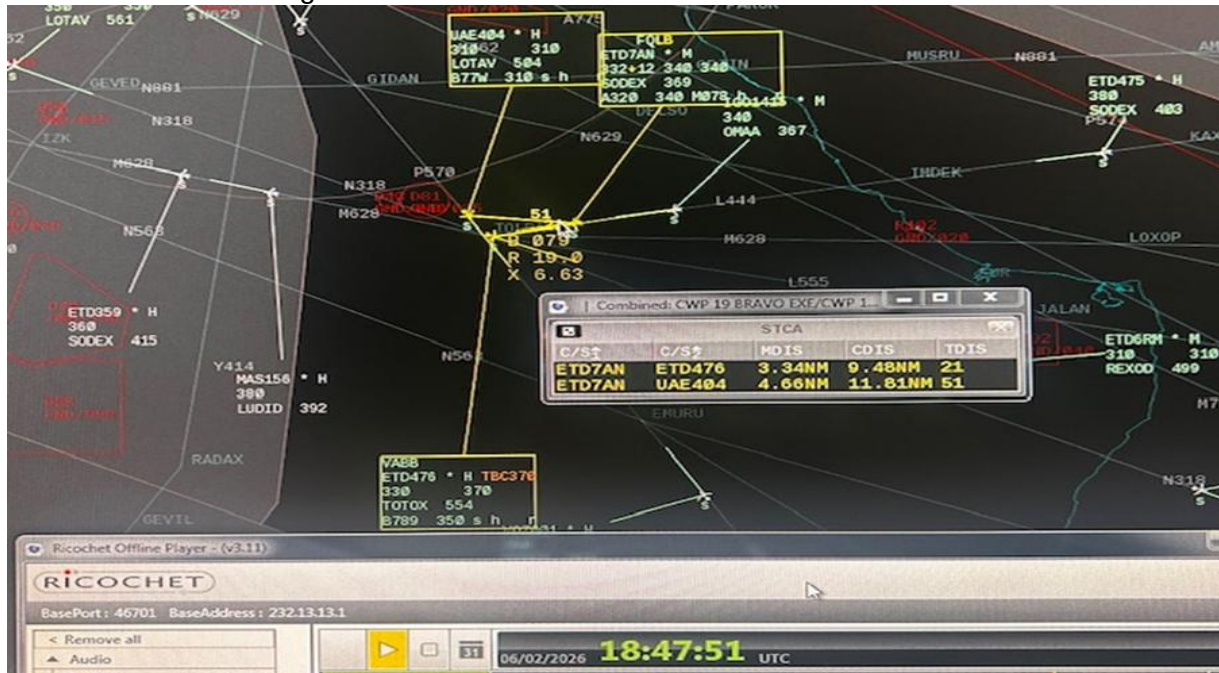
1.1.10 At 18:47:43, ATCO again called the flight crew of ETD7AN for the third time and the flight crew responded by stating "7AN go ahead". At 18:47:48, ATCO instructed the flight crew of ETD7AN to maintain FL340 and to turn right 50° and there was no response. At 18:47:51 yellow STCA window deactivated displaying conflicts between aircraft ETD7AN descending through FL332 with a ROD1200FPM and ETD476 maintaining FL330 and at the same time the yellow STCA continued displaying conflict between ETD7AN and UAE404 maintaining FL310 as shown in figure 6 below.

Figure 6 shows yellow STCA displaying conflict between ETD7AN descending through FL332 ROD 1200FPM and ETD476 maintaining FL330 and between ETD7AN and UAE404 maintaining FL310 (Source: DGAN).

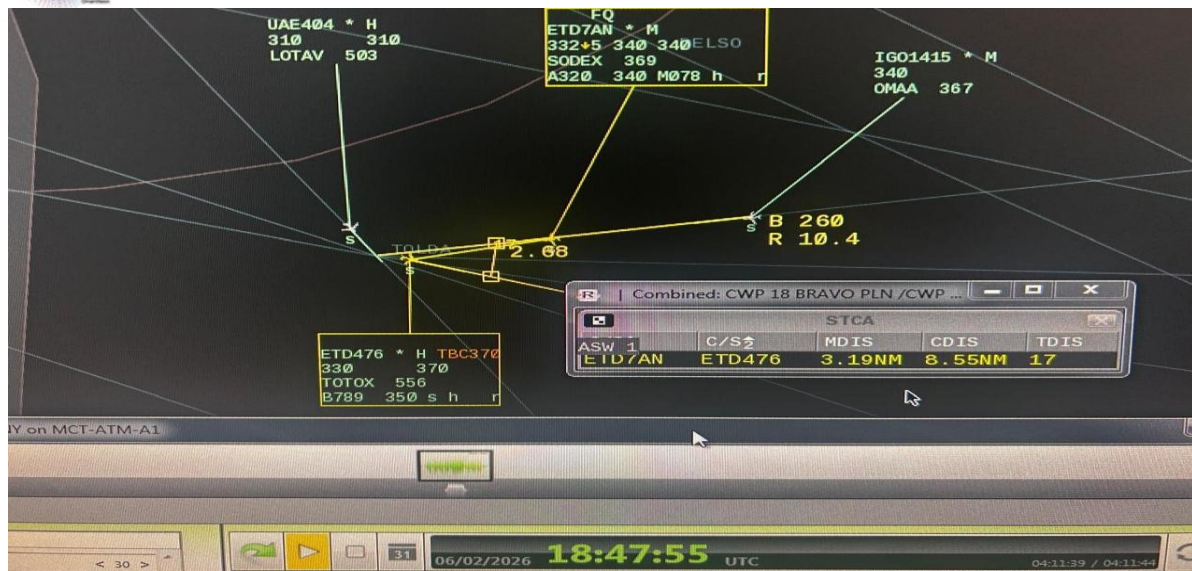
1.1.11 At 18:47:55, the yellow STCA alert between ETD7AN and UAE404 was cleared out of the radar screen as the rate of descent reduced significantly from 3100 FPM to 500 FPM, and the yellow STCA remained between conflicting aircraft ETD7AN descending through FL332 with ROD of 500FPM and ETD476 maintaining FL330 with a distance of 8.55 NM. At this time, the flight crew of ETD476 reported TCAS RA and the ATCO acknowledged as indicated in figure 7 below. At 18:48:04 ATCO instructed All stations standby.

Figure 7 shows TCAS RA between ETD476 maintaining FL330 while ETD7AN was descending through FL332 with ROD of 500FPM on opposite direction and the distance between the two aircraft is 8.55NM (Source: DGAN).

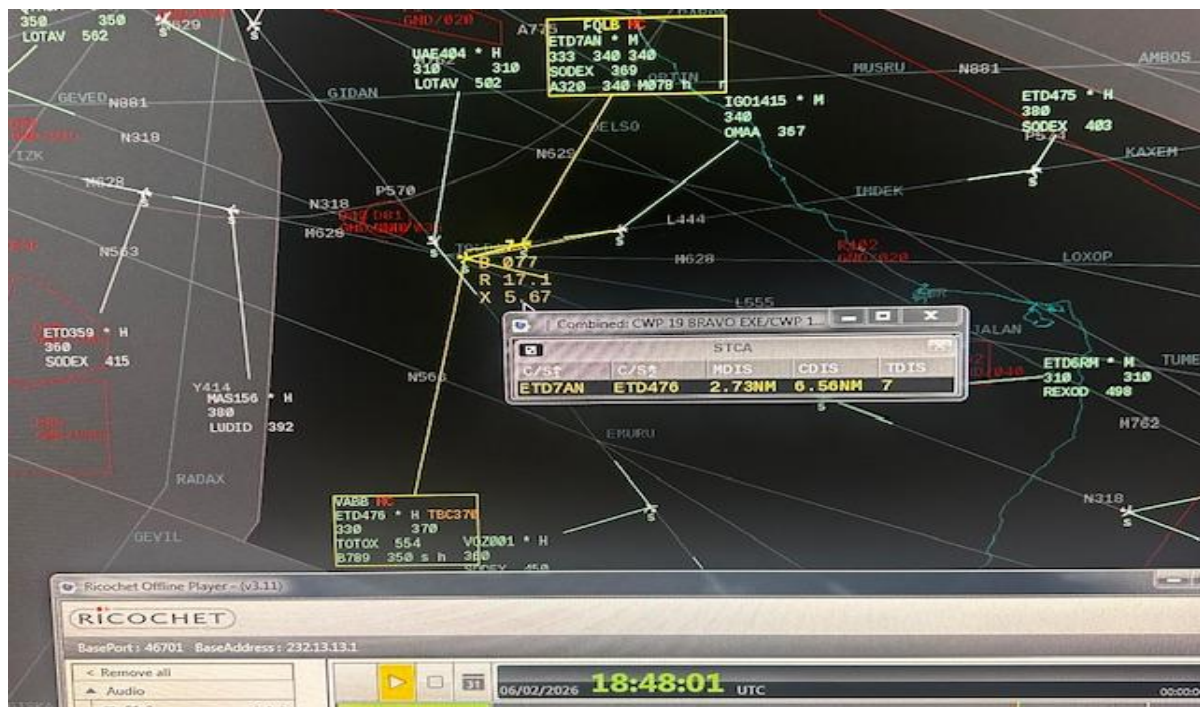
1.1.12 At 18:48:01, MC activated between ETD7AN maintaining FL333 and ETD476 maintaining FL330. The current distance between the two aircraft reduced to 6.56NM as shown in figure 8 below.

Figure 8 shows MC between ETD7AN maintaining FL333 and ETD476 maintaining FL330 when the current distance between the two aircraft reduced to 6.56NM (Source: DGAN).

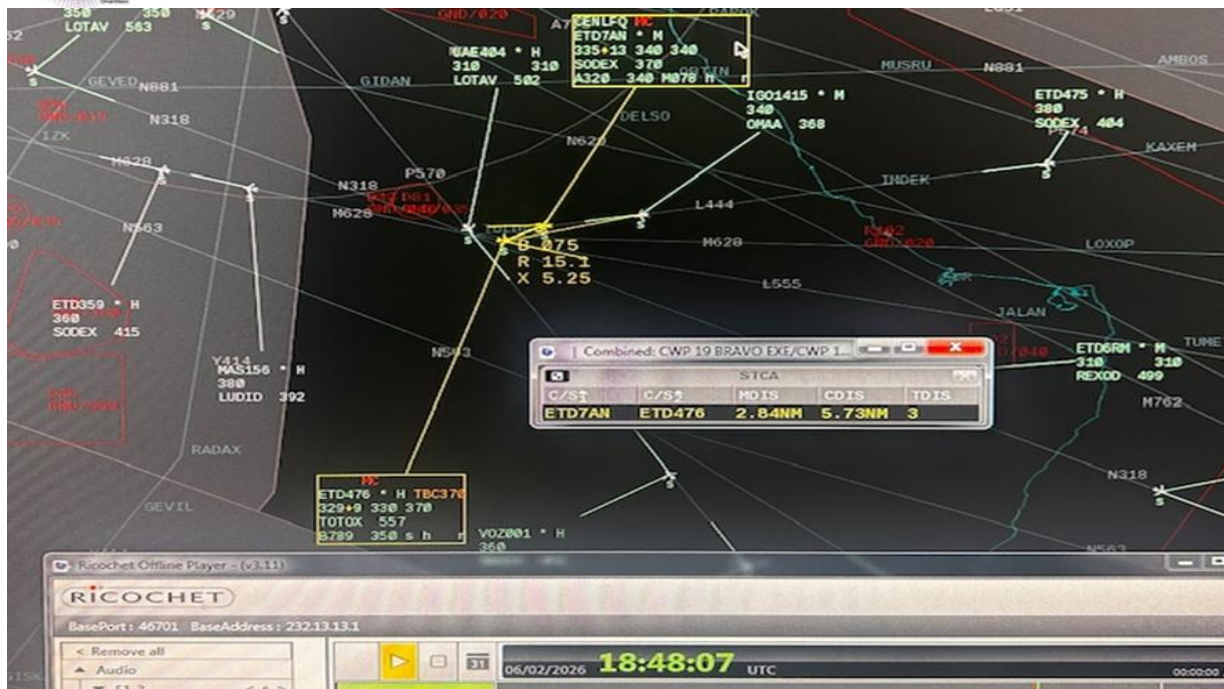
1.1.13 At 18:48:07, Radar display shows ETD7AN and ETD476 while reacting to TCAS RA, ETD7AN climbing passing through FL335 at ROC1300FPM while ETD476 descending passing through FL329 at ROD 900FPM as shown in figure 9. The distance between the two aircraft was 5.73NM.

Figure 9 shows ETD7AN and ETD476 while reacting to the TCAS RA (Source: DGAN).

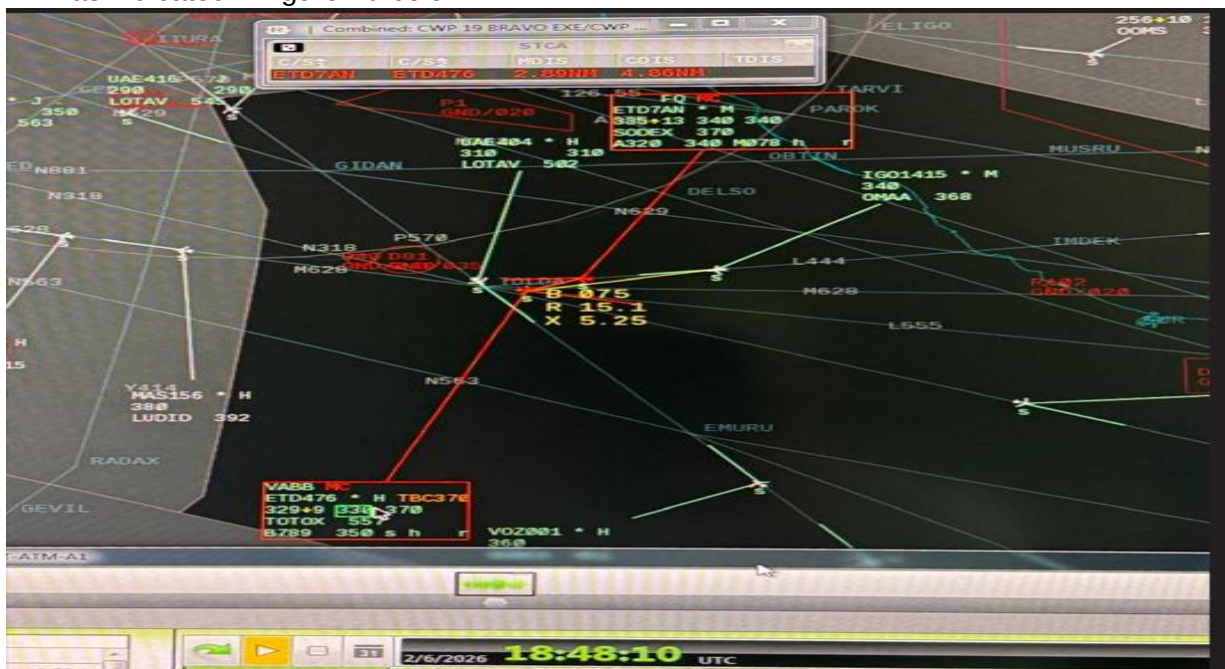
1.1.14 At 18:48:10, the distance between ETD7AN and ETD476 reduced to 4.86 NM and vertical separation reduced to 600FT, MC and red STCA warnings were activated on the radar screen on both aircraft while aircraft ETD7AN was climbing passing through FL335 for FL340 with ROC 1300FPM and aircraft ETD476 was descending passing through FL329 with ROD 900 FPM as indicated in figure 10 below.

Figure 10. shows MC and red STCA warning for both aircraft ETD7AN and ETD476 and the distance between both aircraft was 4.86NM (Source: DGAN).

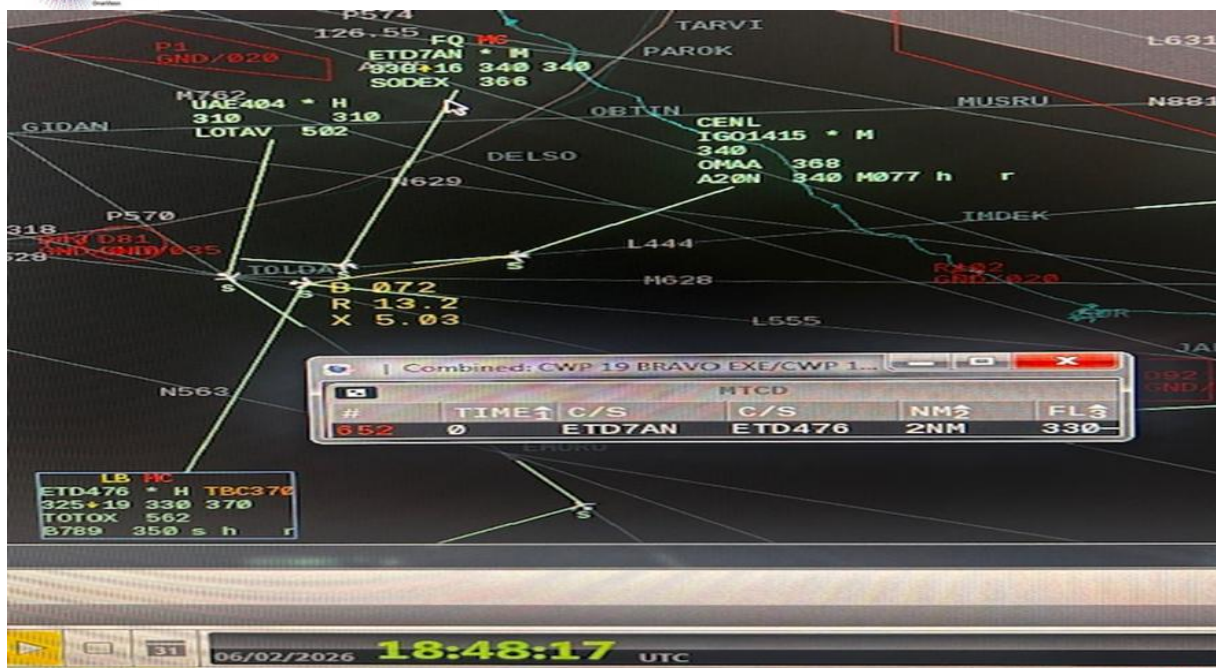
1.1.16 At 18:48:17, the Red STCA was deactivated between the two aircraft as the vertical separation was exceeded 1300FT while ETD7AN was climbing to FL340 passing through FL338 at ROC1600FPM and ETD476 descending to FL320 passing through FL325 at ROD 1900FPM as shown in figure 11 below.

Figure 11 shows the Red STCA deactivated between the two aircraft as the vertical separation was 1300FT as ETD7AN was climbing to FL340 at ROC1600FPM and ETD476 descending to FL320 at ROD 1900FPM (Source: DGAN).

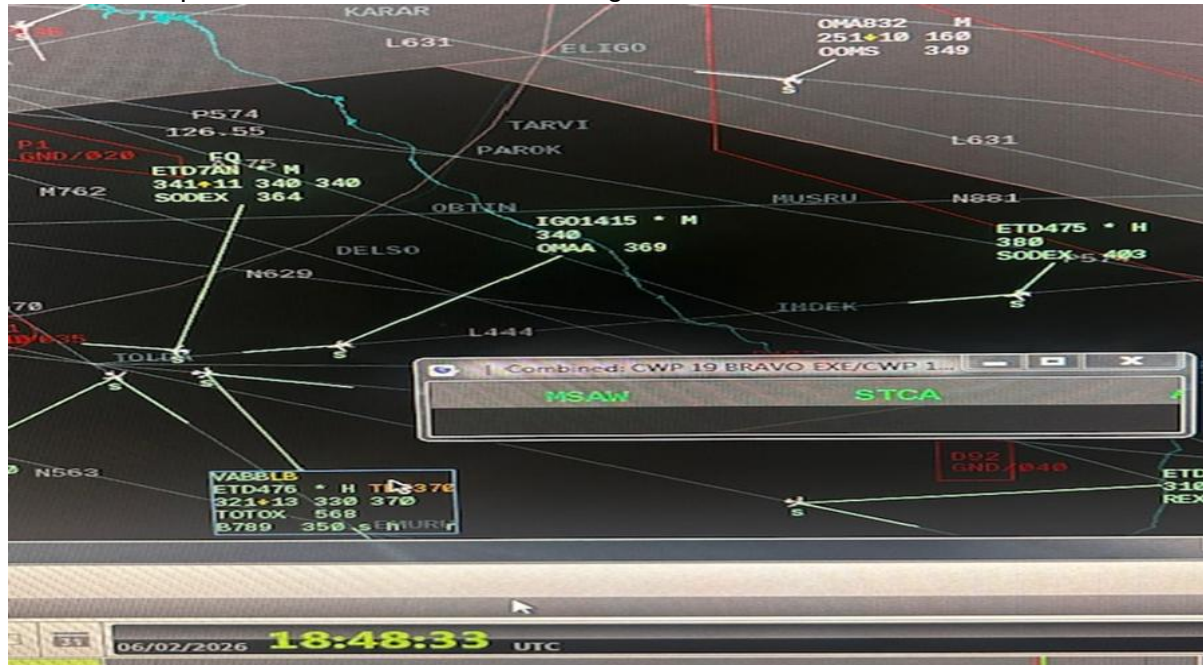
1.1.18 At 18:48:33, the conflict display window was deactivated from radar screen after ETD7AN and ETD476 passed each other as shown in figure 12 below.

Figure 12 shows conflict display deactivated from the radar screen as both aircraft passed each other (Source: DGAN).

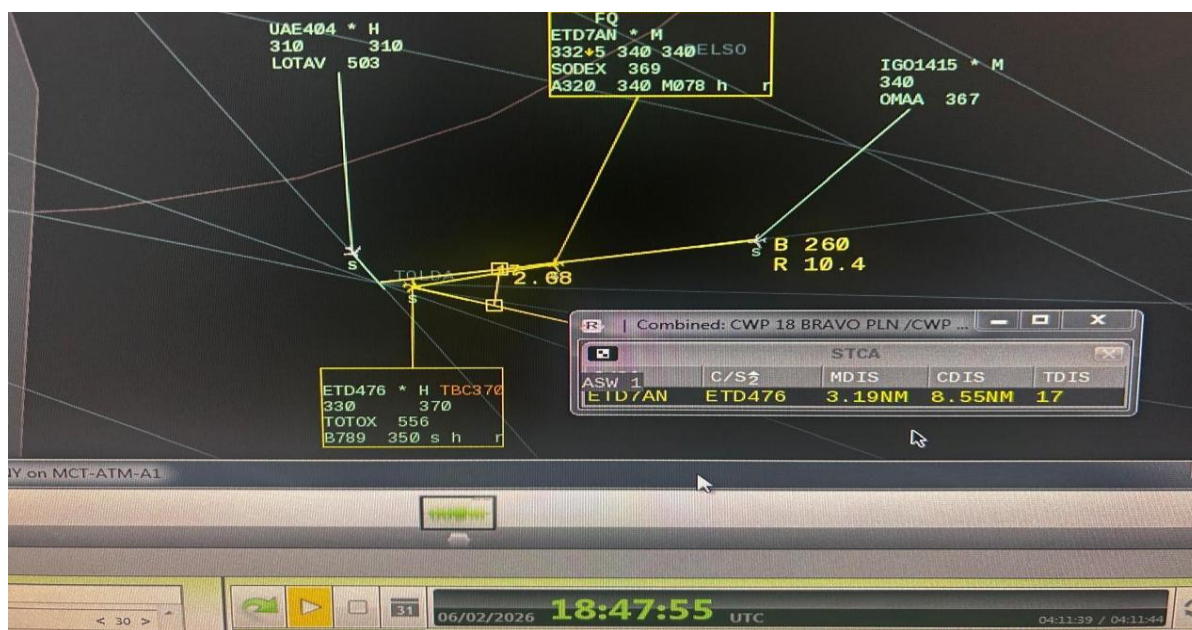
- 2.1.5 The descent action by the flight crew of ETD7AN resulted in reducing the prescribed minimum from 1000FT to vertical separation of 200 FT between aircraft ETD7AN and opposite direction aircraft ETD476. Meanwhile, the horizontal separation was 8.55NM closing and both aircraft TCAS detected the conflict and triggered RA. The flight crew of both ETD7AN and ETD476 responded and followed the TCAS RA as required by the operator's operational procedures, executing the appropriate vertical maneuvers and reported TCAS RA to ATCO as shown in figure 14.

Figure 14. shows TCAS RA was reported between ETD476 maintaining FL330 and opposite direction ETD7AN descending through FL332 with ROD of 500FPM with a vertical separation of 200FT (Source: DGAN)

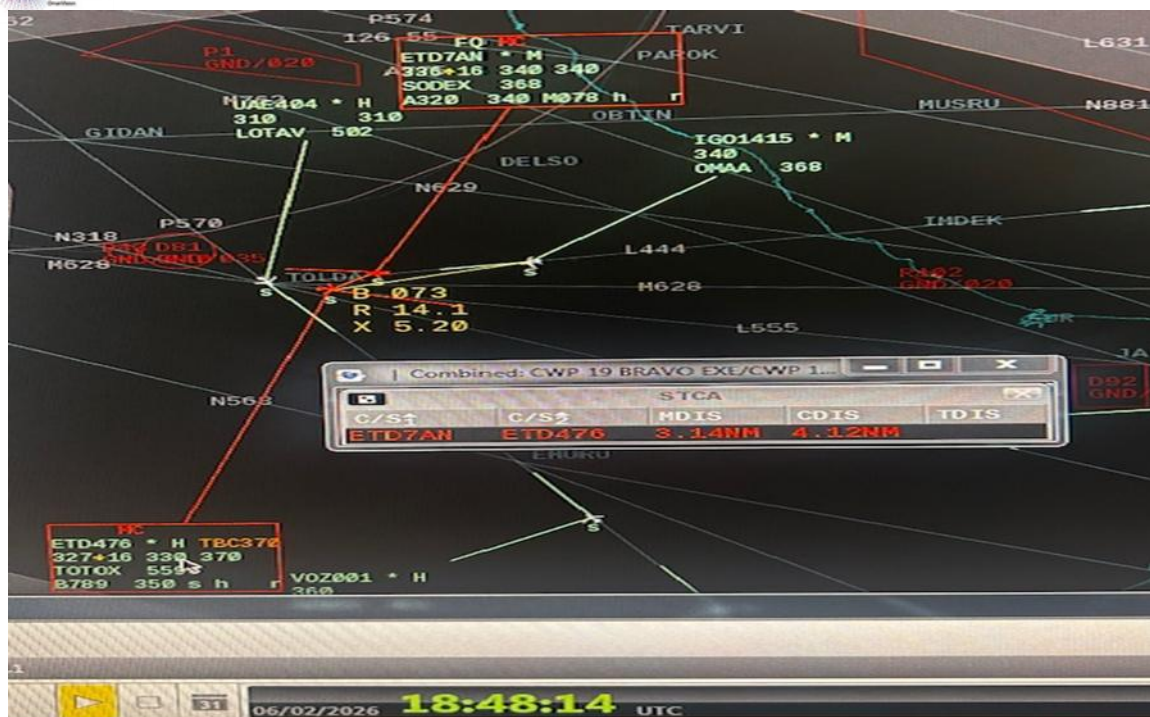
- 2.1.6 Figure 15 below shows red STCA between ETD476 descending through FL327 with ROD 1600FPM and ETD7AN climbing through FL336 with ROC of 1600FPM with a vertical separation of 900FT and horizontal distance of 4.12NM.

Figure 15. shows red STCA between ETD7AN climbing through FL336 with ROC of 1600FPM with a vertical separation of 900FT and ETD476 descending through FL327 with ROD 1600FPM (Source: DGAN).
