Oman Transport Safety Bureau

Preliminary Report

OTSB Case File No: AIFN-001/01/2024

Singapore Airline B777 Flight Level Bust during Cruise over MCT FIR

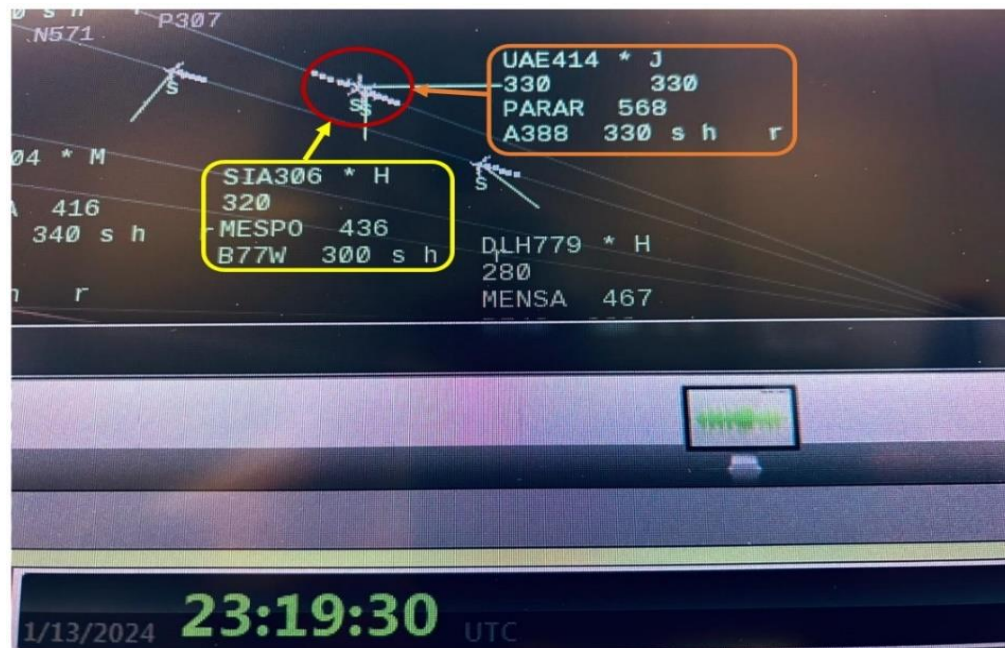
- 1.1.4. SIA306 contacted Muscat Air Traffic Control (ATC) over WAP PARAR at time 23:12. The Air Traffic Controller (ATCO) instructed SIA306 to maintain FL320 and to continue on Flight Plan Route with Squawk 3256. Meanwhile, UAE414 (Airbus 380) was on the same airway P307 at FL330, crossed over SIA306 which was at FL320 on AWY P307 at time 23:19:30 as per the below ATC radar screen (Figure 1)

Figure 1 ATC Radar screen showing flight levels and details of SIA306 and UAE 414

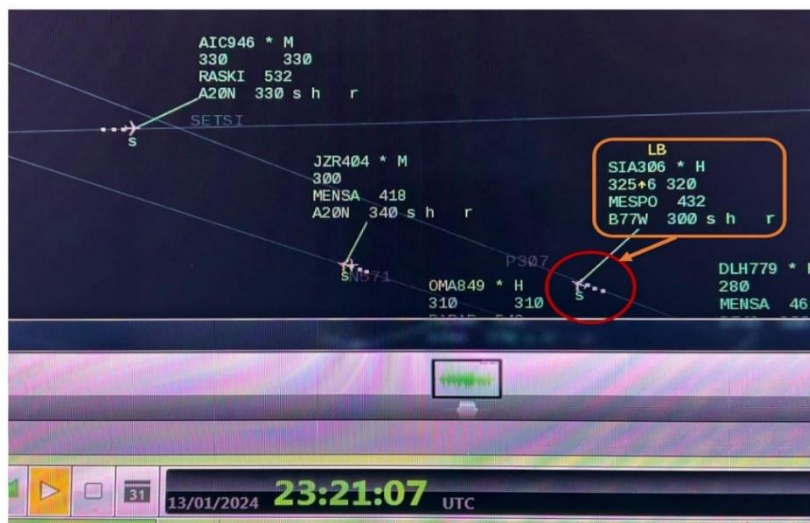
- 1.1.10. At time: 23:21:07, the ATCO noticed that SIA306 had climbed to FL325 on the AWY P307 and immediately called the flight crew for verifying the reason of the climb however there was no response from SIA306 flight crew.

Figure 2 is from ATC radar screen showing SIA306 at flight level 325

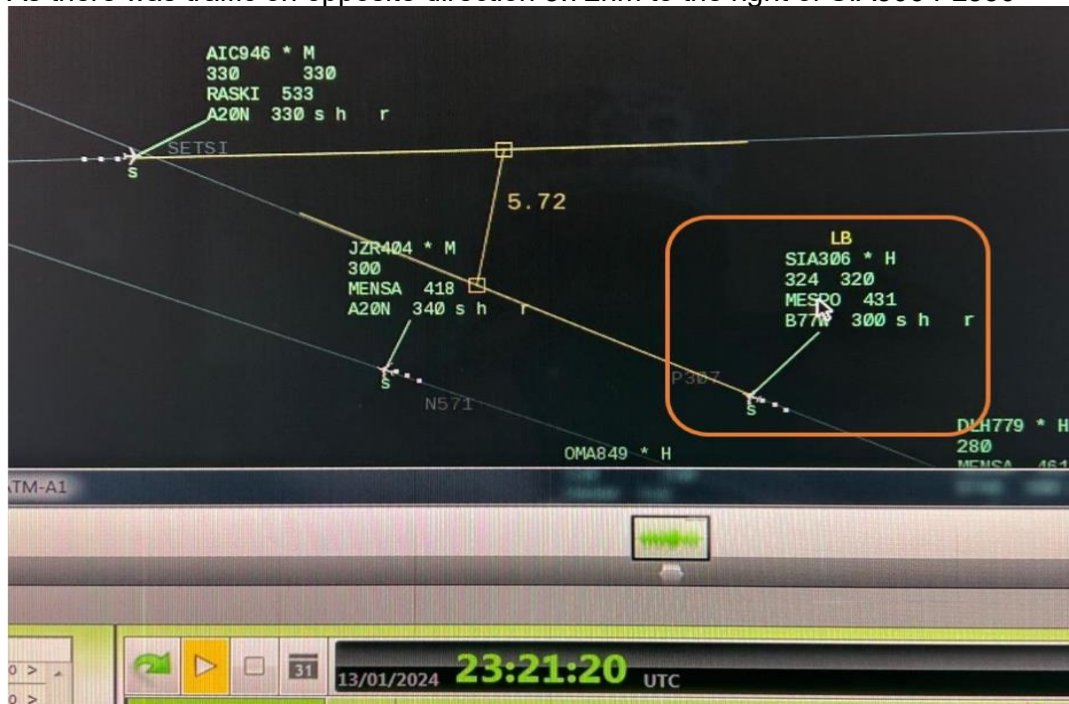
- 1.1.14. According to the ATC radar screenshot in Figure 3, in case of any deviation there was a possibility to trigger the SIA306 TCAS alert with a minor deviation as there was traffic AIC946 at FL330 on distance of 5.72 Nautical Mile (NM). As there was traffic on opposite direction 5.72nm to the right of SIA306 FL330

Figure 3 shows ATC radar screen shot of SAI306 during the recovery phase

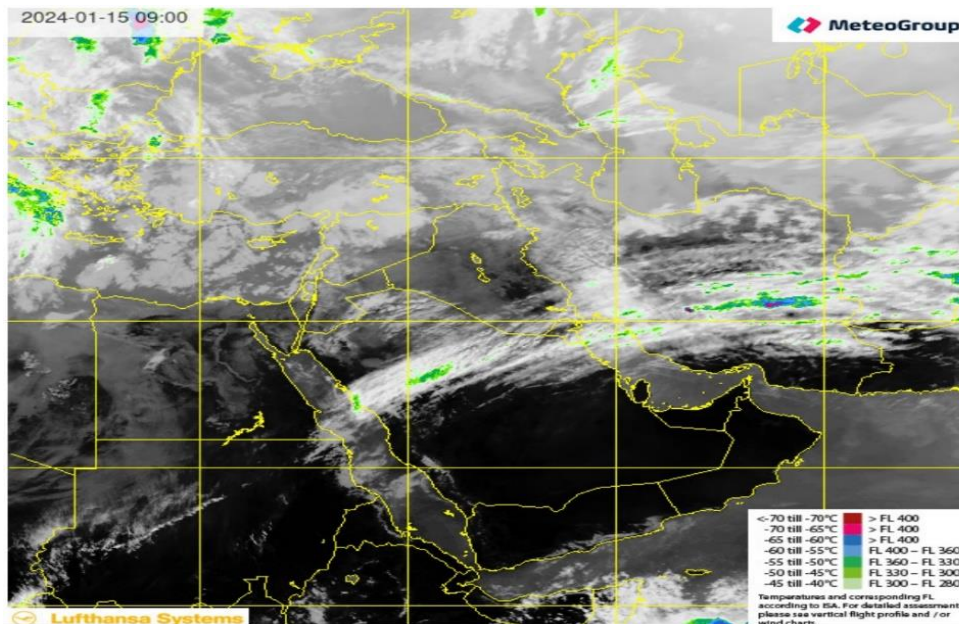
The Satellite image of time of the occurrence shown below, indicates it was a clear sky and this could indicate that no turbulence can be associated at the time of the occurrence.

.Figure 5: Clouds around the area where the aircraft experienced wake turbulence
