Oman Transport Safety Bureau

Preliminary Report

OTSB Case File No: AIFN-001/10/2023

Oman Air B787 severe turbulence with minor injuries to some of the cabin crew

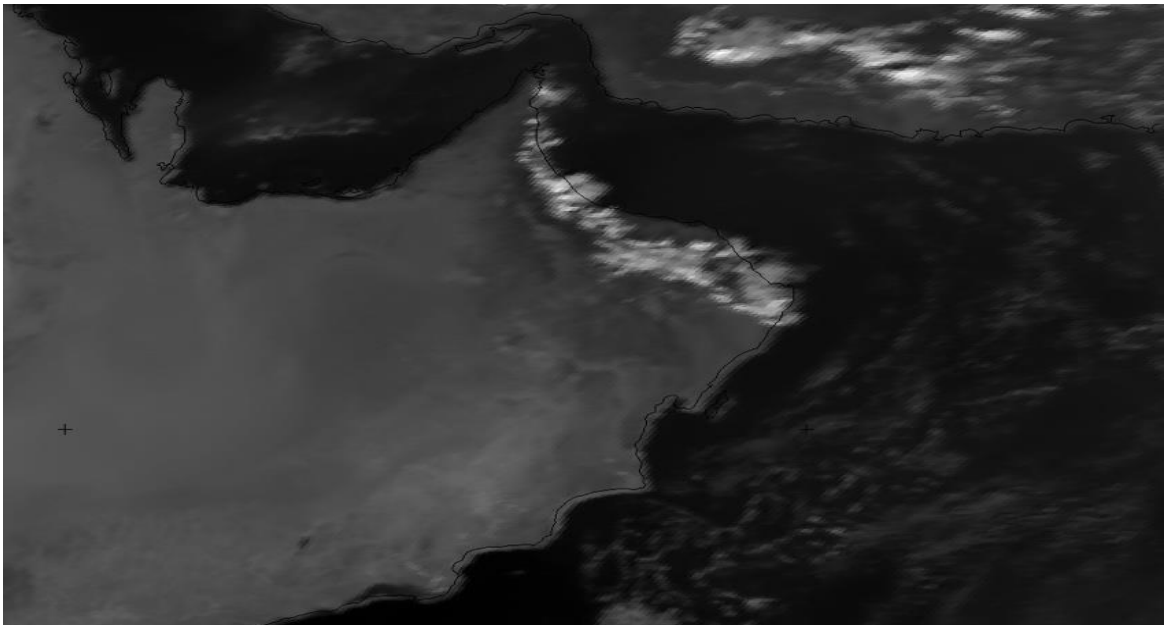
The Satellite image of time of the occurrence, shown below, reveals some convective clouds (towering cumulus) but still not CB clouds existed nearby the location of the occurrence. The TAF for Muscat Airport, issued on the 18th at 0500 UTC and valid from the 18th at 06:00 UTC to the 19th at 12:00 UTC, indicated the forecast of CB (Cumulonimbus) clouds between 10:00 UTC and 14:00 UTC. No Sigmet was issued.

Figure 2: showing Clouds around the area where the aircraft experienced severe turbulence.

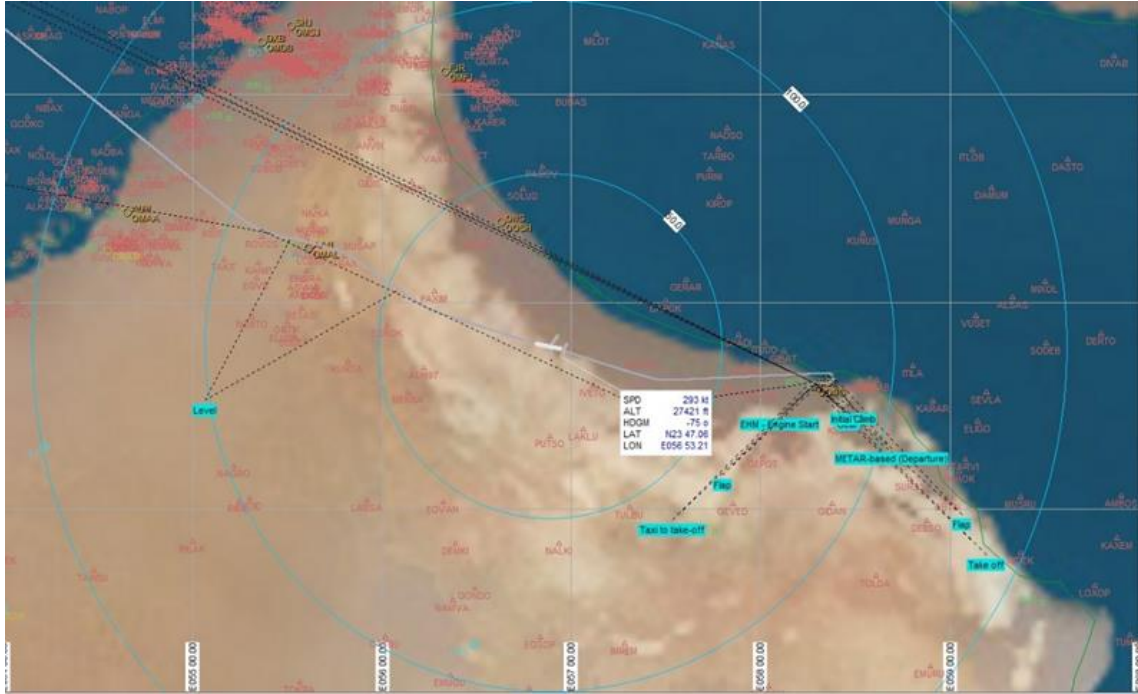
Figure 3: Satellite weather radar showing the position of the aircraft where the aircraft experience severe turbulence.
