Oman Transport Safety Bureau (OTSB)

Final Report

OTSB Case File No: AIFN-006/10/2024

Salam Air A321-251N Ground Proximity Warning System (GPWS) Serious Incident

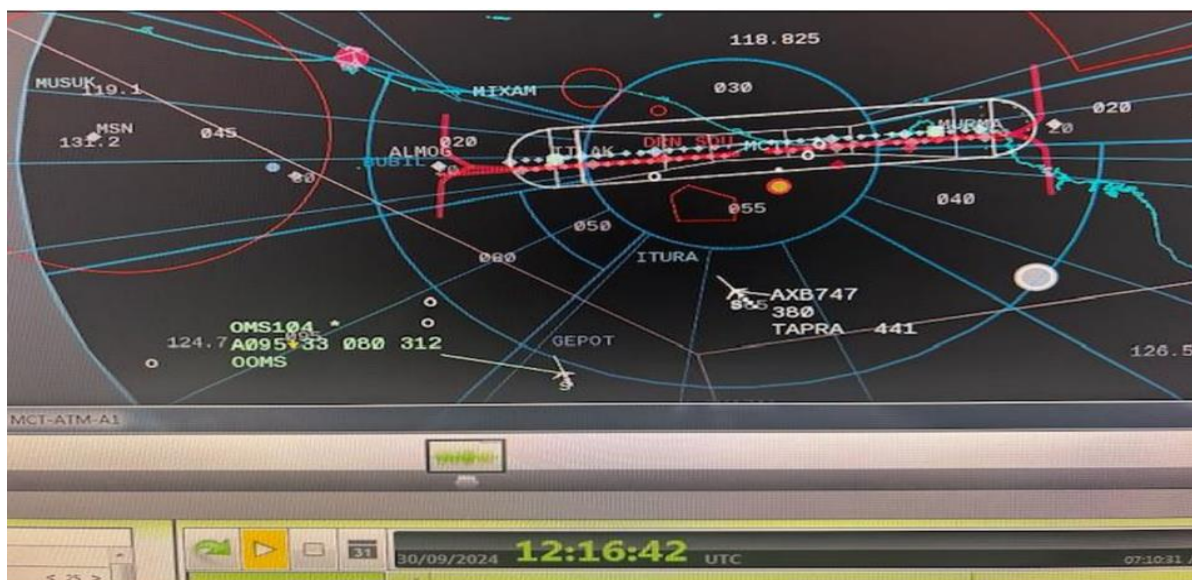
Figure 2: showing aircraft OMS104 observed on radar passing through 9500FT at a ROD3300 FPM descending to 8000FT (Source: DGAN).

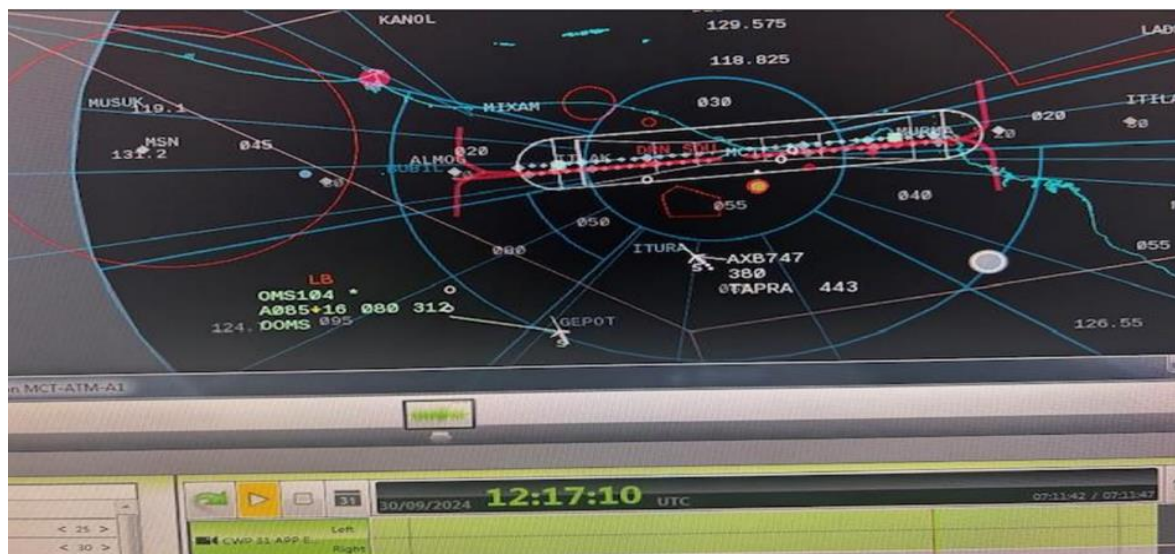
Figure 3: showing aircraft OMS104 observed on radar passing through 8500FT at ROD 1600 FPM descending to 8000FT (Source: DGAN)

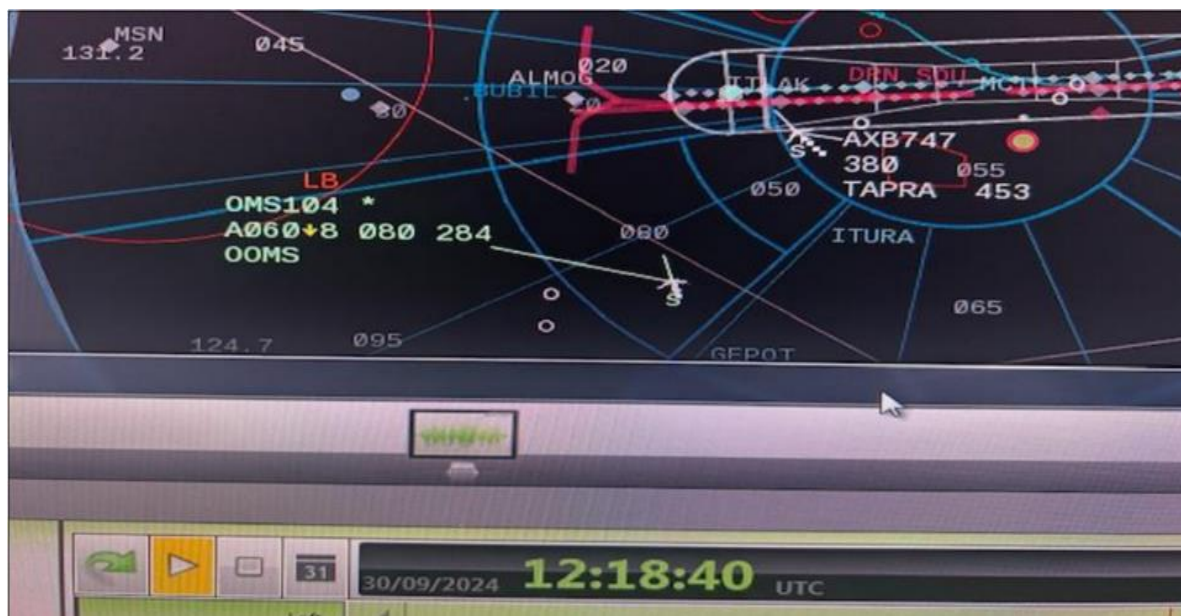
Figure 4: showing aircraft OMS104 observed on radar on passing through 8000FT ROD of 800 FPM descending to 4000FT as cleared by ATCO (Source: DGAN)

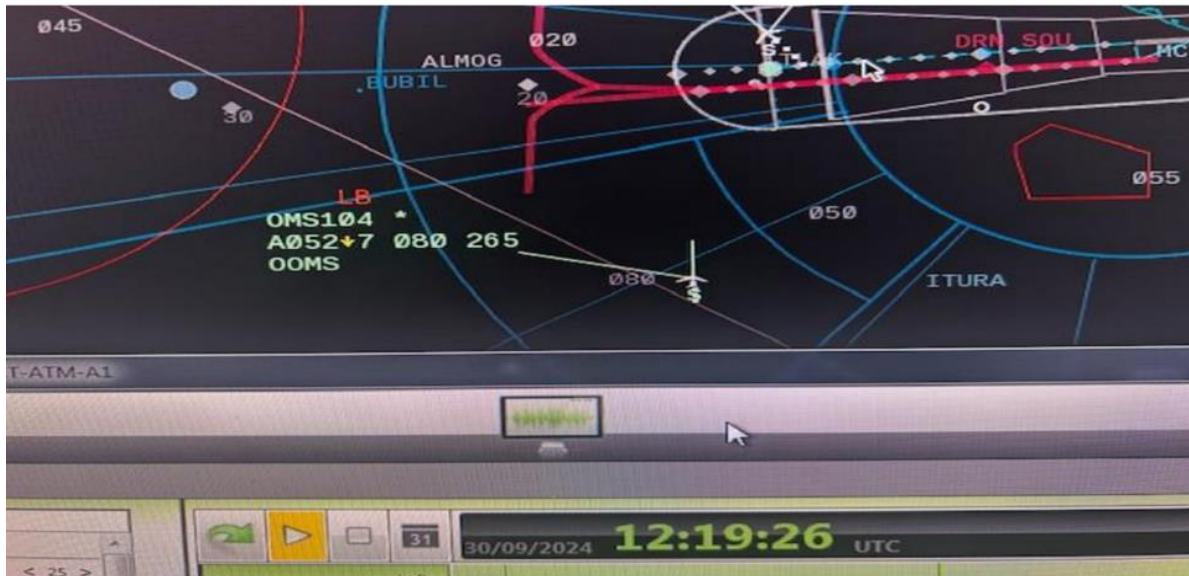
Figure 5: showing aircraft OMS104 observed on radar descending through 5200FT at ROD of 700FPM as cleared ALT by ATCO to 4000FT visually (Source: DGAN).

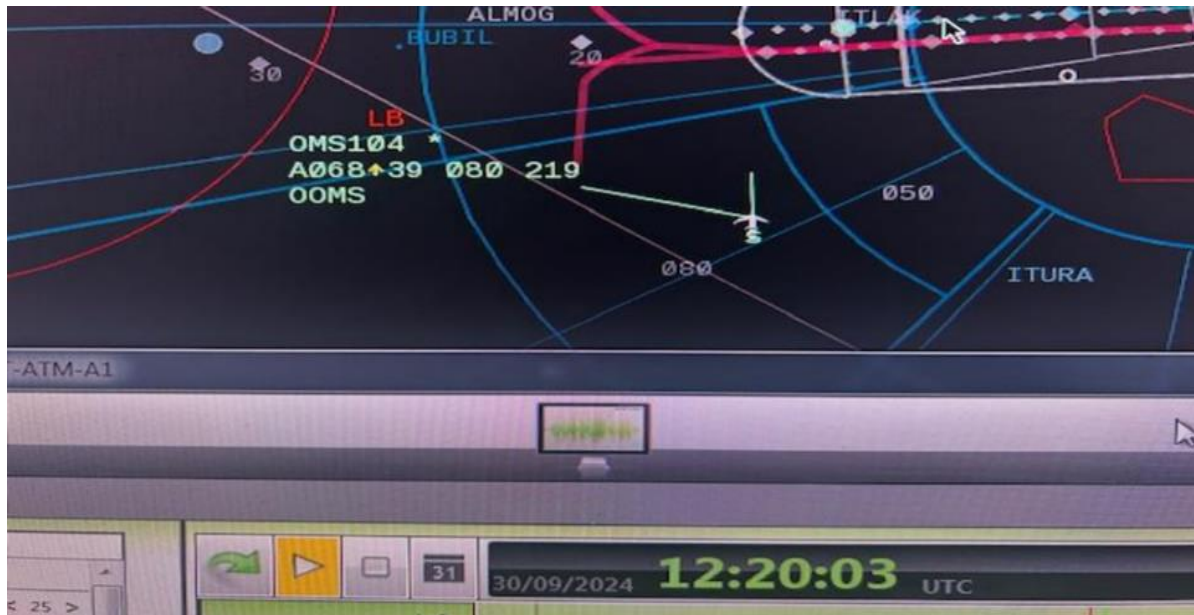
- 1.1.15 At the time 12:19:30, the EGPWS warning triggered to "Pull Up terrain" to which the Flight crew applied memory action procedures and the Flight crew advised ATCO that they were climbing.
- 1.1.16 At the time 12:20:03, the aircraft OMS104 was observed on the radar screen climbing through ALT 6800FT and they requested vectors for ILS 08L and normal operations were followed thereafter and the safe conduct of the flight was always ensured.

Figure 6: showing aircraft OMS104 observed on radar climbing to 8000FT passing through 6800FT at ROC of 3900FPM over an MSA sector of 8000FT (Source: DGAN)

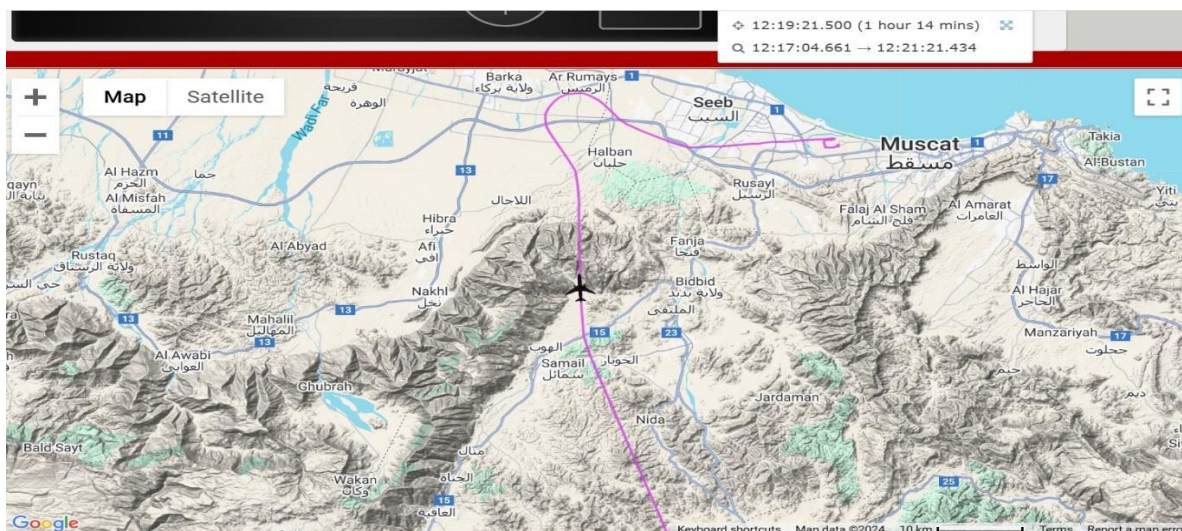
1.1.14 As per the aircraft Flight Data Monitoring (FDM) recording between 12:15:00 and 12:20:00 the aircraft OMS104 got EGPWS caution message “terrain ahead” and the Flight crew selected vertical speed to zero while flying level at green dot.

Figure 7: showing aircraft OMS104 observed on FDM flight path 5 seconds before approaching terrain GPWS CAUTION (Source: Salam Air)

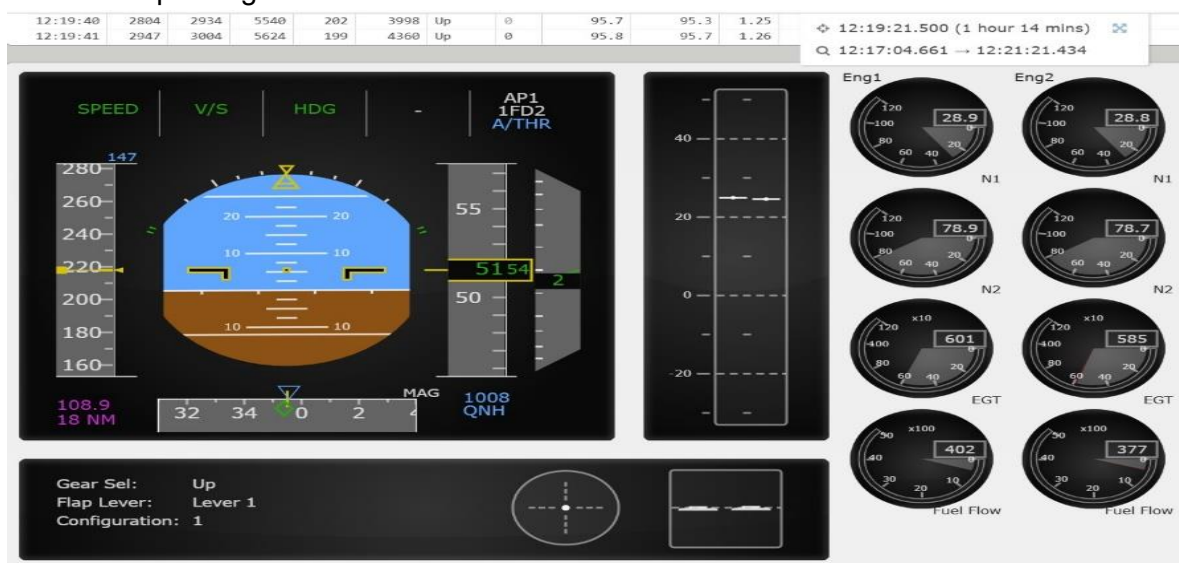
Figure 8: showing aircraft OMS104 observed on FDM climbing through ALT 5154FT to ALT 8000FT (Source: Salam Air)

1.1.18 During the interview, the Flight crew stated that during the descent they shallowed the ROD. As per the FDM the aircraft was observed climbing passing through 5154 FT as in figure 8. The Flight crew levelled off at around 5500FT as they were in Visual Meteorological Condition (VMC) with the terrain clearly insight and with sufficient terrain clearance (more than 2000 FT above the terrain highest point).

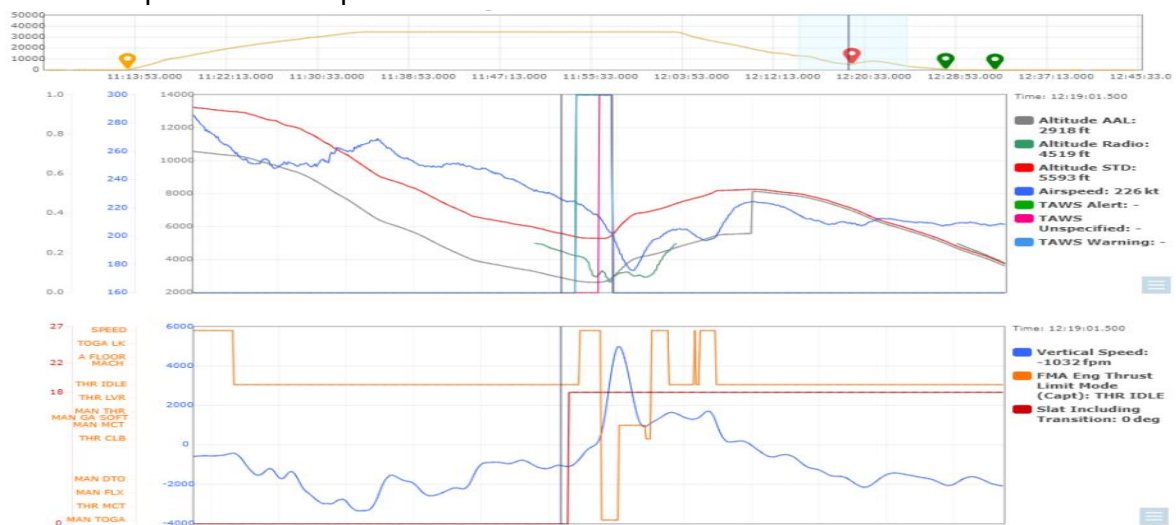
Minimum Safe Altitude (MSA): 8500/9100FT
Altitude at Trigger: Approximately 5100FT

Figure 14 indicates TAWS warning at 5593FT, Vertical Speed and Thrust Mode (aircraft OMS104-Source: Operator)

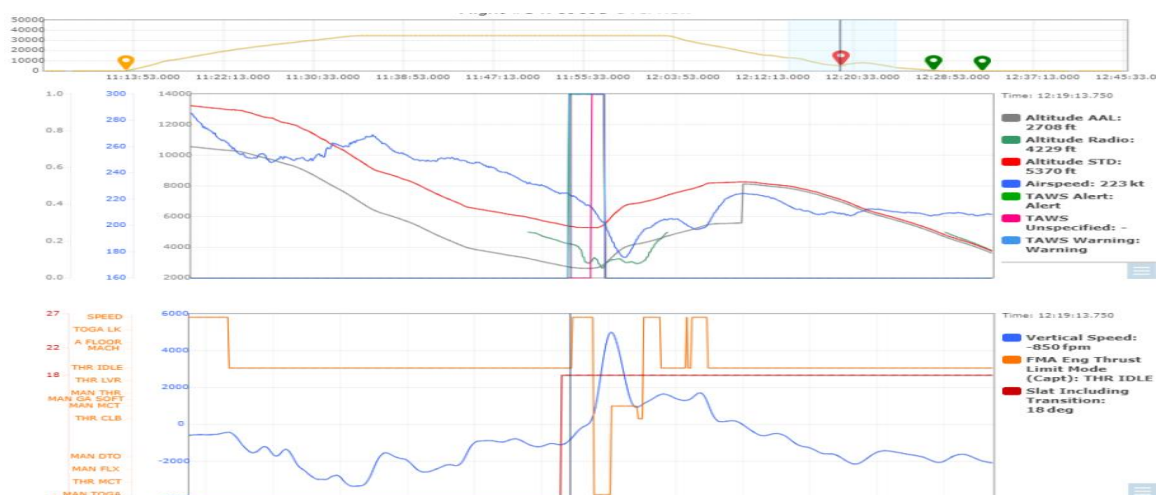
Figure 15 indicates TAWS warning, Vertical Speed, Thrust Mode and Config 1 selected (aircraft OMS104-Source: Operator)

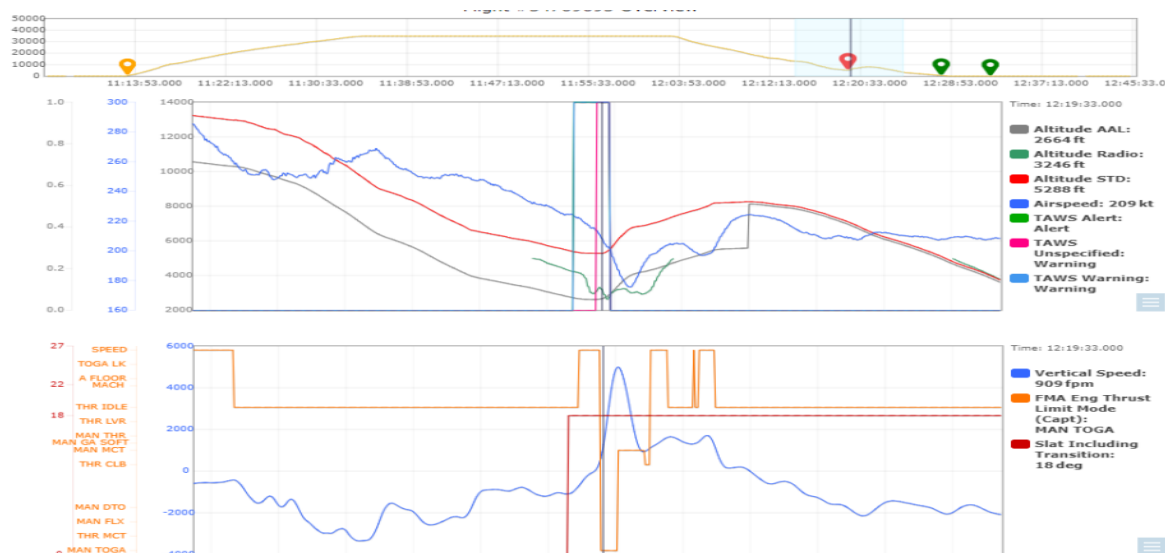
Figure 16: indicates GPWS recovery action (aircraft OMS104-Source: Operator)
