Oman Transport Safety Bureau (OTSB)

Final Report

OTSB Case File No: AIFN-004/06/2024

TCAS Resolution Advisory between Etihad Airways-Airbus 321-231 and Air India Express Boeing 737-800NG over Muscat FIR

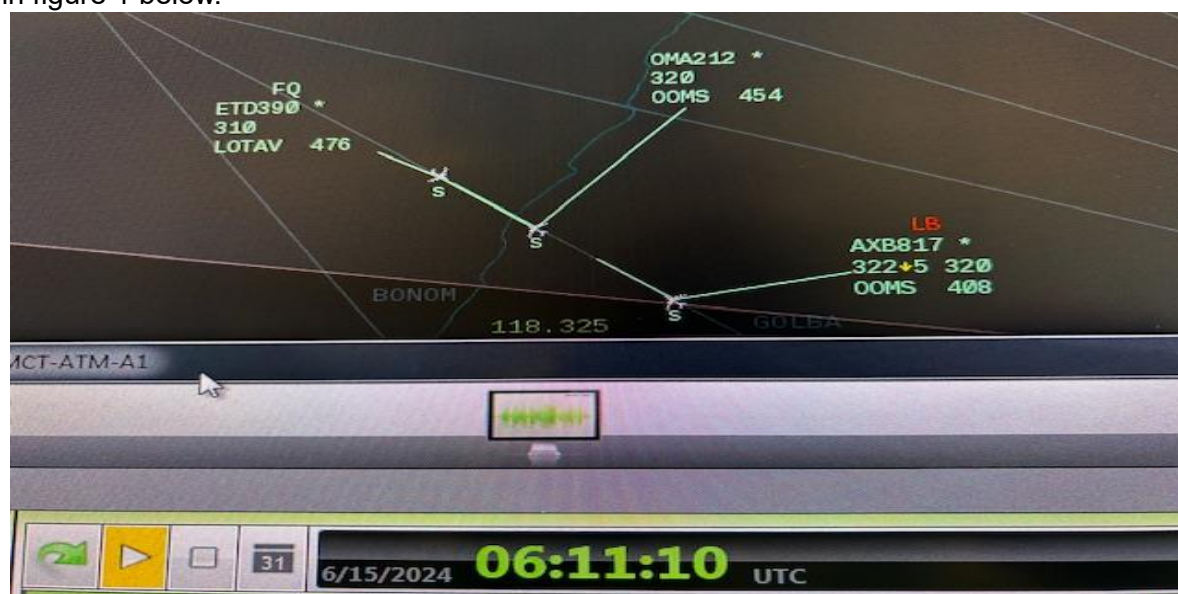
- 1.1.13 At the time 06:11:10, Level Burst (LB) alert was activated on the ATCO Indra radar display screen as aircraft AXB817 was on descent passing through FL322 with a Rate of Descent (ROD) 500 feet per minute (FPM) and aircraft ETD390 was maintaining FL310 as indicated in figure 1 below.

Figure 1: indicating Level Burst (LB) on aircraft AXB817 while descending through FL322 for FL160 with ROD 500FPM.

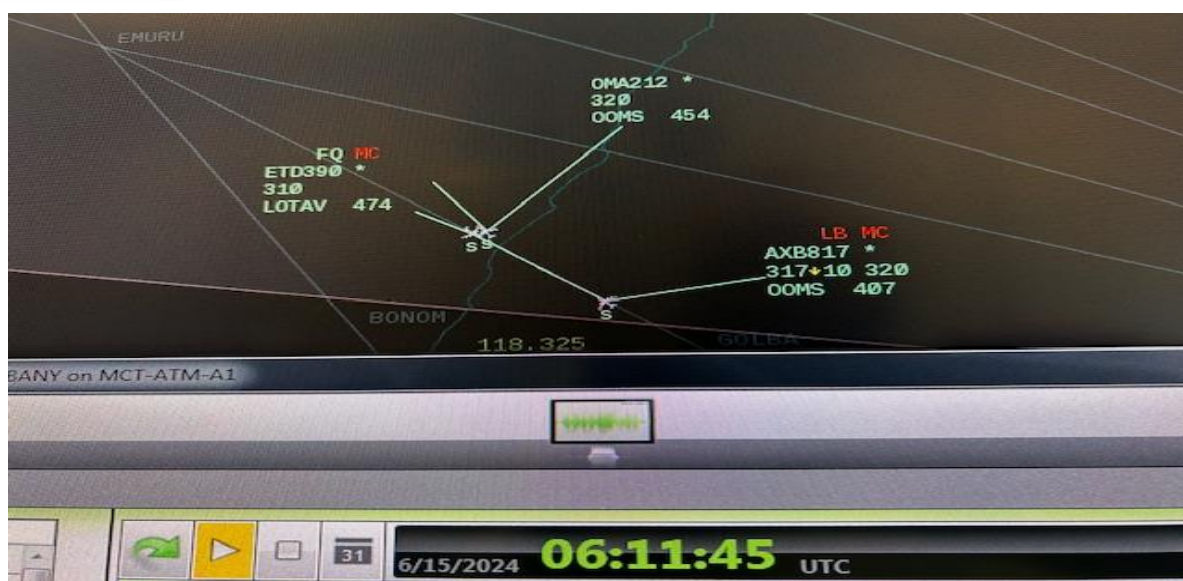
- 1.1.14. At the time 06:11:45, the Medium-Term Conflict Detection (MC) alert along with the LB was activated on aircraft AXB817 displayed on Middle sector ATCO radar screen while the Medium-Term Conflict Detection (MC) alert was activated on aircraft ETD390 which was maintaining FL310. The aircraft AXB817 was descending through FL317 for FL160 at a ROD 1000FPM as indicated on the below figure 2.

Figure 2: indicates Medium Term Conflict Detection activated on both aircraft ETD390 and aircraft AXB817.

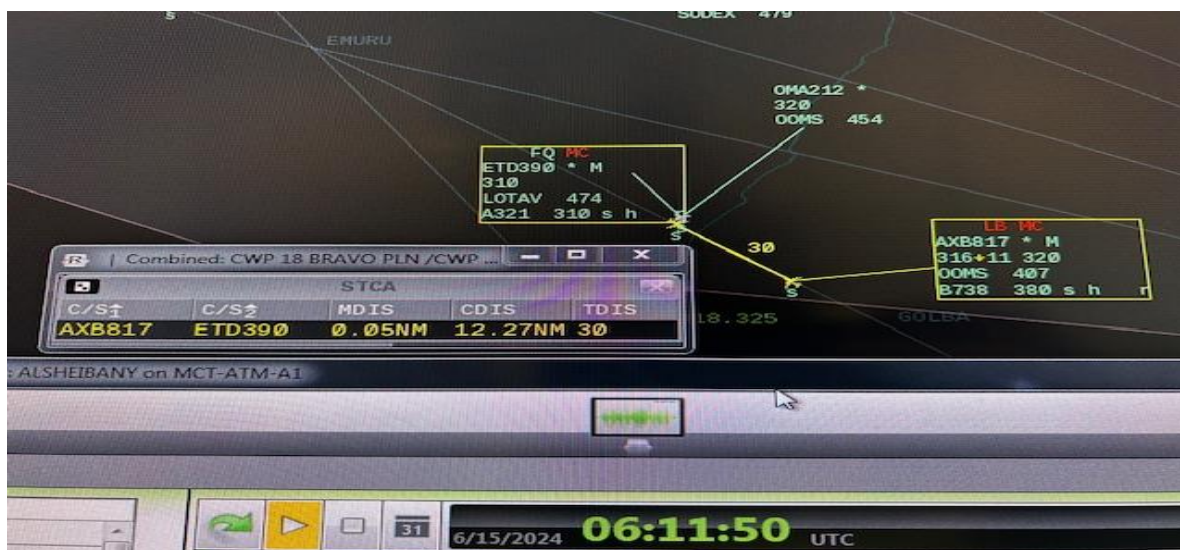
- 1.1.15 At the time 06:11:50, yellow Short-Term Conflict Alert (STCA) was activated on the Middle sector ATCO radar screen between aircraft ETD390 and aircraft AXB817 with a distance of 12.27 Nautical Mile (NM) and distance in time of 30 Seconds apart as per the below figure 3.

Figure. 3: STCA alert activated on Middle sector ATCO radar screen between aircraft ETD390 and aircraft AXB817

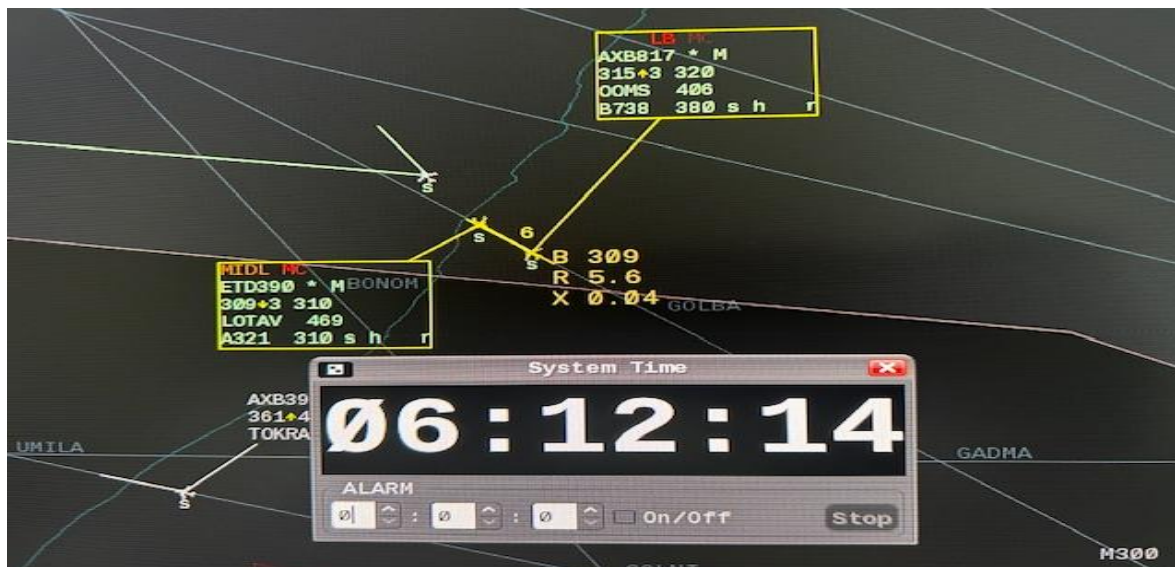
- 1.1.18 At the time 06:12:14, during radar playback both aircraft ETD390 and aircraft AXB817 were observed responding to TCAS RA, aircraft AXB817 was climbing through FL315 to FL320 with ROC 300FPM and aircraft ETD390 was descending through FL309 and leaving FL310 with ROD 300FPM as shown in the below figure 4.

Figure 4: shows aircraft AXB817 was observed on the radar climbing through FL315 to FL320 with ROC 300FPM while aircraft ETD390 was descending through FL309 and leaving FL310 with a ROD 300FPM.

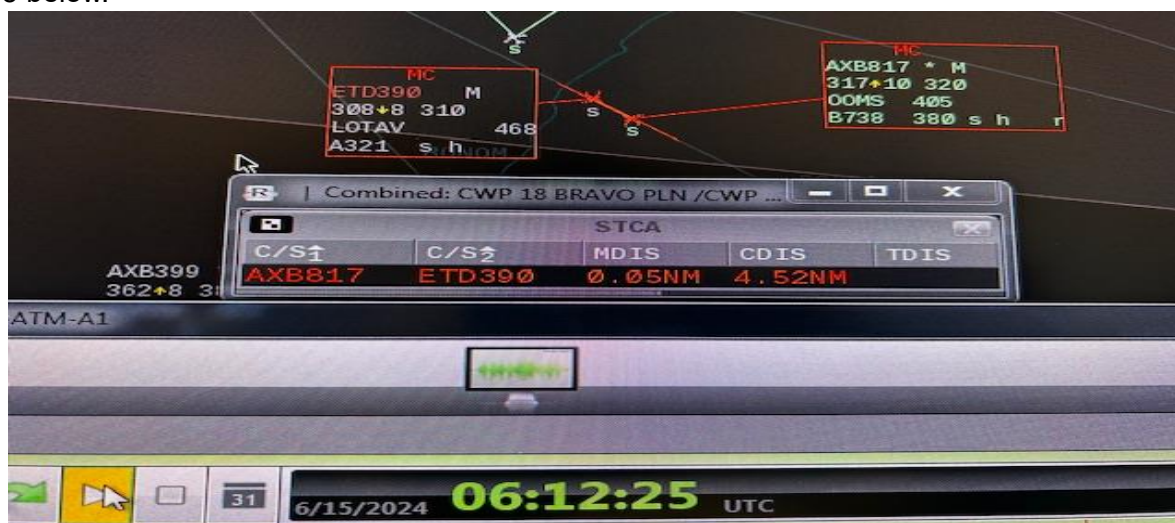
- 1.1.19 At the time 06:12:22, the distance between the two aircraft AXB817 and aircraft ETD390 was reduced to 4.52NM and vertical separation was 800 feet the STCA turned Red. At the time 06:12:25, red alert (STCA) displayed on the Middle sector ATCO radar screen between aircraft AXB817 while on climb passing through FL317 to FL320 with ROC 1000FPM and aircraft ETD390 descending through FL308 from FL310 with ROD 800FPM with a closing head-on distance of 4.52NM apart prior to both aircraft passing each other as shown in figure 5 below.

Figure 5: showing aircraft AXB817 while on climb passing through FL317 ROC 1000FPM and aircraft ETD390 on descent passing through FL308 ROD 800FPM with closing distance 4.52NM.

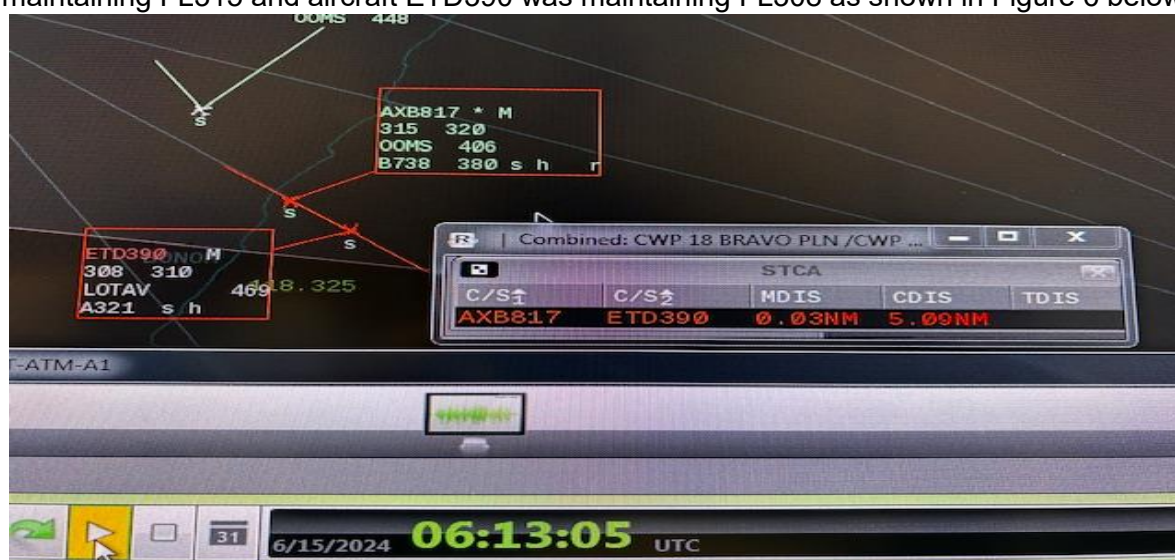
- 1.1.22 At the time 06:13:05, the red STCA was still activated on the Middle sector ATCO Radar display screen even after both aircraft passed each other safely while aircraft AXB817 was maintaining FL315 and aircraft ETD390 was maintaining FL308 as shown in Figure 6 below.

Figure 6: shows the red STCA was still activated on the Middle sector ATCO Radar display screen even after both aircraft passed each other safely.

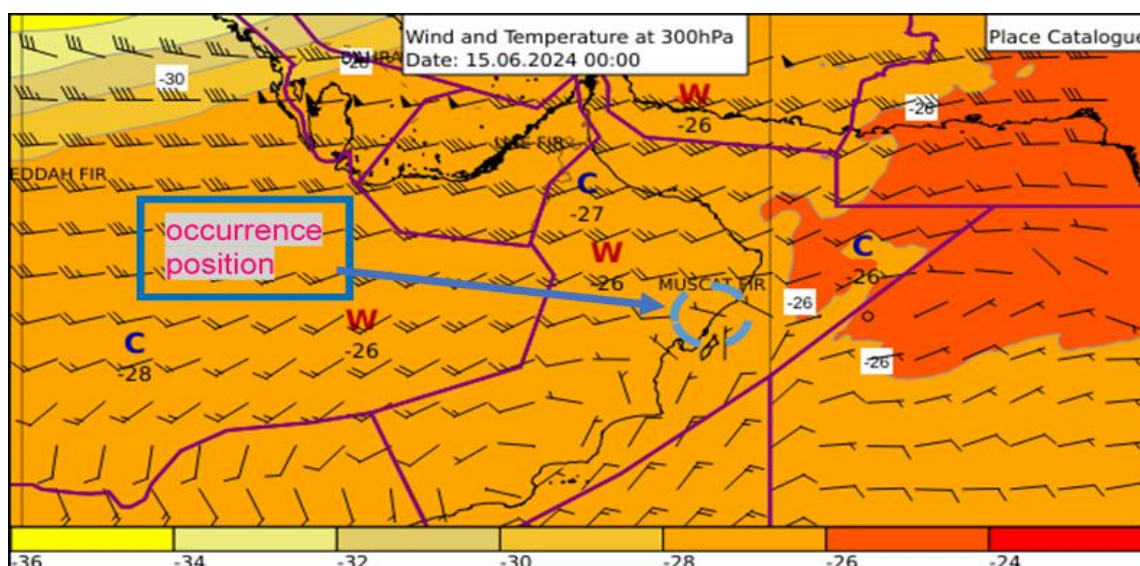
1.7.2 According to the Oman Directorate General of Meteorology (DGMET) office there was no significant weather and the wind indicated south westerly at 5 Knots as it shown in figure 7.

Figure 7: showing the weather conditions at the time and date of the occurrence.
