Oman Transport Safety Bureau (OTSB)

- Final Report -

OTSB Case File No: AIFN/003/05/2024

TCAS Resolution Advisory between Salam

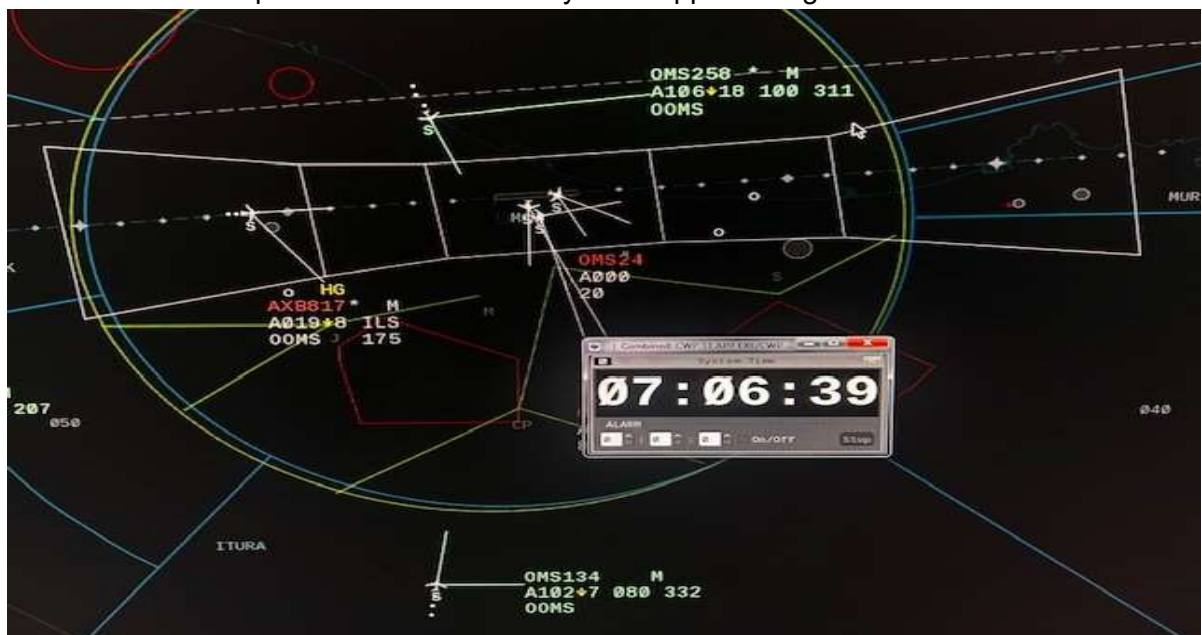
Figure 1: aircraft OMS258 was observed on radar descending through ALT10600FT to ALT 10000FT with ROD of 1000FPM while aircraft OMS134 was descending through ALT 10200FT to ALT 8000FT with ROD of 700FPM (Source: DGAN).

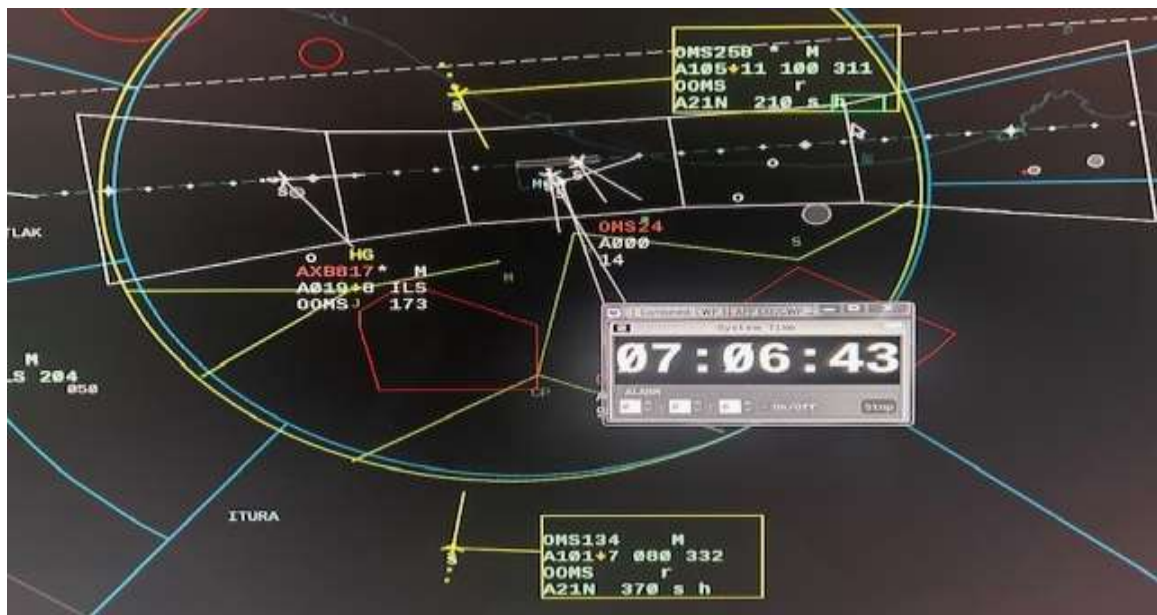
Figure 2: showing the yellow STCA was activated between aircraft OMS258 and aircraft OMS134 (Source: DGAN)

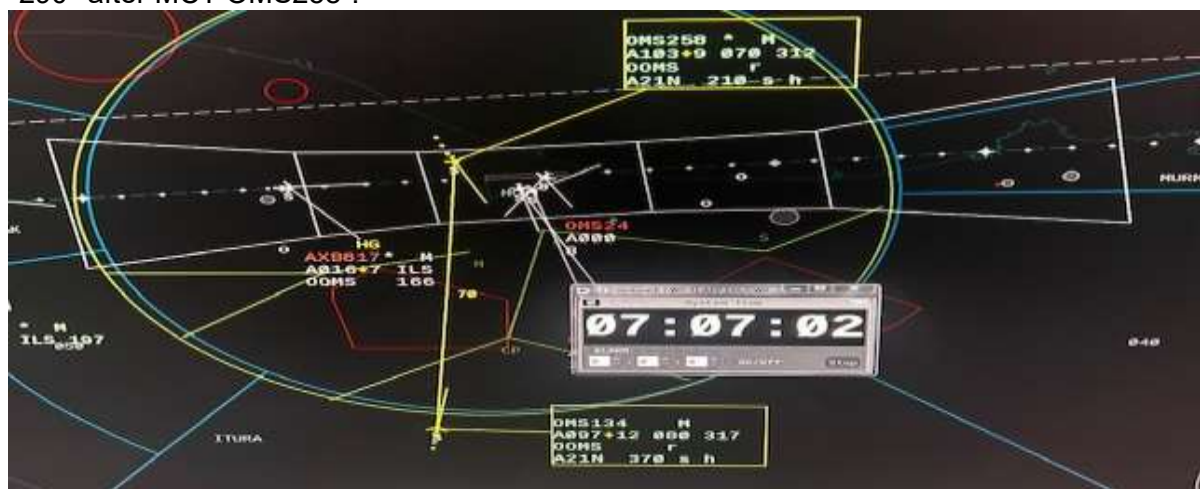
Figure 3: aircraft OMS258 was observed on radar on descend passing through ALT 10300FT descending to for ALT 7000FT with a rate of descent 900FPM while aircraft OMS134 was on descent passing through ALT 9700FT descending to 8000FT with a rate of descent 1200FPM with a distance of 70 seconds apart (Source: DGAN)

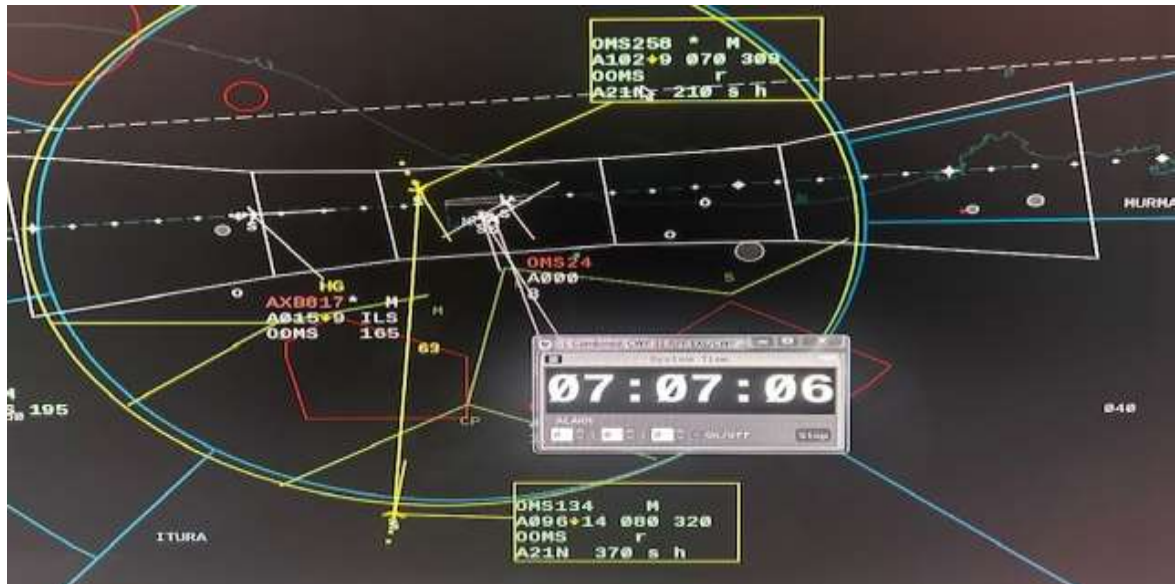
- 1.1.13 At the time 07:07:06, aircraft OMS258 was 1.5NM north of MCT VOR at ALT of 10200FT descending to ALT of 7000FT and at a ROD of 900FPM and a speed of around 250kts IAS. At the same time aircraft OMS134 was 11NM south of MCT VOR at ALT of 9600FT descending to ALT of 8000FT at a ROD of 1400 FPM and a speed of 250kts IAS.

Figure 4: showing aircraft OMS258 1.5NM north of MCT at ALT 10200FT descending through ALT 7000FT at a speed of 320kts IAS (Source: DGAN)

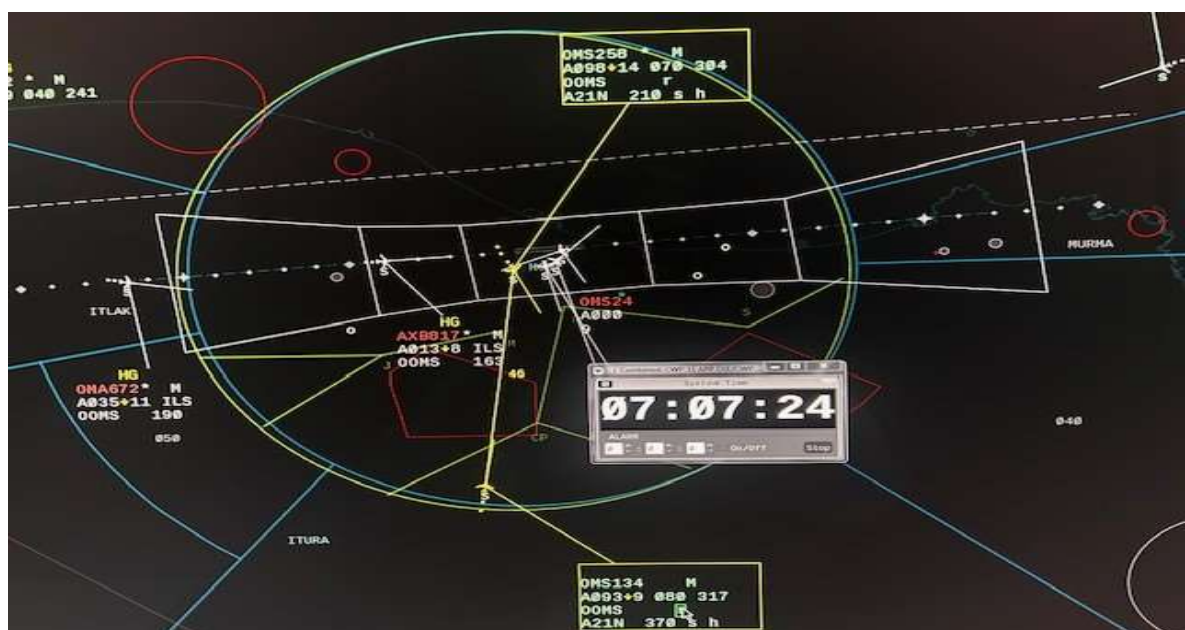
- 1.1.14 At the time 07:07:24, the APP ATCO confirmed if OMA134 was descending through ALT of 8000FT but there was no reply as there was no aircraft on frequency with such callsign. At the same time aircraft OMS258 was overhead MCT VOR descending through ALT 9800FT to ALT of 7000FT at ROD 1400FPM and IAS 304kts while aircraft OMS134 was descending through ALT 9300FT to ALT 8000FT at ROD of 900FPM, air speed of 317kts IAS. The distance in time between the two aircraft was 46 seconds.

Figure 5: showing both aircraft OMS258 and aircraft OMS134 descending with distance in time between them 46 seconds (Source: DGAN)

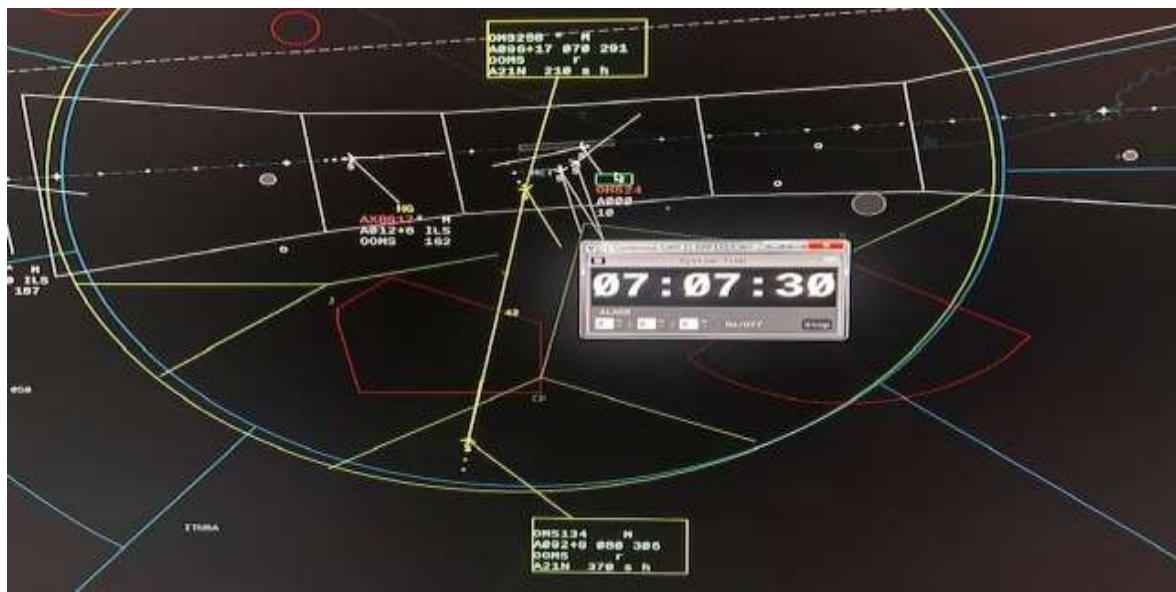
Figure 6: showing aircraft OMS258 descending through ALT 9600FT to ALT 7000FT at ROD of 1700FPM while aircraft OMS134 descending through ALT 9200FT to ALT 8000FT at ROD 800FPM and the distance in time between them was 39 seconds (Source: DGAN)

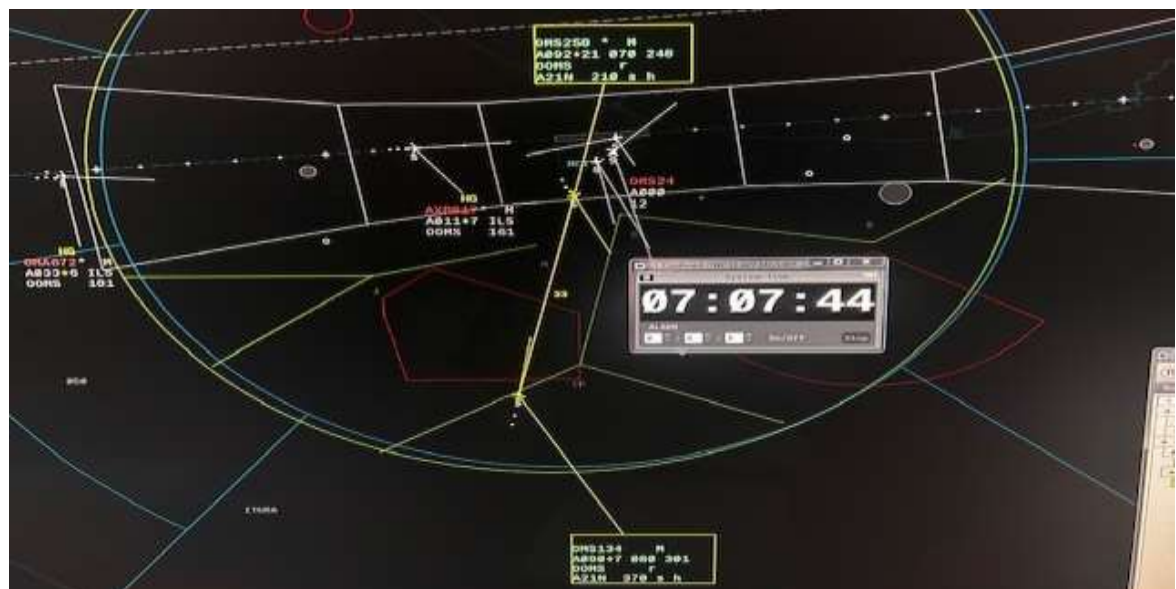
Figure 7: showing aircraft OMS258 descending through ALT 9200FT to ALT 7000FT at ROD 2100FPM while aircraft OMS134 descending through ALT 9000FT to 8000FT at ROD of 700FPM and the distance between the two aircraft in time was 33 seconds (Source: DGAN)

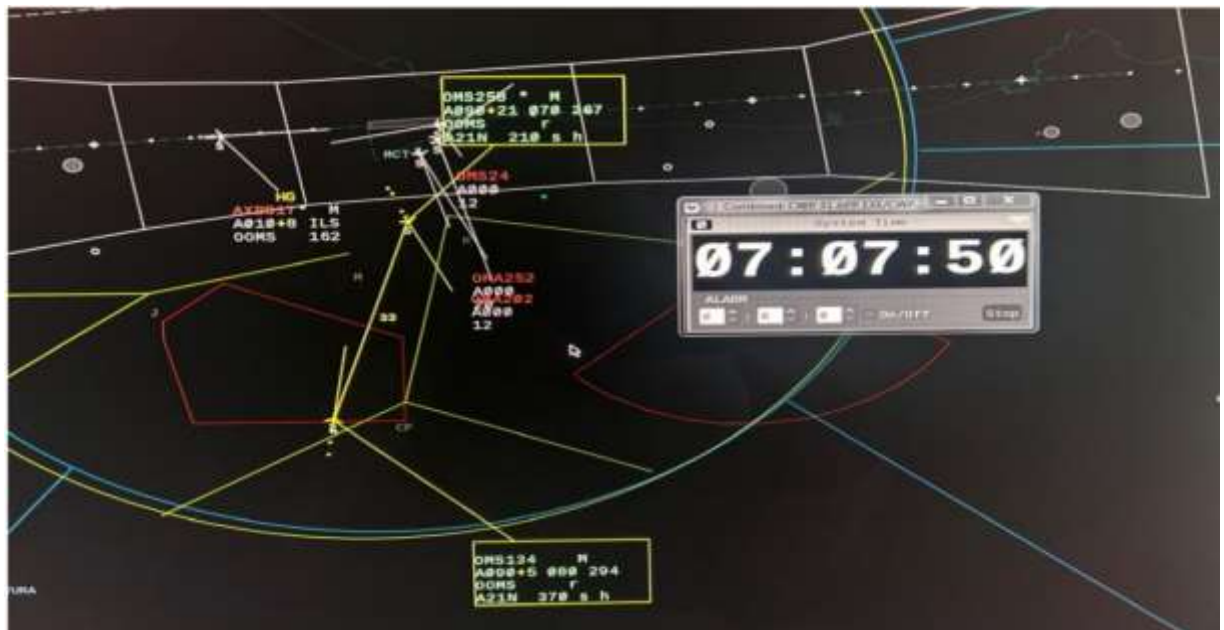
- 1.1.17 While aircraft OMS258 was changing its direction from right to left and at the time 07:07:44, aircraft OMS258 had Traffic Advisory (TA) and at the time 07:07:46 aircraft OMS134 also had TA. Both aircraft were at ALT of 9000FT and the distance between both aircraft was 1.98NM.

Figure 8: showing aircraft OMS258 was observed on radar descending through ALT 9000FT descending to ALT 7000FT at ROD of 2100FPM while aircraft OMS134 was descending through ALT 9000FT to ALT 8000FT at ROD of 500FPM-Yellow STCA (Source: DGAN)

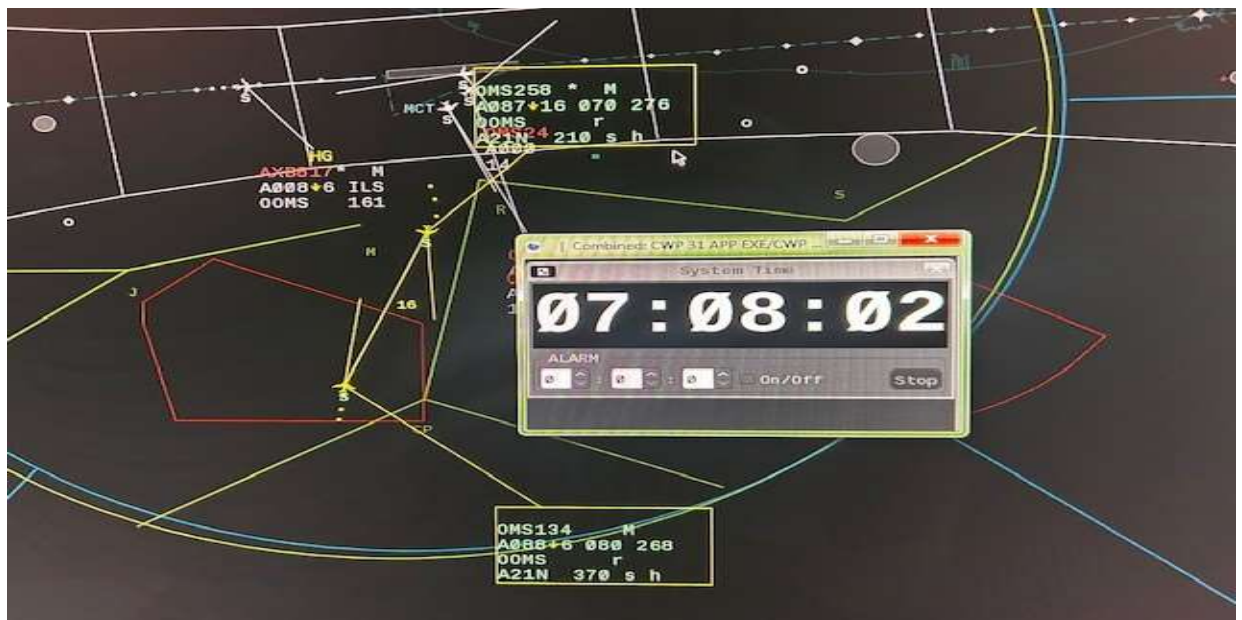
Figure 9 shows at 07:08:02 aircraft OMS258 and aircraft OMS134 had RA 2 seconds apart and the distance in time was 16 seconds (Source: DGAN)

- 1.1.19 At this time 07:08.05, the flight crew of aircraft OMS258 reported to ATCO that they have a conflict alert and 2 seconds later aircraft OMS134 had RA. The distance between the two aircraft in time was 16 seconds.

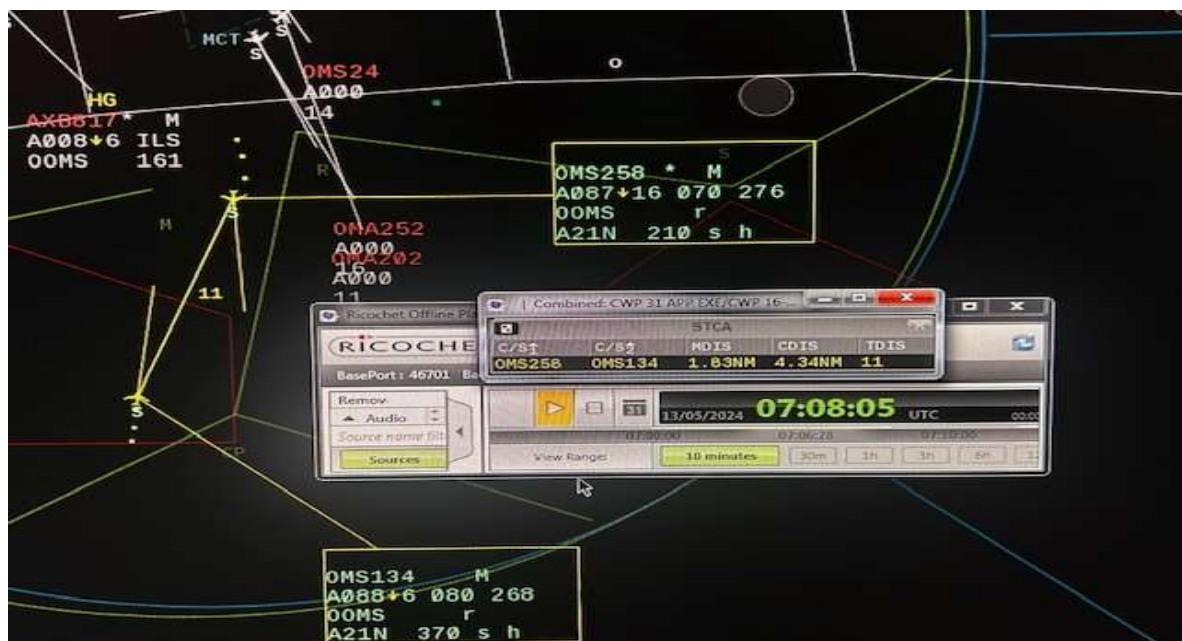
Figure 10: showing aircraft OMS258 was observed on radar descending through ALT 8700FT to ALT 7000FT at ROD of 1600FPM while aircraft OMS134 was descending through ALT 8800FT to ALT 8000FT at ROD of 600FPM (Source: DGAN)

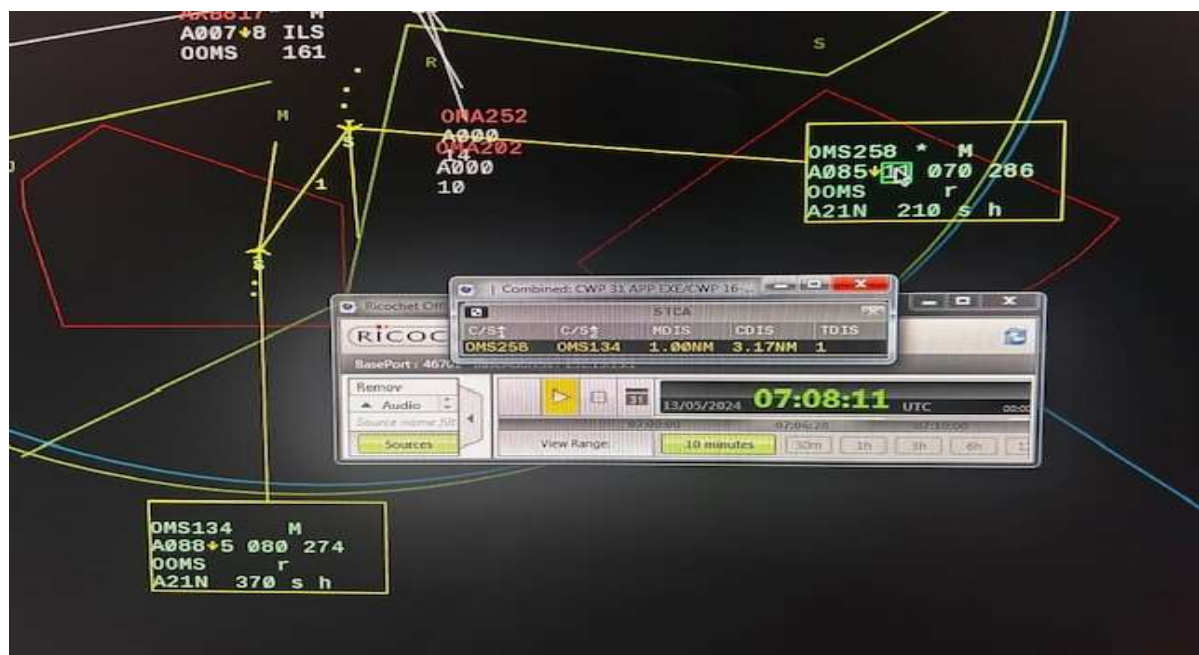
1.1.20 The ATCO radar screen showed that at the time 07:08:11 aircraft OMS258 was descending through ALT 8500FT to 7000FT, with a ROD of 1100FPM and a ground speed of 286kts IAS. Meanwhile aircraft OMS134 was descending through ALT 8800FT to 8000FT with a ROD of 500FPM and a ground speed of 274kts IAS. The distance between both traffic in time was 1 seconds.

Figure 11 showing aircraft OMS258 was observed on radar descending through ALT 8500FT to 7000FT while aircraft OMS134 was descending through ALT 8800FT to 8000FT with a ROD of 500FPM (Source: DGAN)

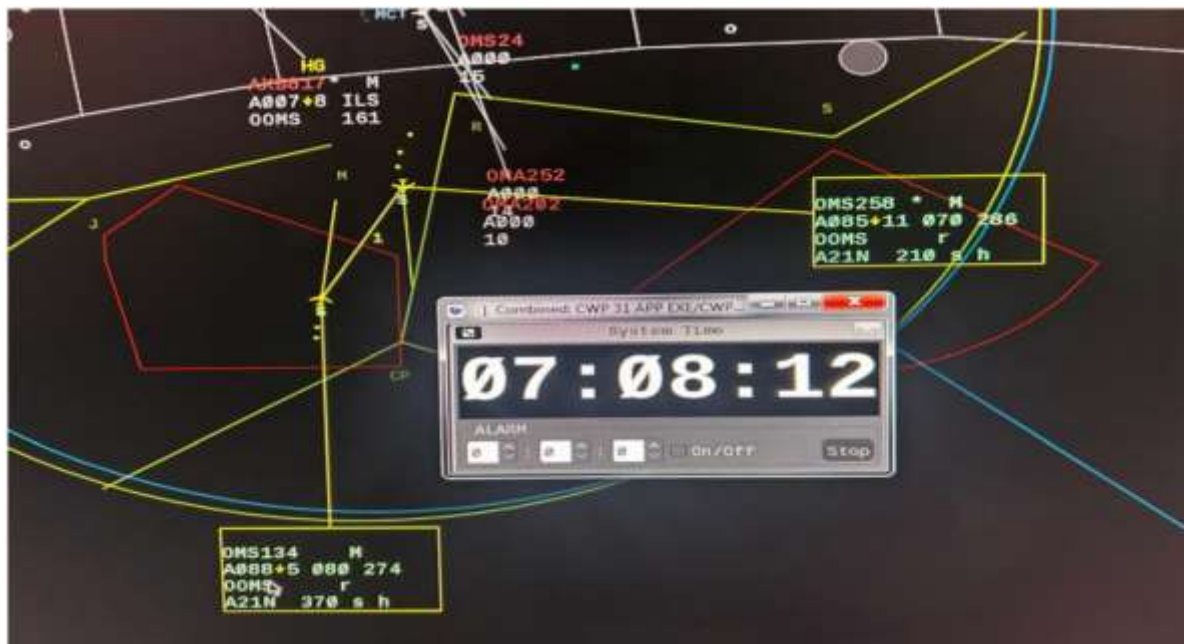
- 1.1.21 At the time 07:08:12, aircraft OMS258 while descending through ALT 8500FT to 7000FT at ROD of 1100FPM was observed on radar screen turning to the left.

Figure 12 showing radar screen where aircraft OMS258 was turning left while descending through ALT 8500FT to 7000FT and aircraft OMS134 descending through ALT 8800FT to 8000FT after they were clear of TCAS conflict (Source: DGAN)

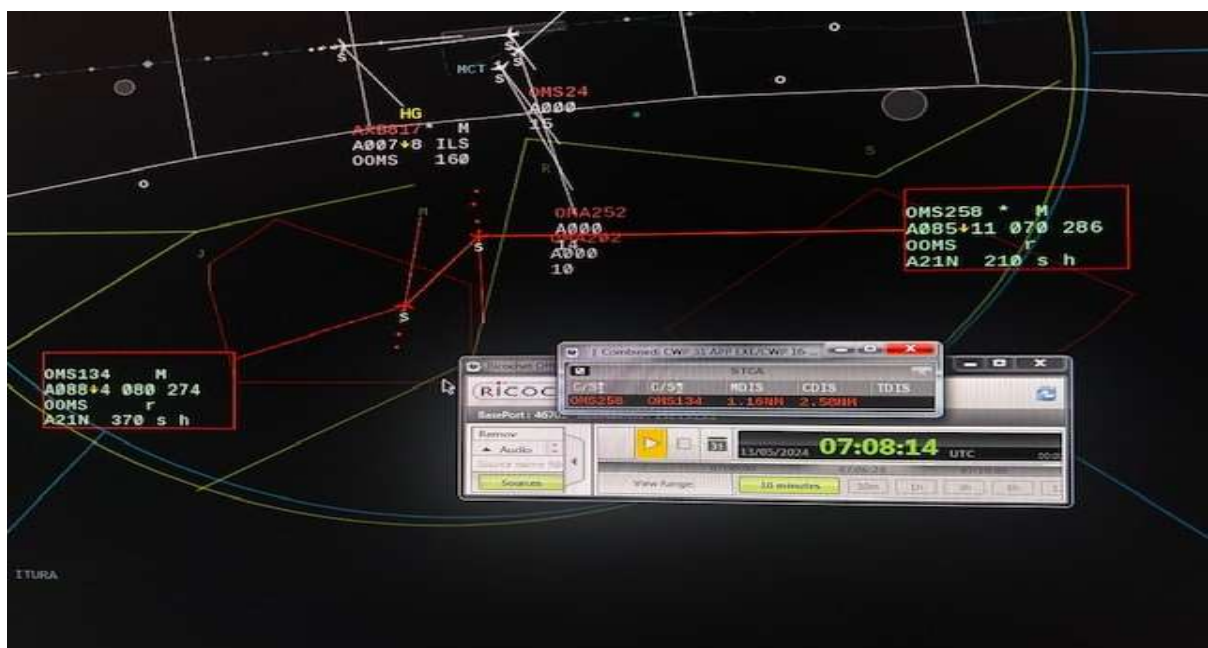
- 1.1.22 At the time 07:08:14, OMS134 while descending through ALT 8800FT to 8000FT reported they were clear of TCAS conflict. The red STCA alert was activated for 36 seconds from the time 07:08:14 to the time 07:08:50. The red STCA alert deactivated at the time 07:08:51, while aircraft OMS134 was descending through ALT 8500FT to 8300FT with ROD of 400FPM and aircraft OMS258 descending through 7700FT with ROD of 1100FPM.

Figure 13 showing the RED STCA activated between aircraft OMS134 descending through ALT 8800FT to 8000FT at ROD of 400FPM and aircraft OMS258 was descending through ALT 8500FT to 7000FT at ROD of 1100FPM (Source: DGAN)

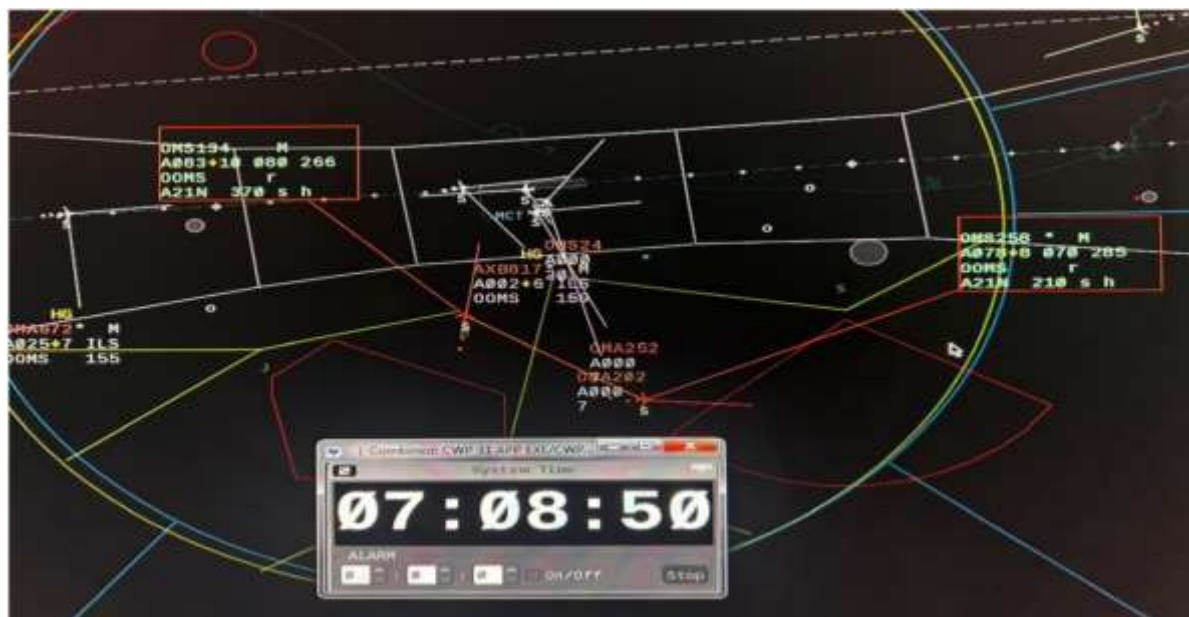
Figure 14 showing the RED STCA was deactivated between aircraft OMS134 and aircraft OMS258 while descending through ALT8300 at ROD of 1000FPM and ALT 7800FT to 7000FT at ROD of 800FPM respectively (Source: DGAN)

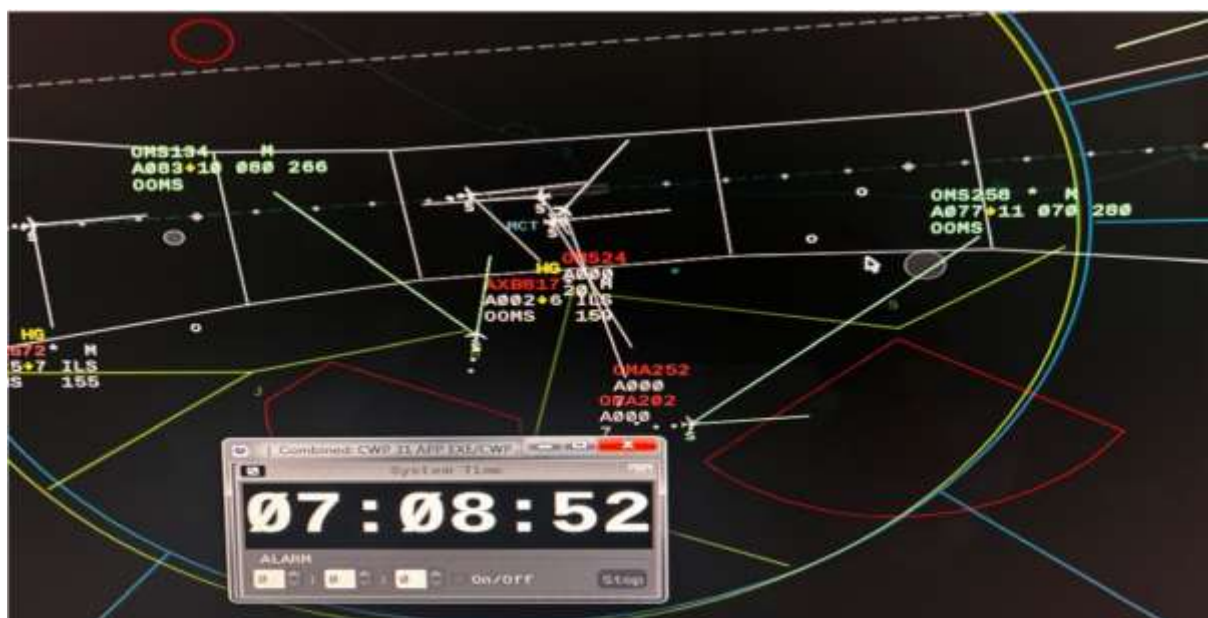
1.1.23 At the time 07:08:52, ATCO cleared the flight crew of aircraft OMS258 to continue descending to ALT 6000FT. Both aircraft OMS258 and aircraft OMS134 were radar vectored by the ATCO and landed safely in OOMS RWY08L with no further incident.

Figure 15 showing aircraft OMS258 descending through ALT 7700FT to 7000FT at ROD of 1100FPM and aircraft OMS134 descending through ALT 8300FT to 8000FT at ROD of 1000FPM and ATCO radar vectored after the RED STCA disappeared (Source: DGAN radar)
