# Oman Transport Safety Bureau

## Final Report

**OTSB Case File No: AIFN-002/02/2024**

# B777 TCAS Resolution between Etihad Airways-Boeing B777-3FXER and Qatar Airways-A320-232 in the Muscat FIR

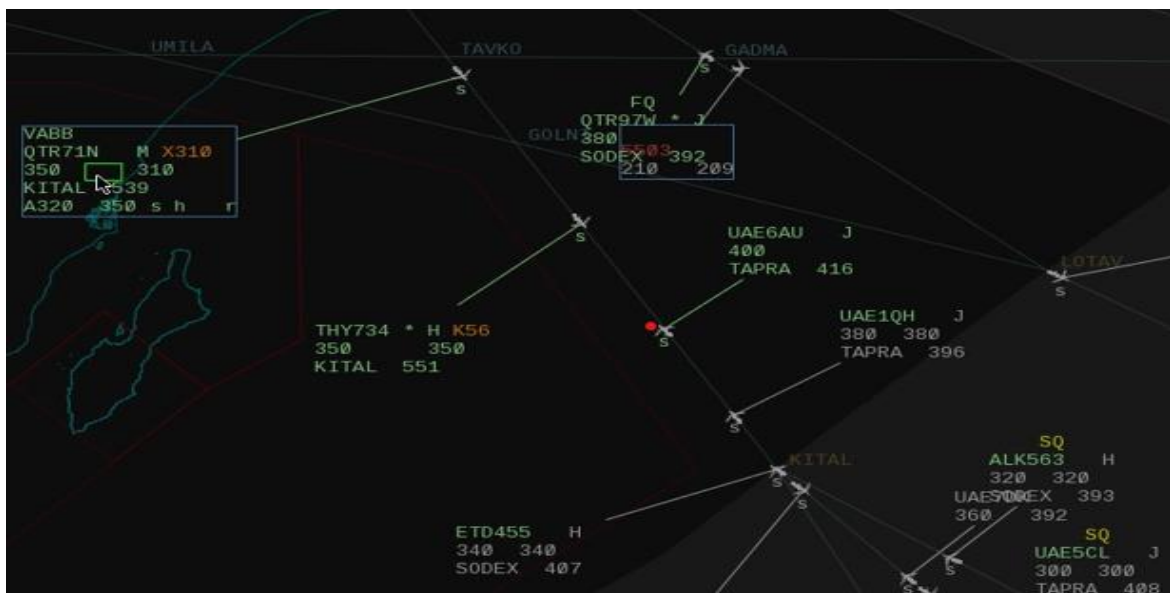
Figure 1: Aircraft QTR71N passed waypoint TAVKO maintaining FL350 and aircraft ETD455 over KITAL maintaining FL340

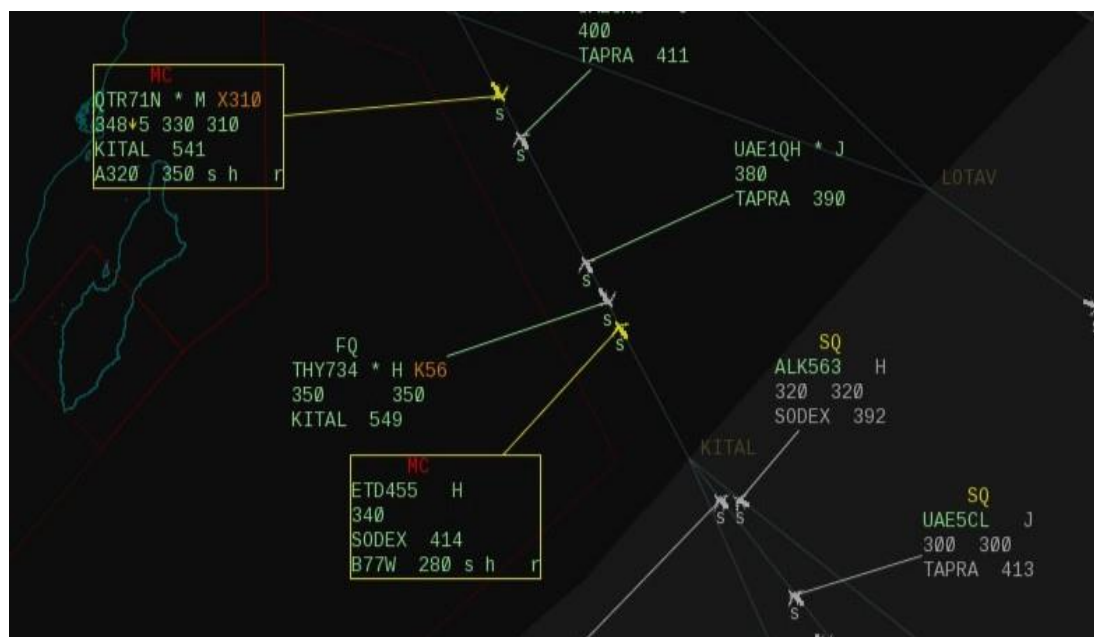
Fig-

ure 2: At the time 23:53:53 ATC Radar screen showing aircraft QTR71N leaving FL350 on descend to FL330 passing thru FL348 -rate of descent 500FPM and aircraft ETD455 maintaining FL340 with MC and STCA both activated.

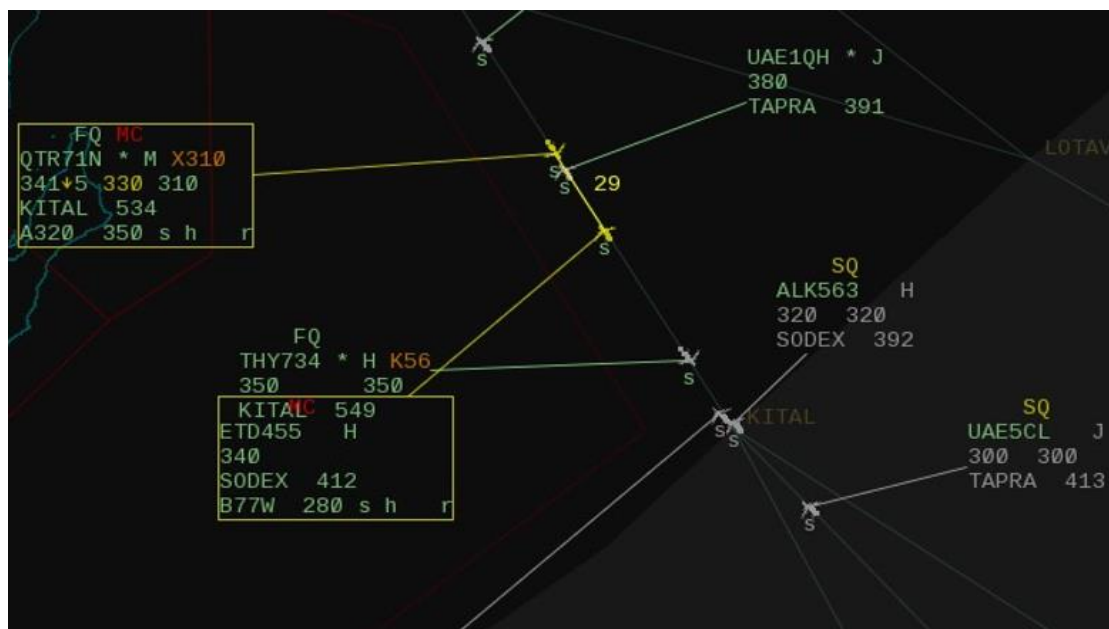
Figure 3: Aircraft QTR71N passing thru` FL341 on descent to FL330 ROD of 500 FPM speed 534 knots and aircraft ETD455 maintaining FL340 speed 412 knots with a separation of 29 seconds head-on closing rapidly.

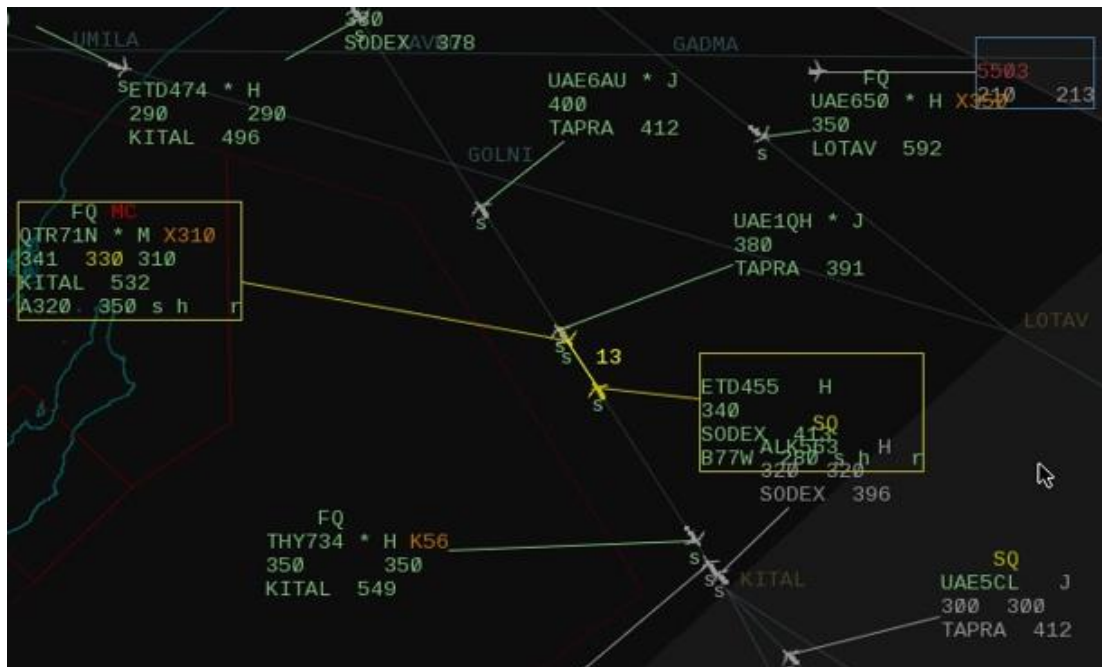
Figure 4: At the time 23:55:38 aircraft QTR71N passing through FL341 descending to FL330 and aircraft ETD455 maintaining FL340 with a separation of 13 seconds head-on closing rapidly at 8.42 NM.

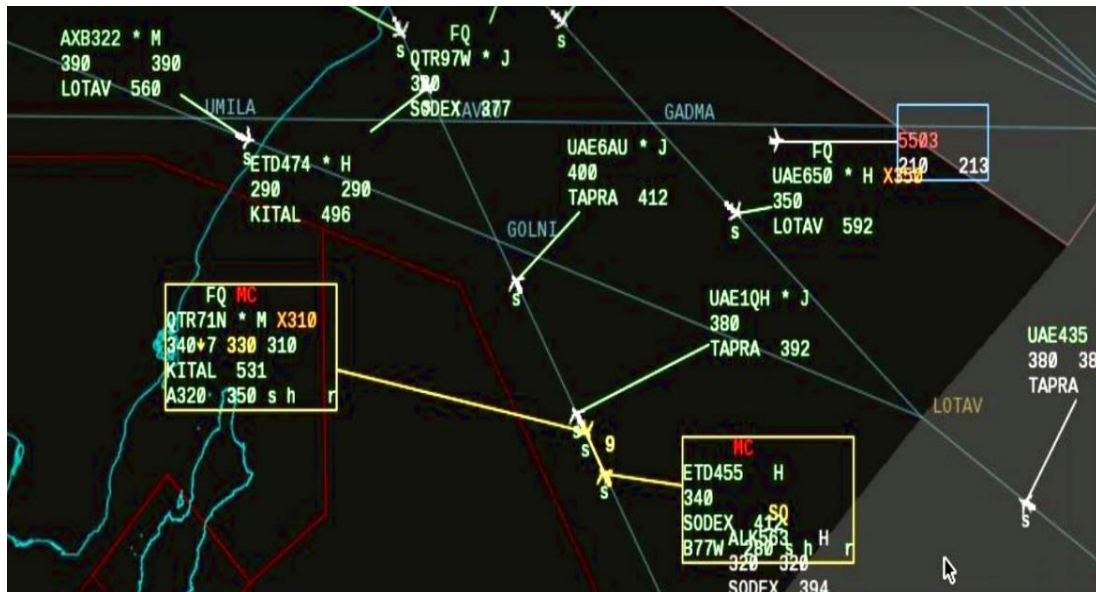
Figure 5: At the time 23:55:39 aircraft QTR71N and aircraft ETD455 both at FL340, with a distance of 7.38 NM and 9 seconds head-on closing rapidly.

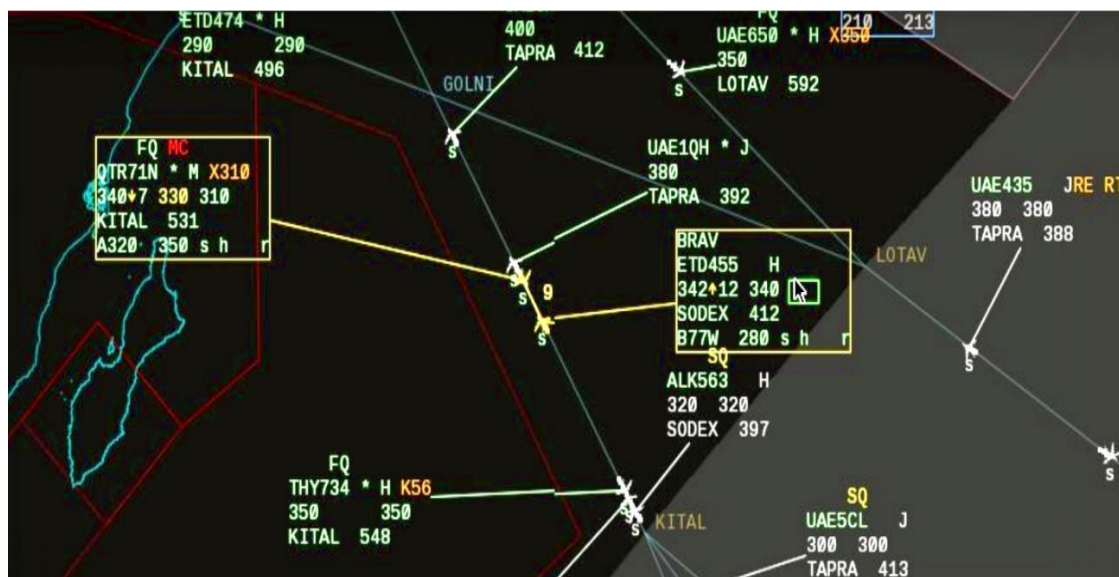
Figure 6: At the time 23:55:41 aircraft QTR71N descending through FL340 for FL330 ROD 700 FPM and aircraft ETD455 climbing through FL342 ROC 1200 FPM. The distance between both traffic was 9 seconds 6.36 NM head-on.

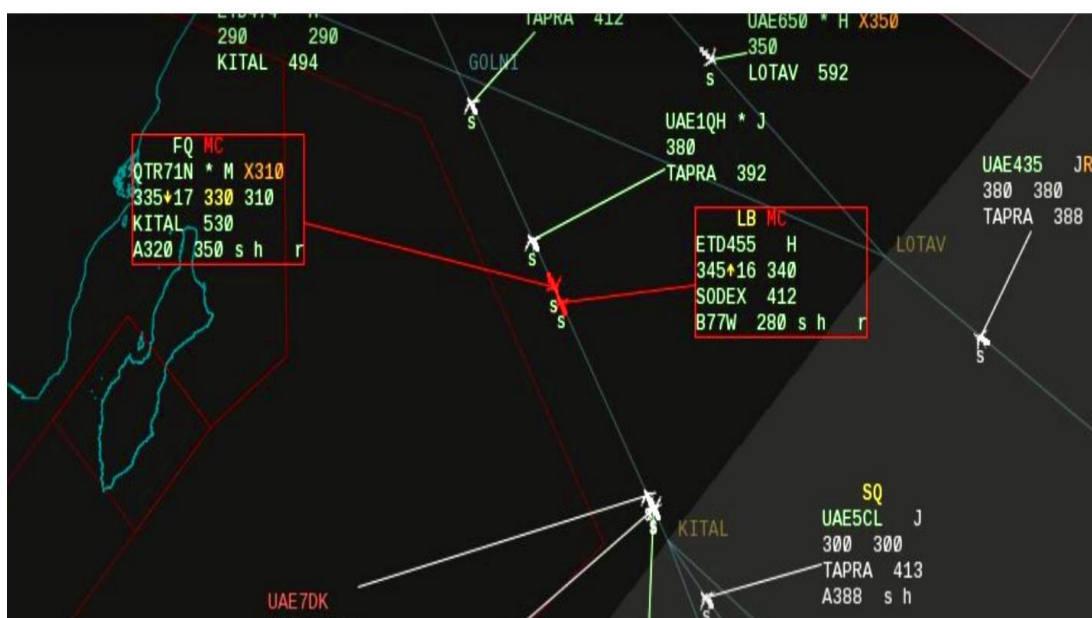
Figure 7: At the time 23:55:55 Vertical separation of 1000FT was achieved while aircraft QTR71N was descending through FL335, ROD1700 FPM and aircraft ETD455 climbing through FL345 ROC 1600 FPM with a distance of 2.16 NM and 5 seconds.

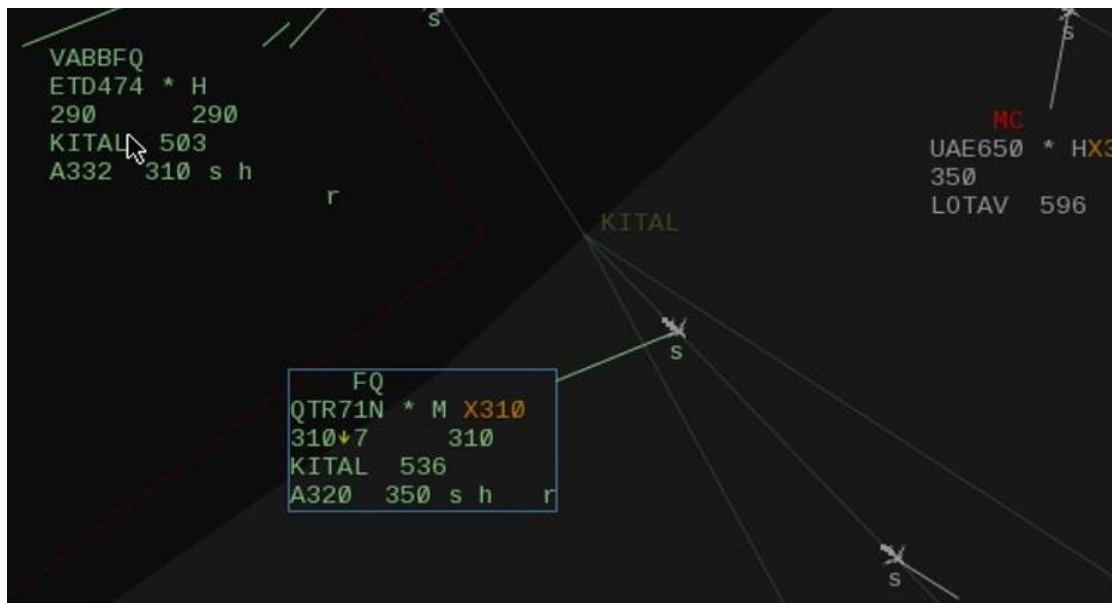
Figure 8: At the time 00:01:35 aircraft QTR71N reaching FL310 after passing waypoint KITAL in MUMBAI FIR.

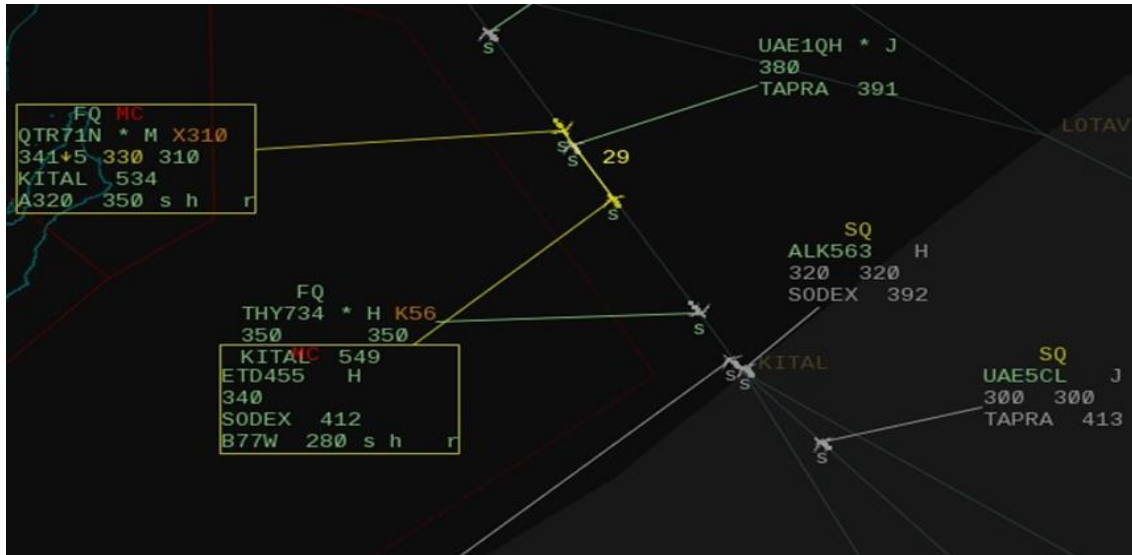
- 2.4.7 During the interview, the ATCO stated that the ATCO saw the Short-Term Collision Alert (STCA) warning, however in the ATCO's mind the ATCO thought that it's a system error and everything is fine. The ATCO was incorrect to think everything was fine while there were warnings regarding a potential loss of separation requiring his attention.

Figure 9: Aircraft QTR71N at FL341 on descent to FL330 ROD 500 FPM speed 534 knots and aircraft ETD455 maintaining FL340 speed 412 knots with a separation of 29 seconds head-on closing rapidly.

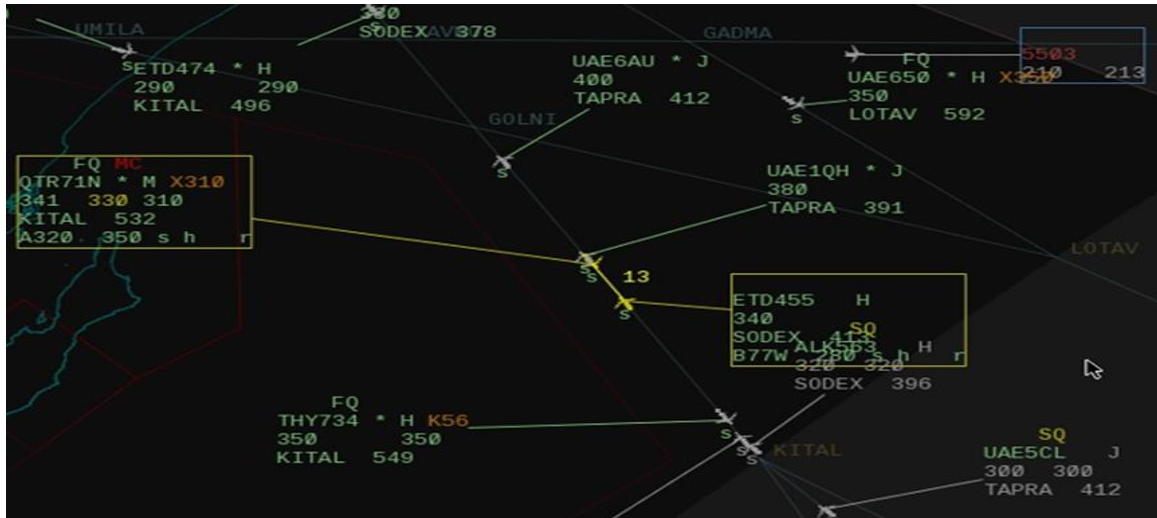
Figure10: At the time 23:55:31 aircraft QTR71N at FL341 descending to FL330 and aircraft ETD455 maintaining FL340 with a separation of 13 seconds head-on closing rapidly.

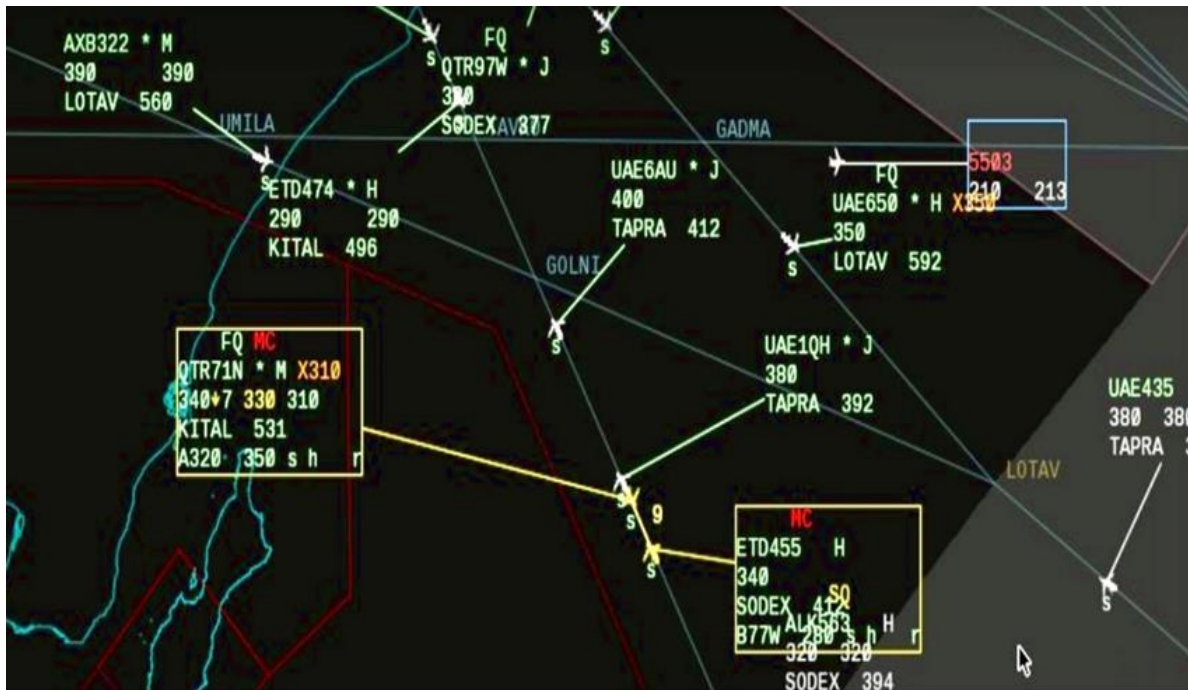
Figure 11: Aircraft QTR71N and aircraft ETD455 both at FL340, with a distance of 7.38 NM and 9 seconds head-on closing rapidly.

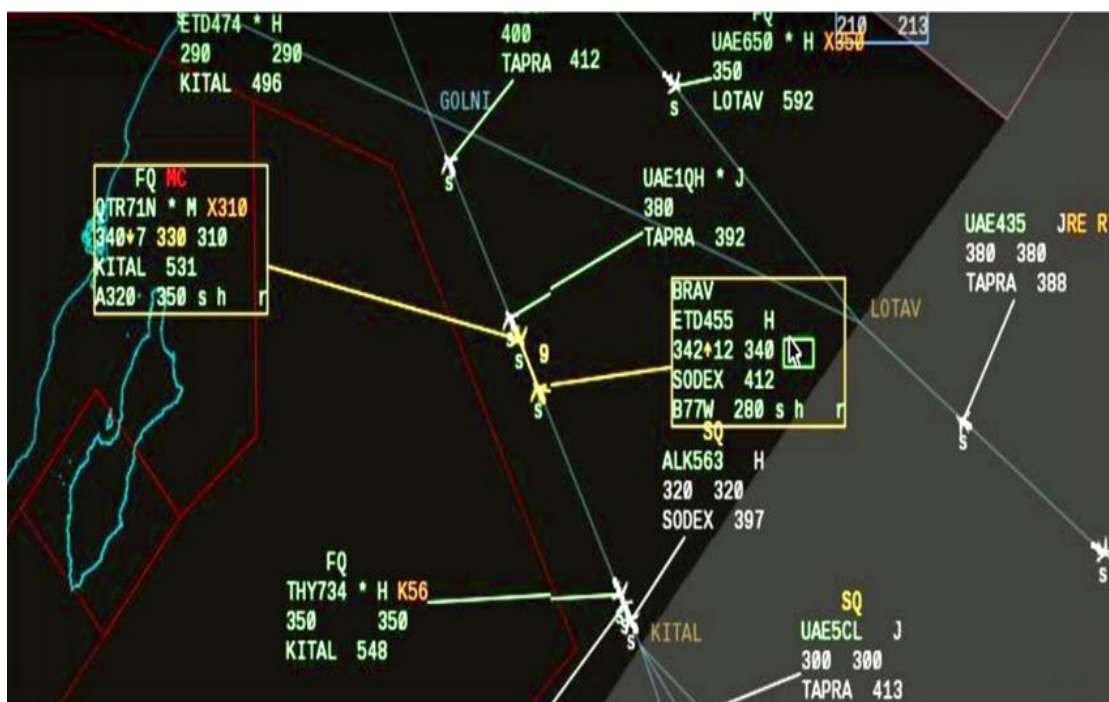
Figure 12: At the time 23:55:42 aircraft QTR71N descending through FL340 for FL330 ROD 700 FPM and aircraft ETD455 climbing thru FL342 ROC 1200 FPM

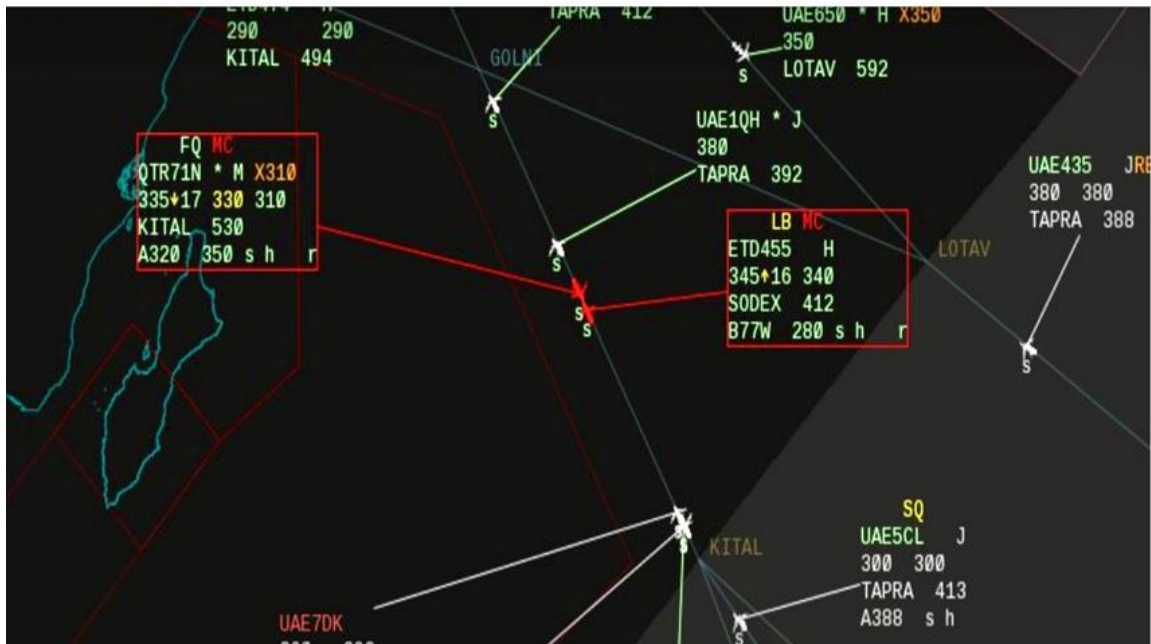
Figure 13: At the time 23:55:55 aircraft QTR71N descending through FL335, ROD1700 FPM and aircraft ETD455 climbing through FL345 ROC 1600 FPM with a distance of 2.16 NM and 5 seconds with a vertical separation of 1000ft.
