Oman Transport Safety Bureau (OTSB)

Singapore Airlines Boeing 777-312 (ER), SIA306

Wake Turbulence over MCT Flight Information Region (FIR) Incident

Final Report

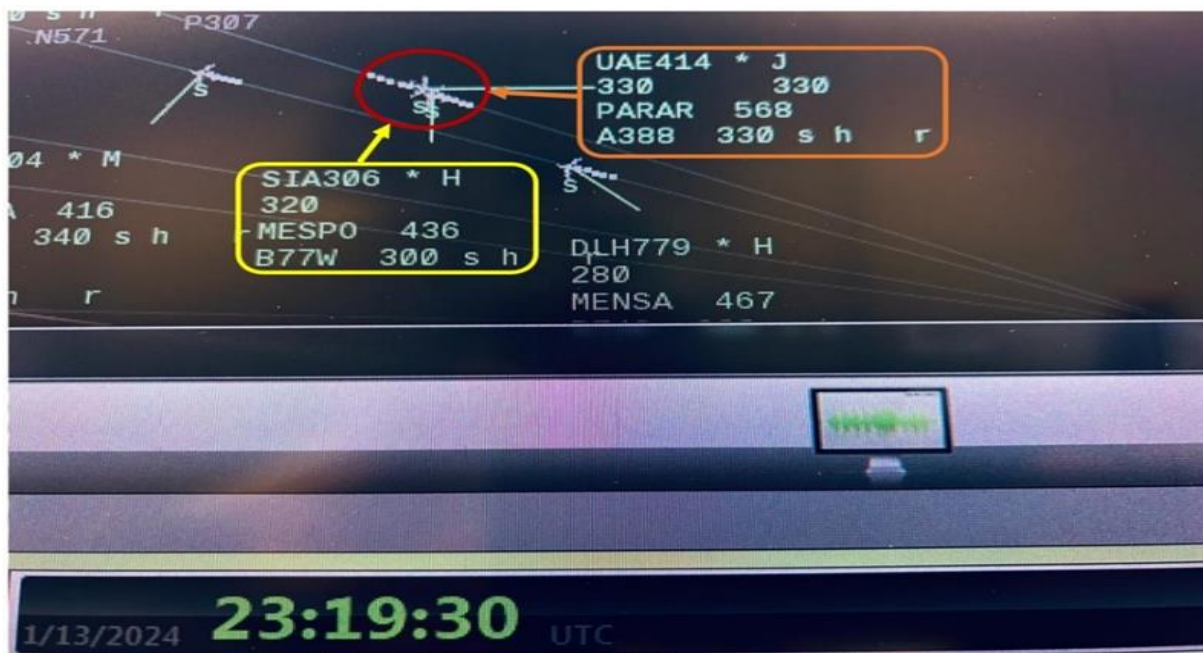
Figure 1 :ATC Radar screen shot showing flight levels and details of aircraft SIA306 and aircraft UAE 414

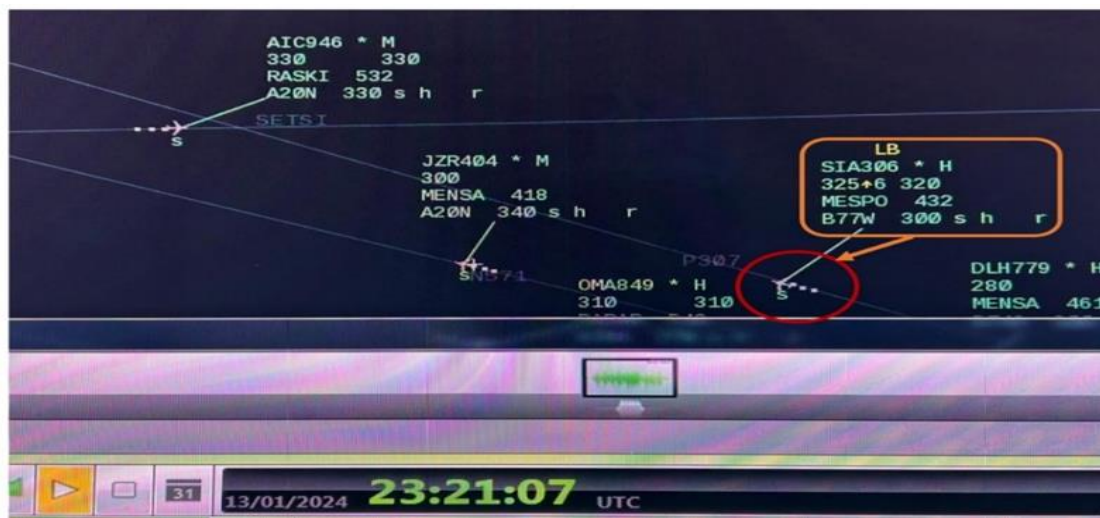
Figure 2: is from ATC radar screen shot showing aircraft SIA306 at flight level 325 with Level Bust(LB)

At the time: 23:21:07, the ATCO noticed that aircraft SIA306 had climbed to FL325 on the AWY P307 and observed on the radar screen Level Bust (LB) of 500ft. Immediately the ATCO called the flight crew of aircraft SIA306 to verify the reason of the climb however there was no response from the flight crew of aircraft SIA306.

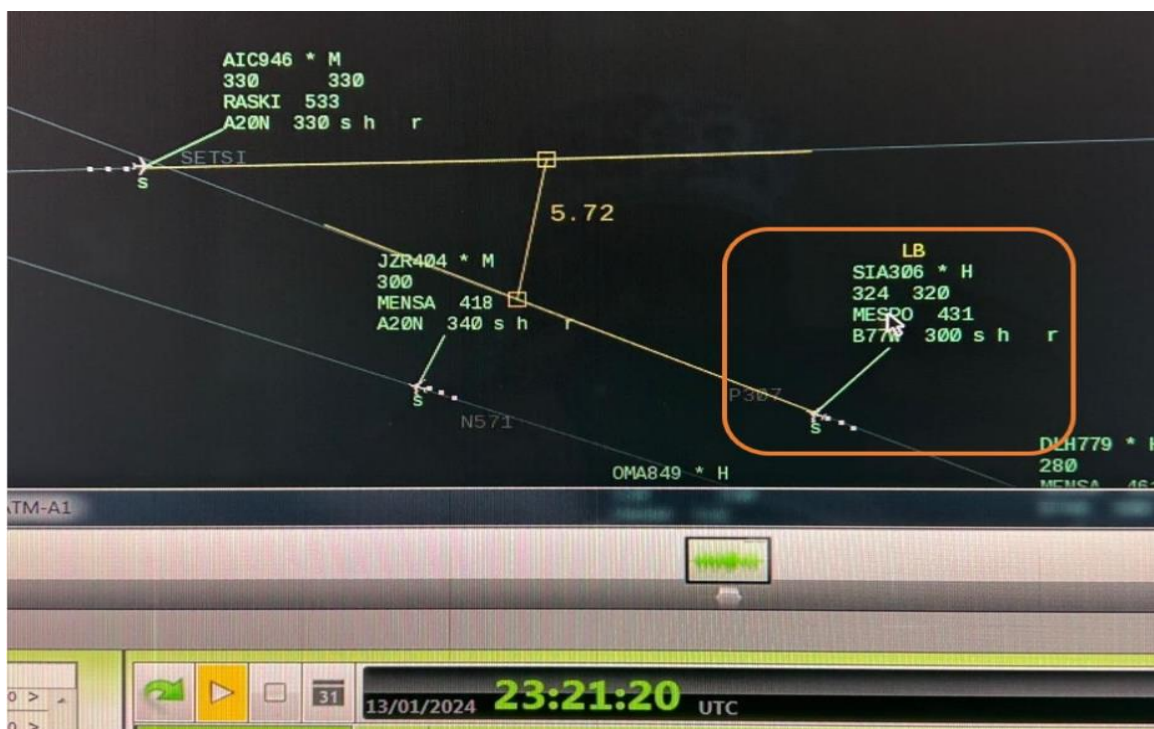
- 1.1.13. According to the ATC radar screen, the aircraft SIA306 was seen deviating from its altitude and there was a traffic on opposite direction aircraft AIC946 at FL330 with a horizontal separation of 5.72nm to the right of aircraft SIA306 FL320.

Figure 3: shows ATC radar screen shot of aircraft SIA306 during the recovery phase and aircraft AIC946

According to the ATC radar screen, the aircraft SIA306 was observed climbing from its flight level and whilst there was a potential conflicting traffic on opposite direction aircraft AIC946 at FL330 with as a horizontal separation of 5.72nm to the right of aircraft SIA306 FL320.

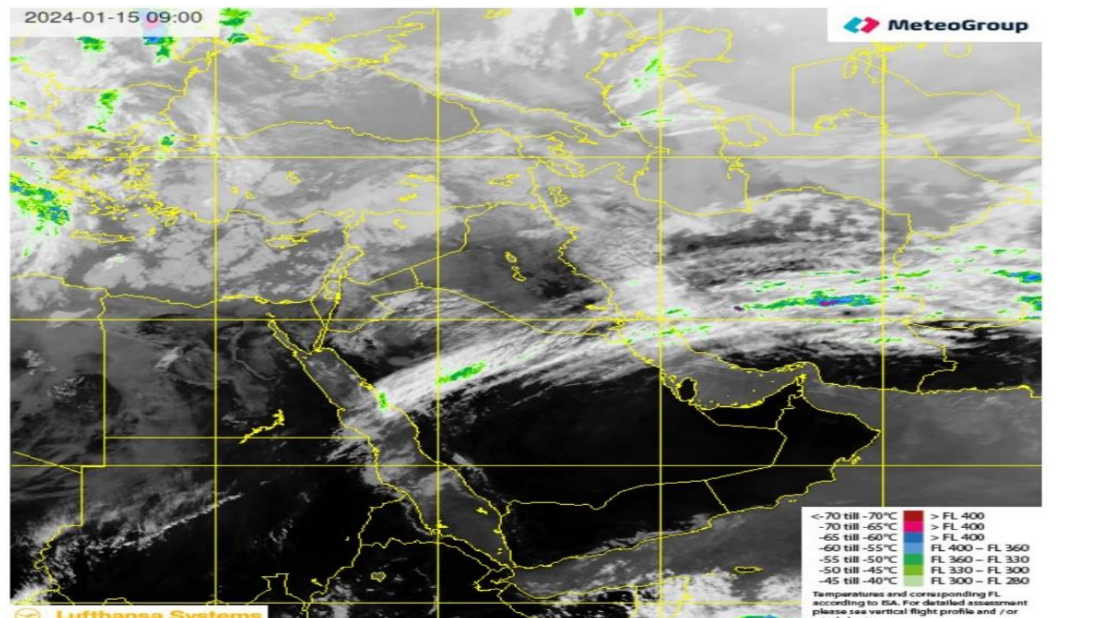
The Satellite image at the time of the occurrence shown below, indicates it was a clear sky and this could indicate that no weather turbulence can be associated at the time of the occurrence.

Figure 4: Clouds around the area where the aircraft experienced wake turbulence (Source:SIA)

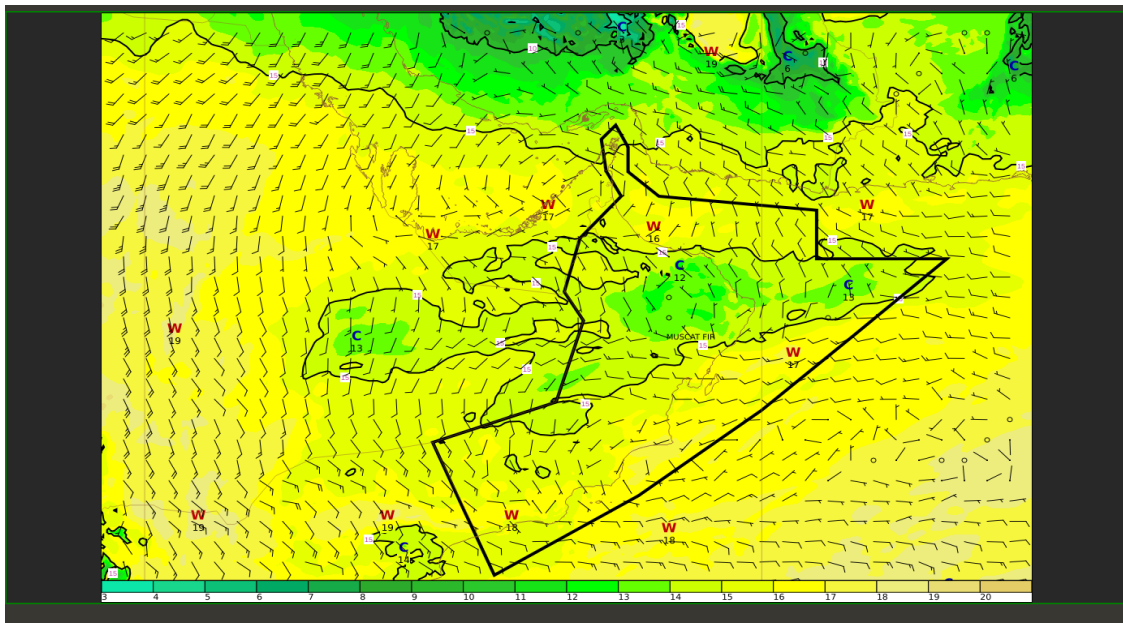
The weather information below was provided by OMAN CAA - Directorate General Meteorology (DGMET). According to the graph below the wind direction was from 290 degrees and wind speed of 60-70 knots at the location and time of the occurrence. The weather forecast indicates no turbulence at the time of the occurrence.

Figure 5: Clouds around the area where the aircraft experienced wake turbulence (Oman CAA-DGMET)

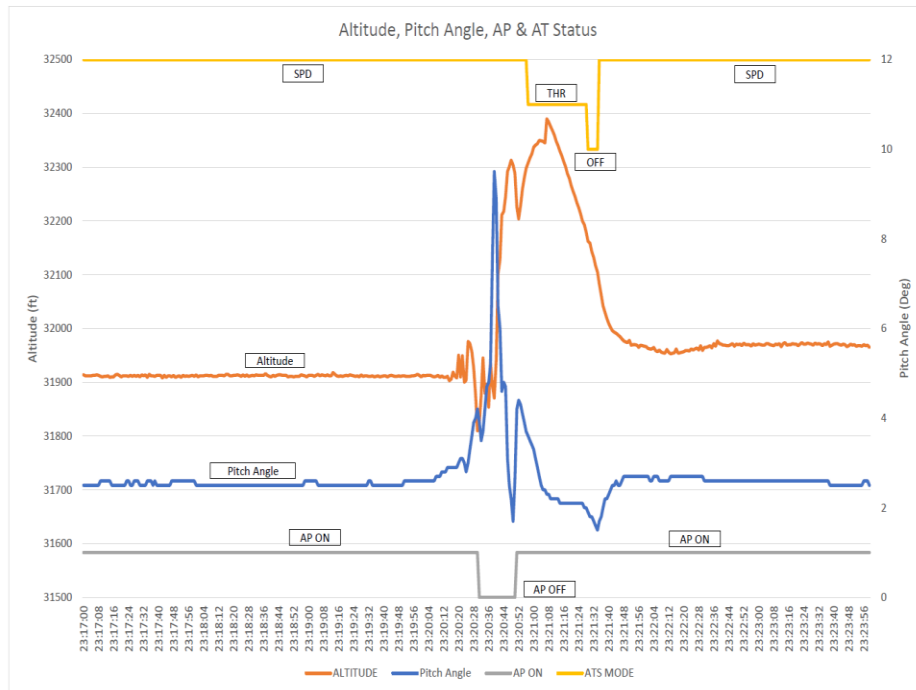
Figure 6: showing Altitude, Pitch Angle, AP and AP Status (Source: SIA)

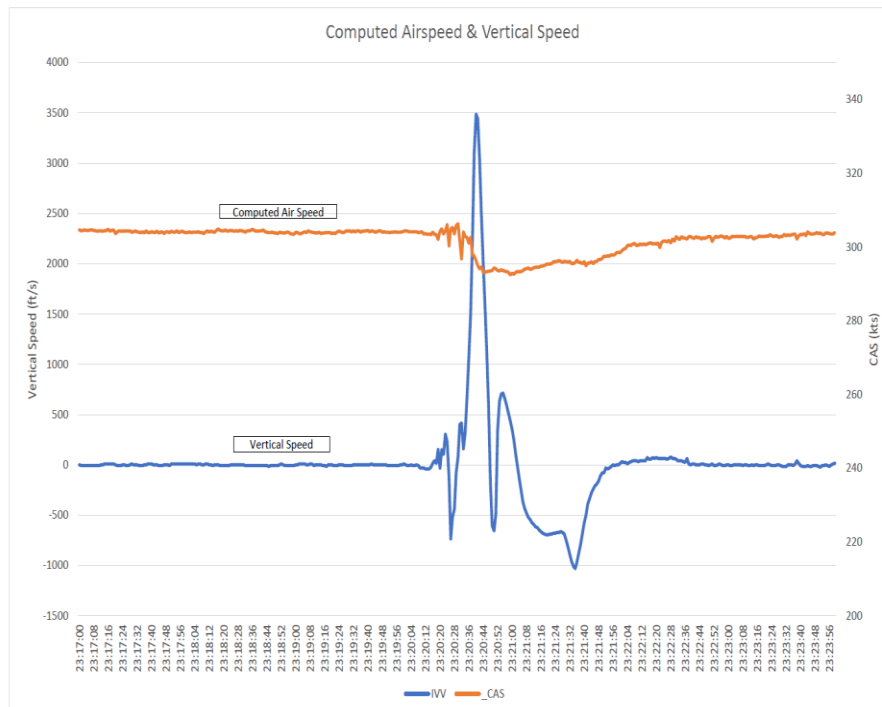
Figure 7 :showing Computed Airspeed and Vertical Speed (Source: SIA)

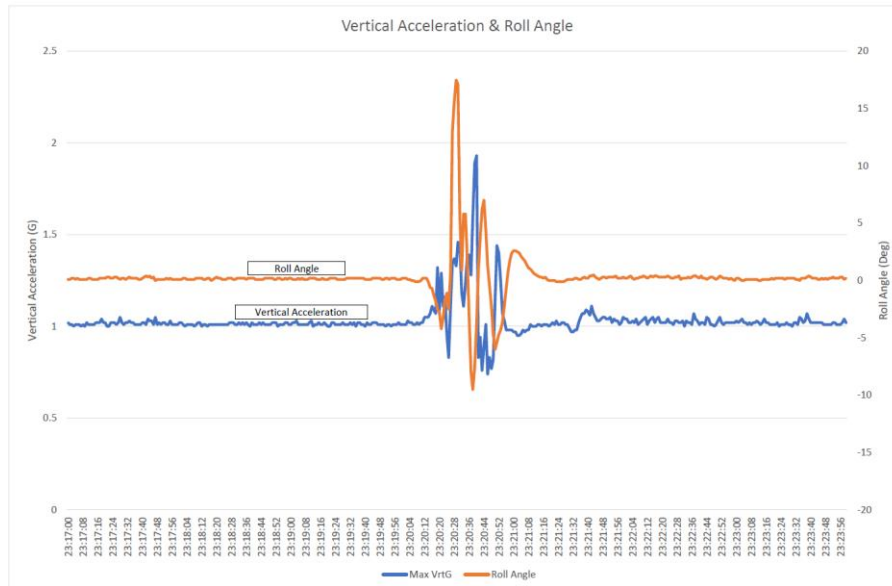
Figure 8 :showing Vertical Acceleration and Roll Angle (Source:SIA)

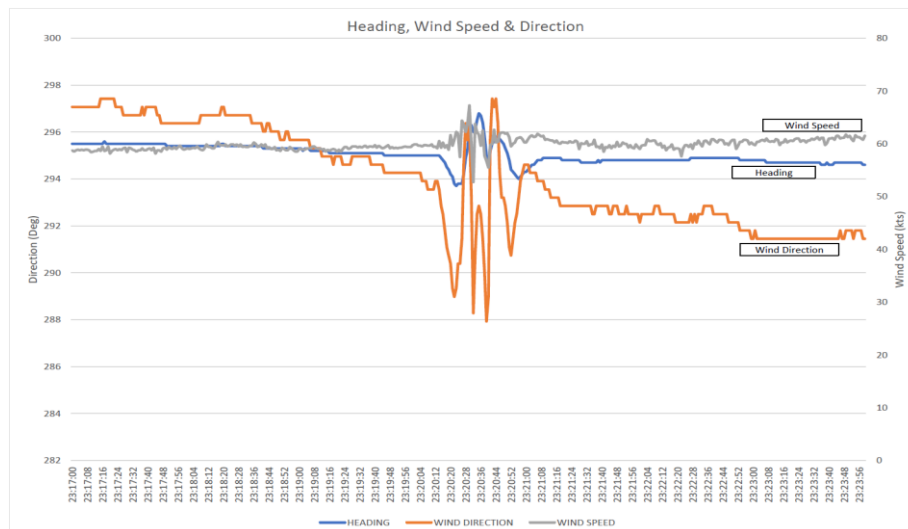
Figure 9: showing Heading, Wind Speed and Direction (Source:SIA)

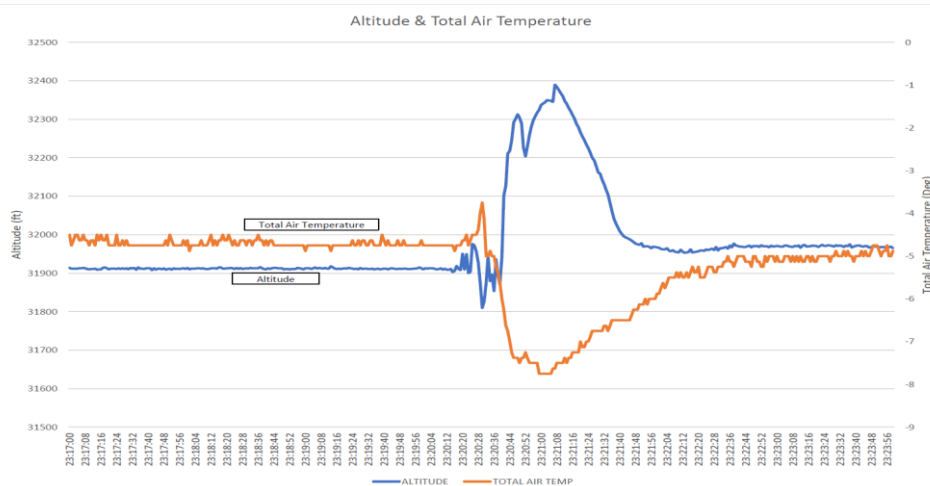
Figure 10 :showing Altitude and Total Air Temperature (Source:SIA)
