# **Oman Transport Safety Bureau**

## **Final Report**

### **OTSB Case File No: AIFN-002/11/2023**

### **IndiGo Airbus A-320neo Unauthorized Turn**

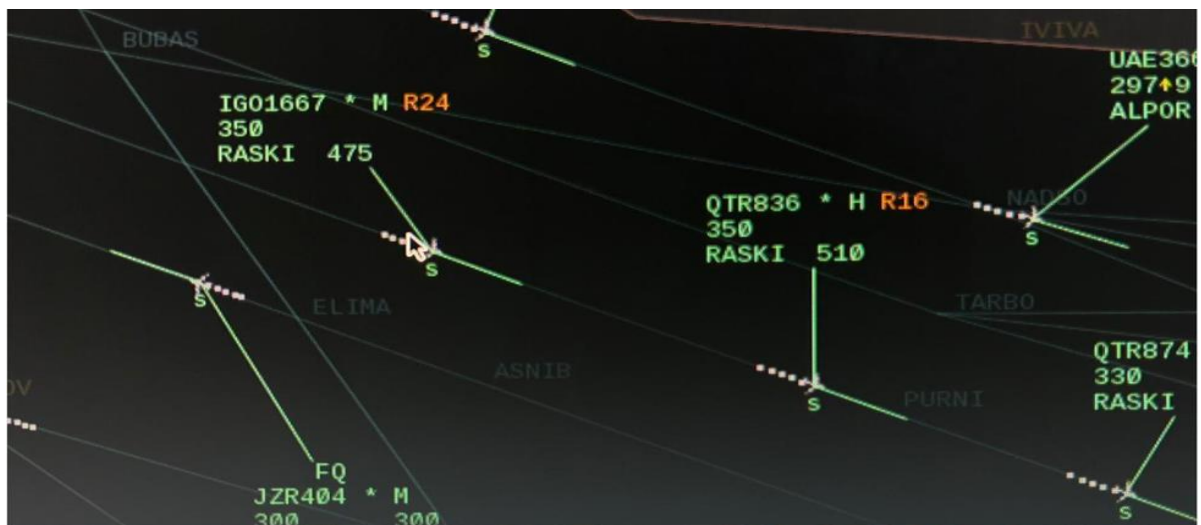
Figure 1. ATC radar shows the IGO1667 on airway P307 at FL350 and QTR836 ahead at FL350.

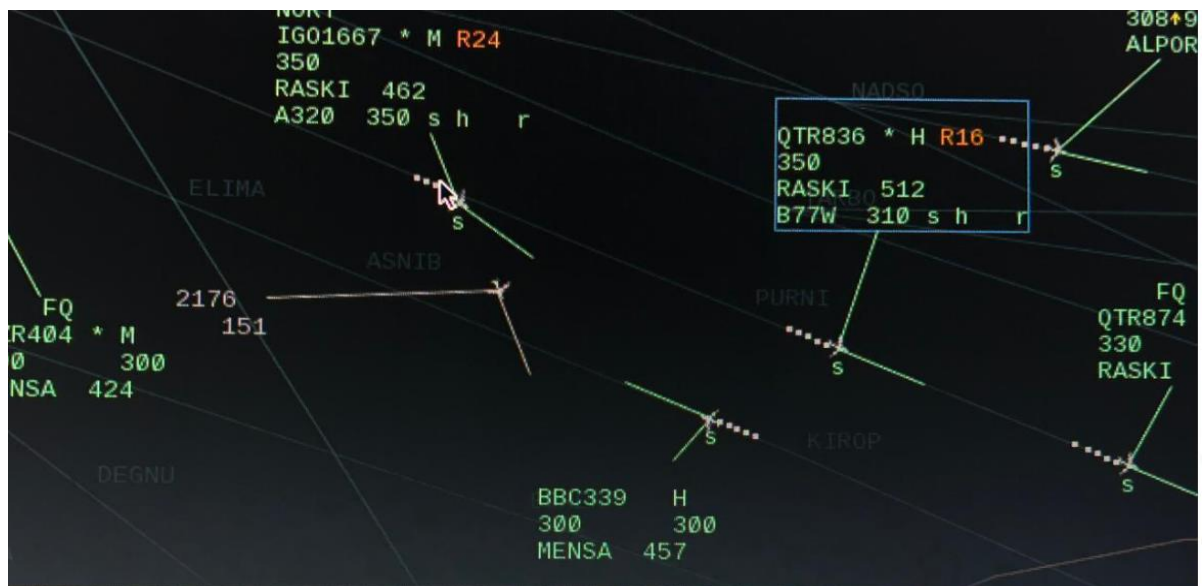
Figure 2. ATC radar screen showing aircraft IGO1667 commencing right turn onto a heading of 150 degrees without ATC clearance.

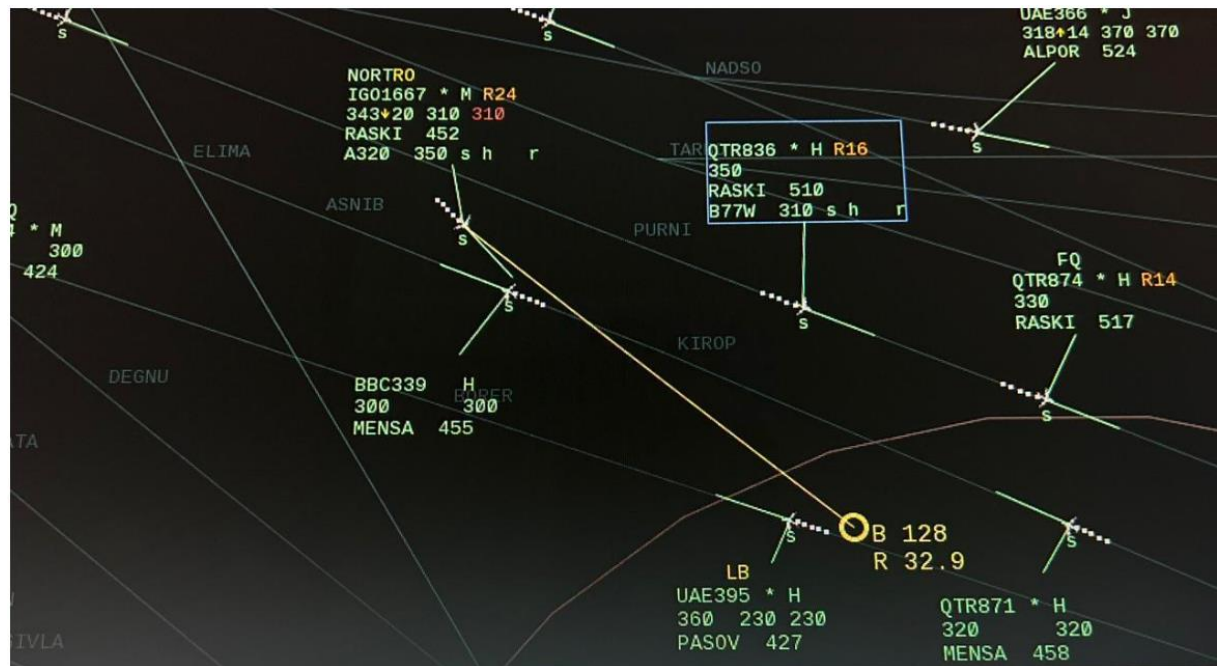
Figure 3. ATC radar shows aircraft IGO1667 while on unauthorized right turn descending to FL310 passing through FL343 and the potential traffic is aircraft QTR871 maintaining FL320

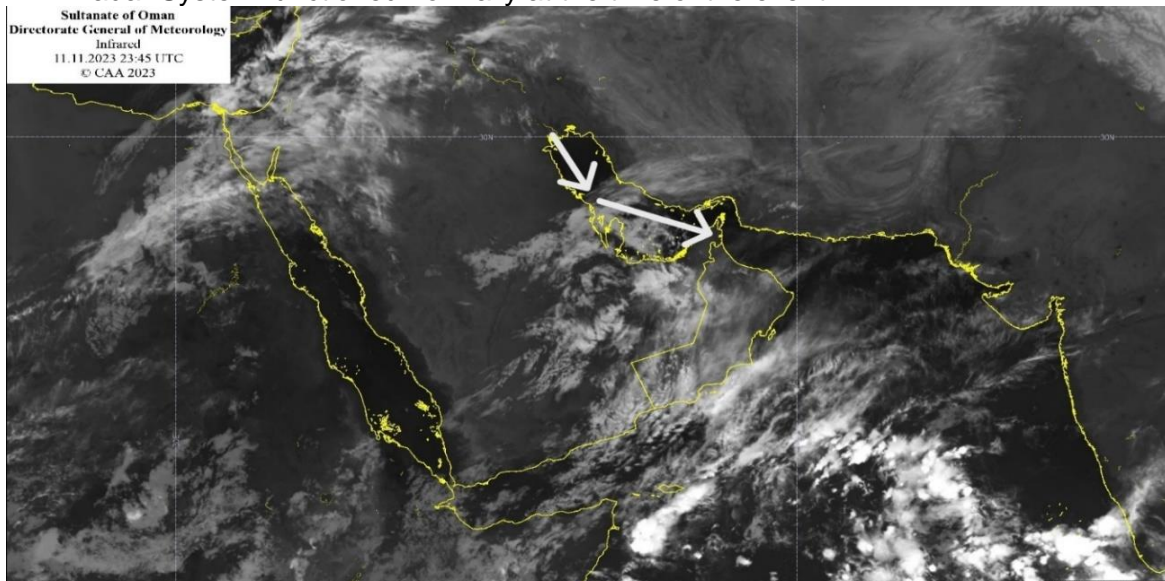
Figure.6 Satellite image

The Satellite image at the time of the occurrence in figure 6, shows the direction from the flight and evidence of no cloud presence in the area north west of Muscat FIR. The Post Flight Report did not record any system failure relevant to the event. The Weather Radar System functioned normally at the time of the event.
