Oman Transport Safety Bureau

Final Report

OTSB Case File No: AIFN-001/10/2023

Oman Air B787 severe turbulence with minor injuries to some of the cabin crew

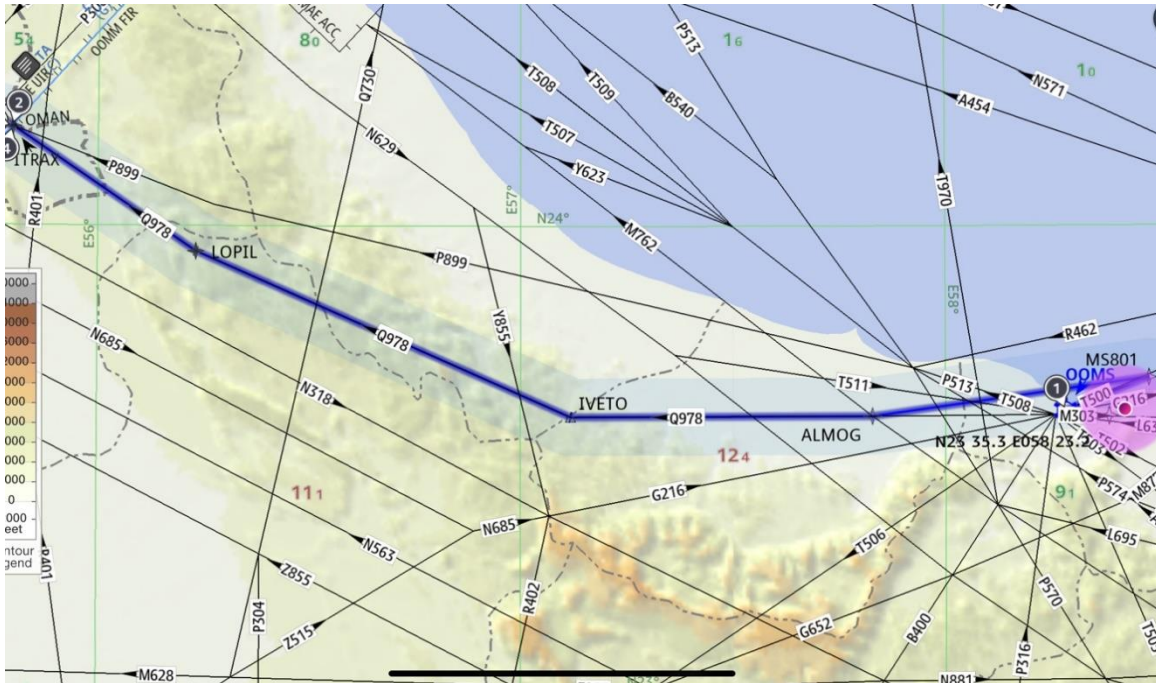
1.1.3. The flight crew filed the flight plan to fly the route MCT, Q978 (which includes IVETO, LOPIL and ITRAX).

Figure 1: Solid blue line indicating the flight plan route of incident flight.

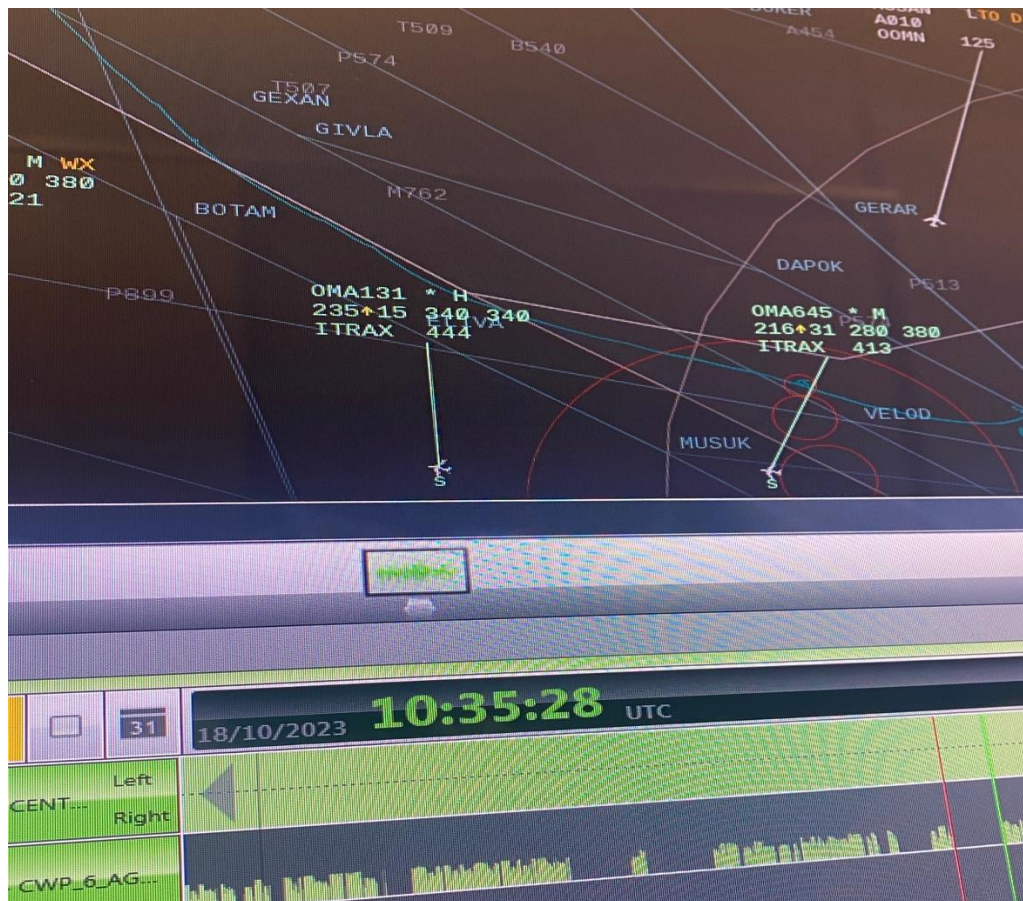
1.1.9. At 10:32, while the aircraft was on climb passing FL194 routing track 266 to IVETO, the ATC instructed the flight crew to route to LOFIL. The aircraft was still in cloud with the new track of 285 towards LOFIL and ROC was approximately 1500 Feet Per Minute (FPM). Light turbulence was encountered.

Figure 2: Indicating the incident flight passing FL194 routing track 266 to IVETO.

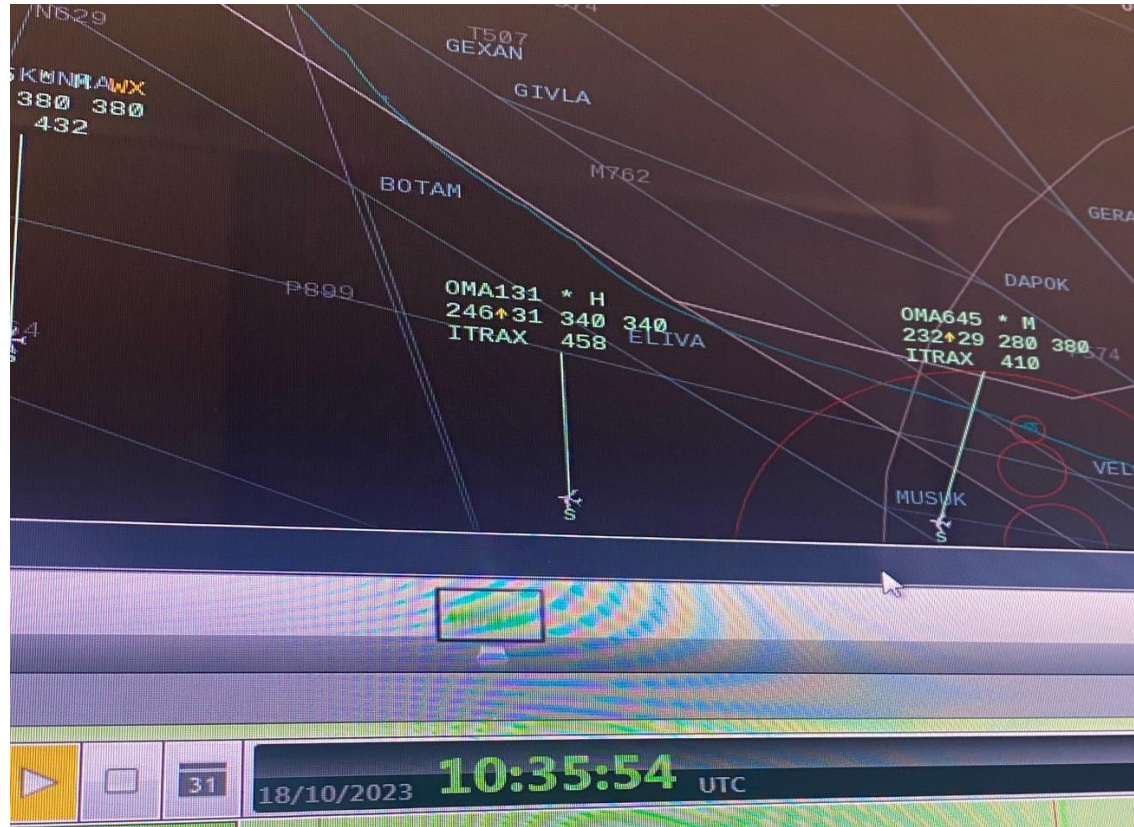
1.1.10. At 10:35:54 while climbing through FL246, aircraft encountered light turbulence. The Rate of Climb (ROC) was 3100 Feet Per Minute (FPM). This information was taken from the ATC radar.

Figure 3: Indicating the incident aircraft climbing through FL246 at 10:35:54

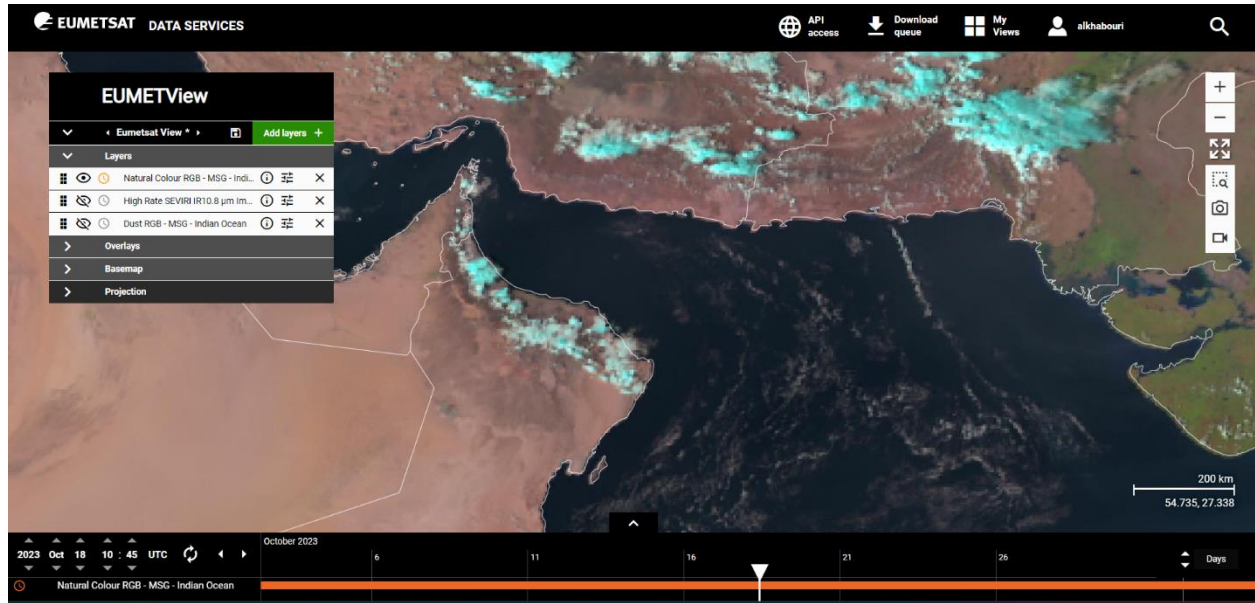
The Satellite image at the time of the occurrence, shown below, reveals some convective clouds Towering Cumulus (TC) but still not Cumulonimbus (CB) clouds existed nearby the location of the occurrence. The Terminal Area Forecast (TAF) for OOMS, issued on the 18th Oct 2023 at 0500 UTC and valid

from the 18th at 06:00 UTC to the 19th at 12:00 UTC, indicated the forecast of CB clouds between 10:00 UTC and 14:00 UTC. No Sigmet was issued.

Figure 4: showing Clouds around the area where the aircraft experienced severe turbulence.

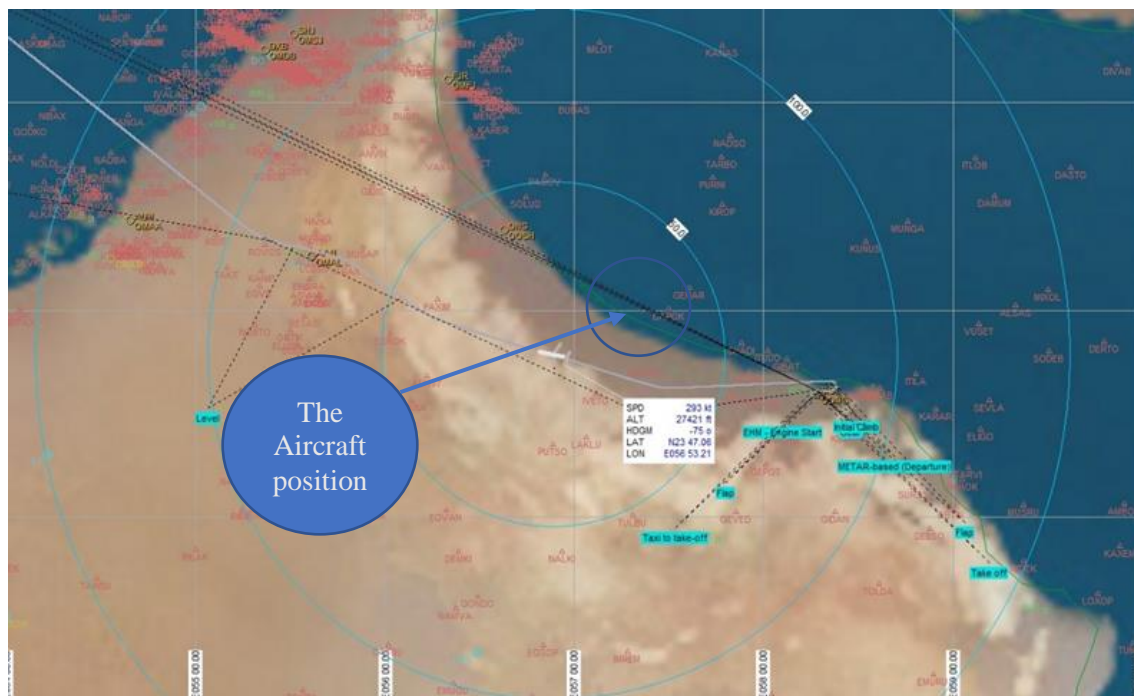
Figure 5: Satellite weather radar showing the position of the aircraft where the aircraft experience severe turbulence.

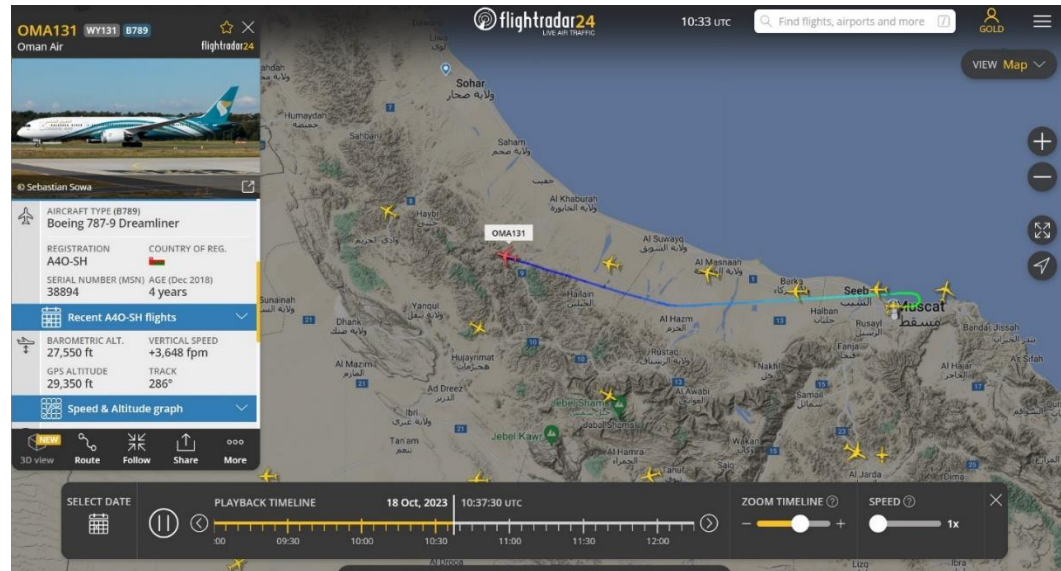
(Fig 6 OMA131 track)

2.7.4.4 During interview with the crew, the visual screen of the weather the flight crew stated the observation of the cloud to the left and ahead of the aircraft that it looks like building up but nothing shown in the radar screen as an indication of CB's. Although, they try different set up but still is not convincing their thought that they might have a sever turbulence and as a precautionary measure they switch the seat belt sign on without making any PA announcement to the passengers and cabin crew to secure themselves.

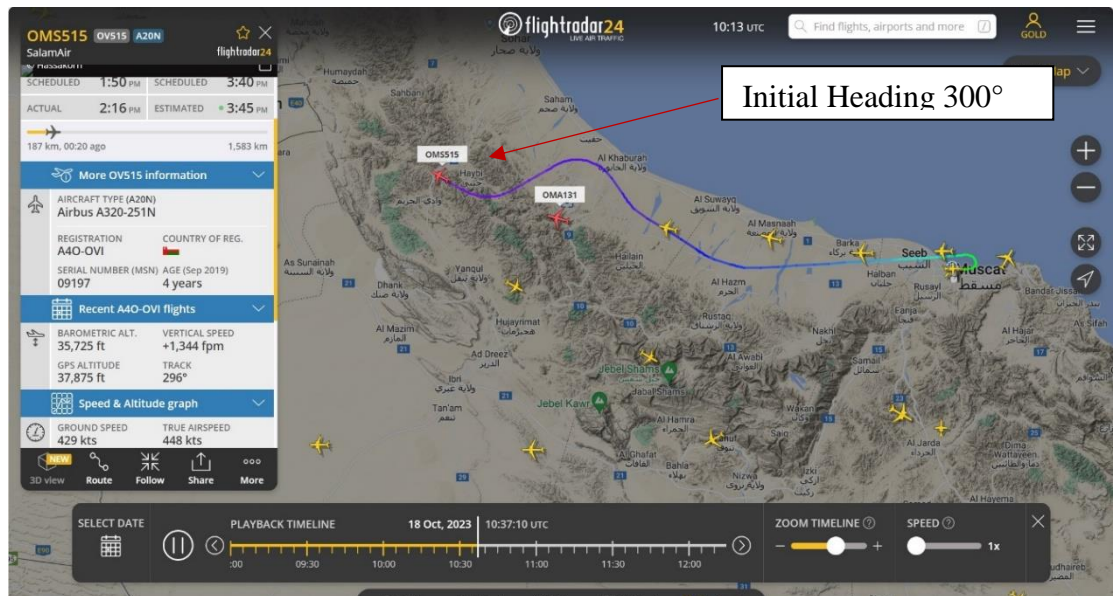
(Fig 7) Aircraft Ahead of OMA131

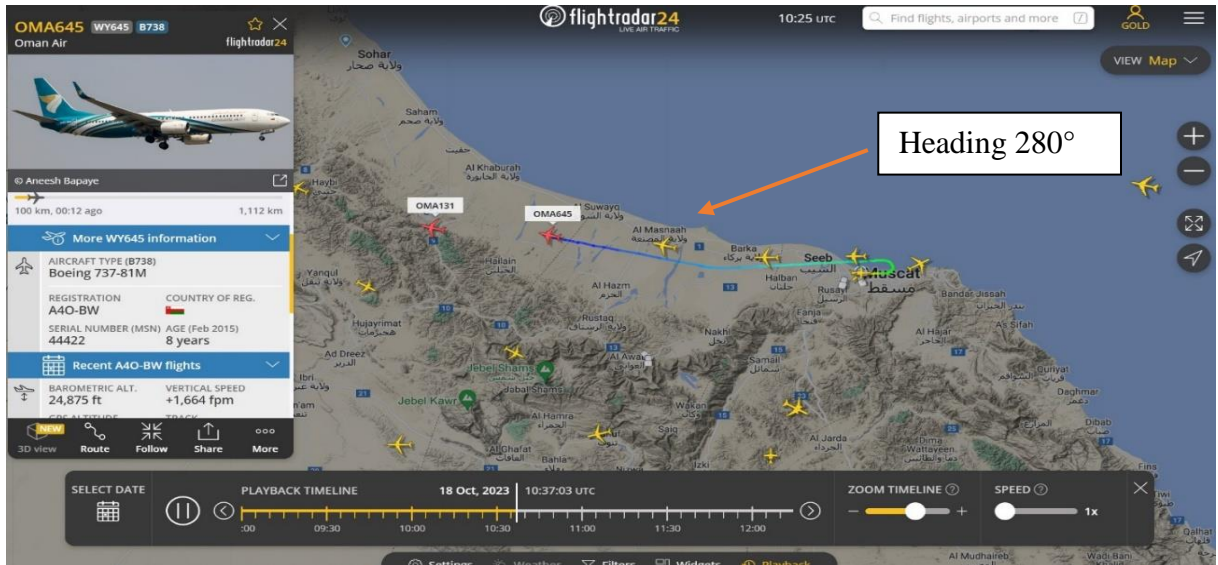
(Fig 8) Aircraft behind OMA 131

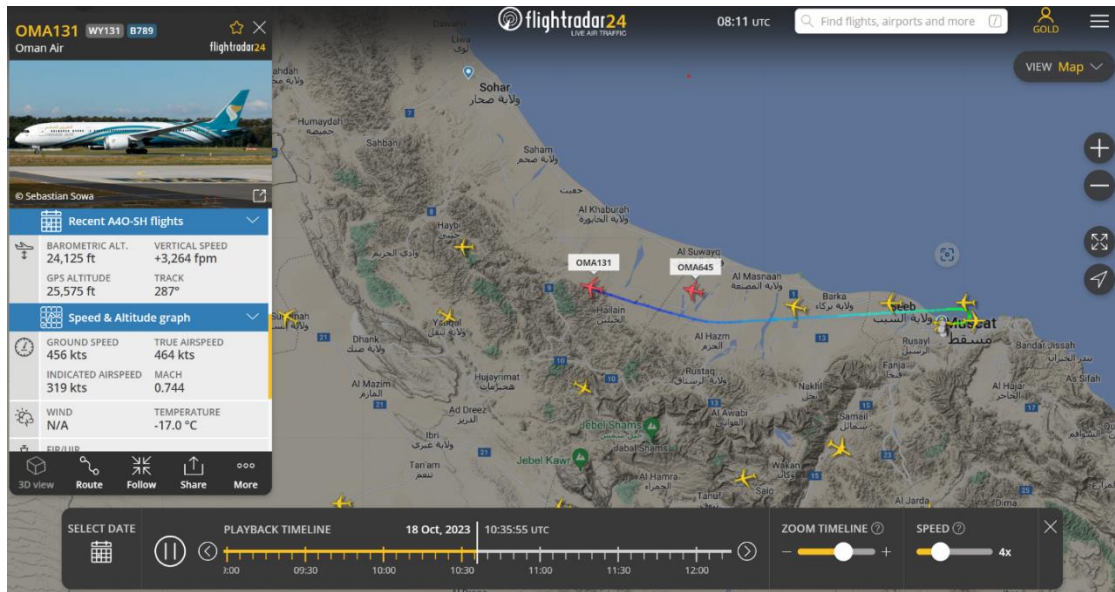
2.7.5.1 The wind was shown from the aircraft FDM in (Table1) that the aircraft experienced adverse wind conditions during climb and the turbulence area revering to (Fig 2). Turbulence Area Referring to (Fig Table1) significant wind variations are recorded in the flight raw data during the turbulence period started from FL240 upwards as the wind had veared about initially 33 causing uplift of the aircraft up to 3300 FPM according to fig 9).

(Fig 9 ROC 3300 FPM)

4.6 SR 27 /2023 It is recommended that Oman Air include the wind shear calculation during climb as part of the Crew Flight Plan for early anticipation of turbulence by the crew.
