Oman Transport Safety Bureau (OTSB)

Final Report

OTSB Case File No: AIFN-002/09/2022

Air India Express Boeing 737-800 Engine Number 2 Fire

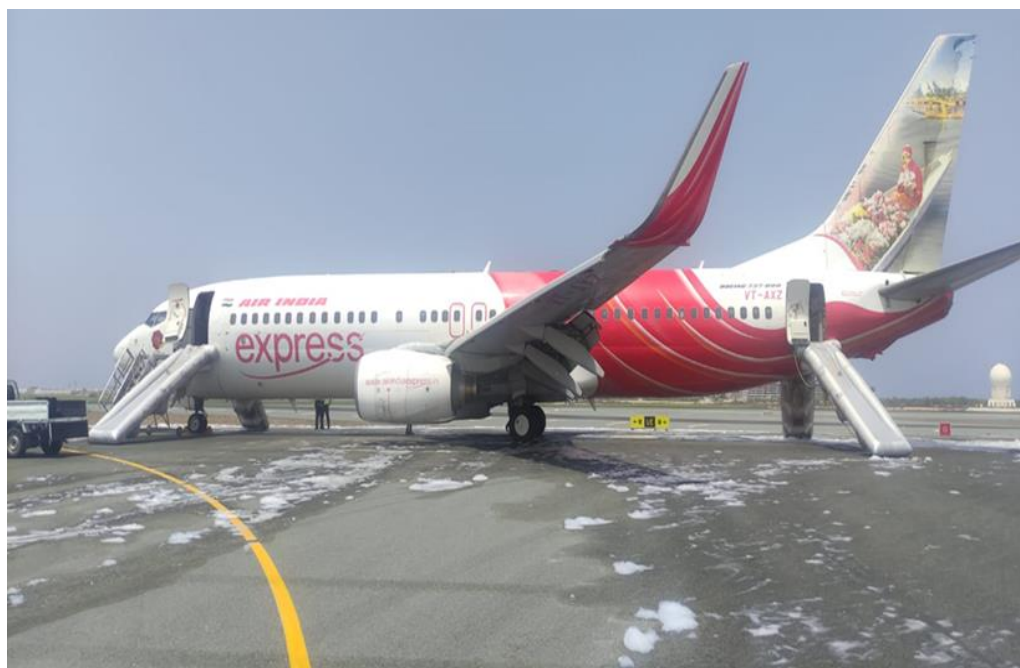
- 1.3.1 The aircraft sustained substantial damages to the engine No: 2 exhaust cone heat damage, pylons areas heat damaged, flap fairing heat damaged and the bottom wing surfaces signs of after burns effects.

Figure 2 showing the aircraft after the fire fighters extinguished the fire on engine number: 2

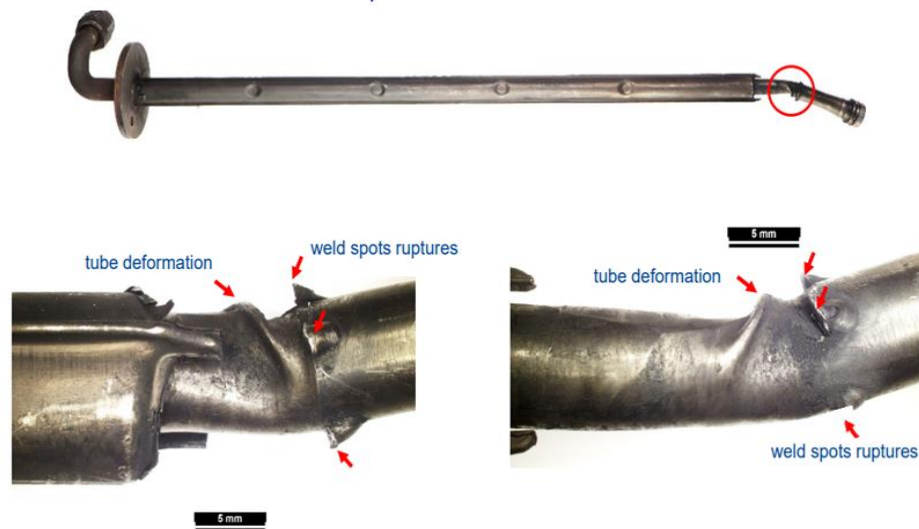
Figure 3 showing damaged/ welded oil supply tube.

- (2) The Thermal shield deformation and tears are related to the heat/ fire or not.
Based on the manufacturer experience in service, this finding is unusual but more in relation with a mechanical damage (not a consequence of heat/fire) and could be linked to the axial movement of the thermal shield after breakage of the welding points.

- (3) All weld spots are broken, thermal shield/ tube de solidarization related to the heat/fire or not.
Tubes with broken welding spots are seen in service. Not in relation with heat or fire event but more in relation with vibration.

- (4) Tube deformation related to the heat/fire.
A repair exists in the Engine Shop Manual to repair welding spots (REP036) but seems to have very low application rate.

Damage to the tube could be linked to the vibration in service and breakage of the 4 welding spots of the thermal shield that could create a movement of the thermal shield and wear of the tube (some oil leakage encountered in service due to the tube wear in this zone). If the thickness of the tube is less than nominal design, or/and if the operator didn't take precaution when he disassembled the other oil supply tube, he could make a torsion of the tube (mechanical effort greater than recommended).

- (6) Manufacturer reported that, the customer uses the repair REP017 to replace the oil supply tube which is approved by manufacturer.
- (7) Tube deformation related to the heat/fire, manufacturer reported that the deformation is not the hypothesis suspected, more a mechanical deformation during disassembly. This deformation existed on the tube when the manufacturer received the TRF with the tube inside (see figures 3 and 4 above).

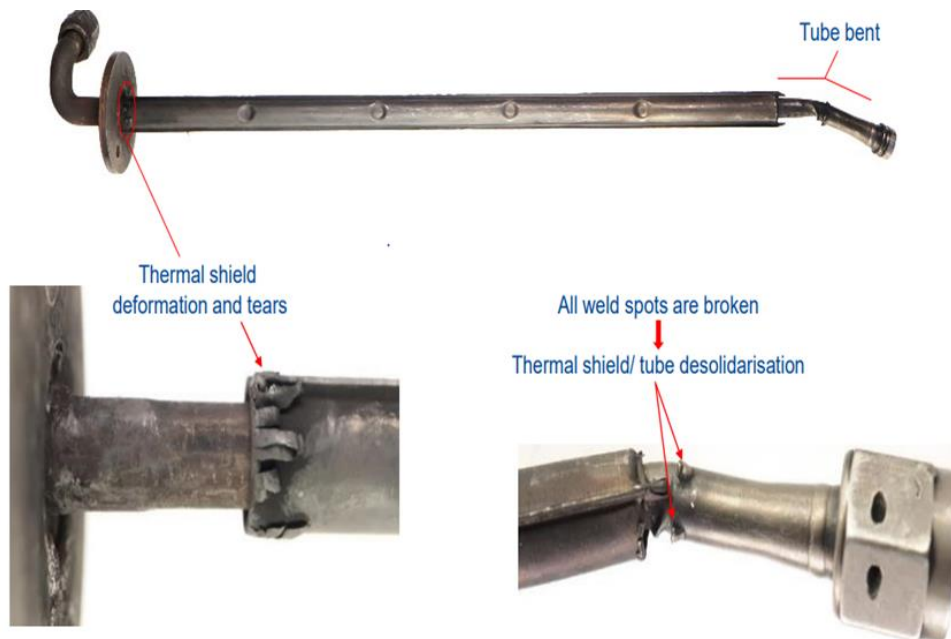
Figure 4 showing thermal shield deformation and tears of the oil supply tube

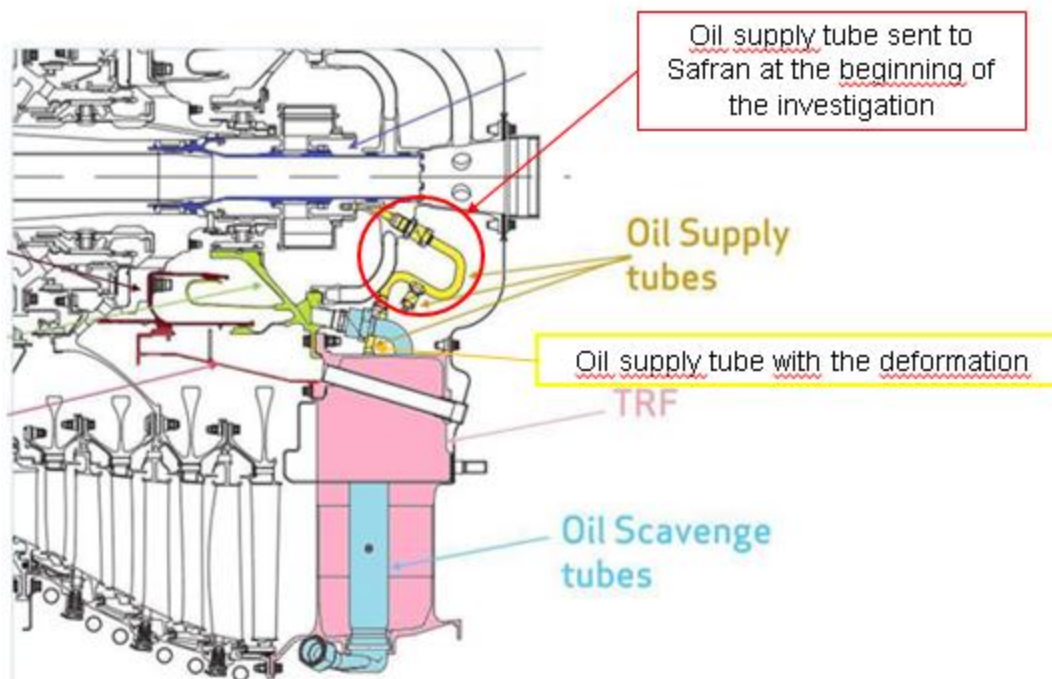
Figure 5 showing the position of the deformed oil supply tube and oil scavenge tube

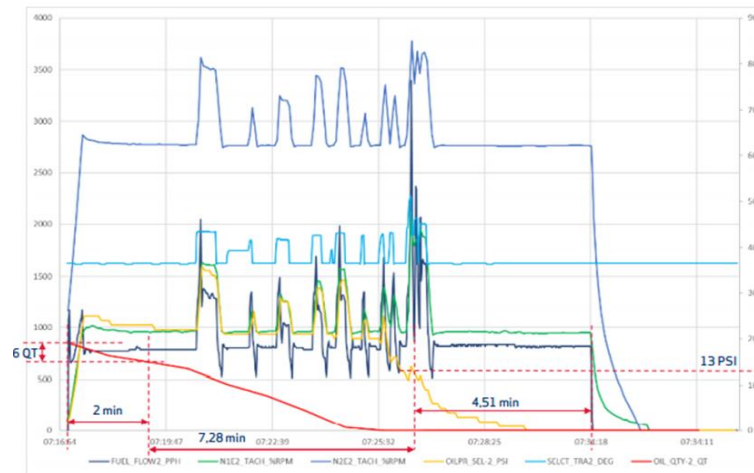
Figure 13 showing the recordings of the downloaded DFDR during taxi.

- Oil quantity decreasing since the engine start. 6 quarts oil loss in 2 min and the oil quantity continue to decrease until to 0 QT within 7min.

- Oil pressure decreasing to zero few minutes later.
- The engine ran with an oil pressure below 13 PSI for than 4minutes.

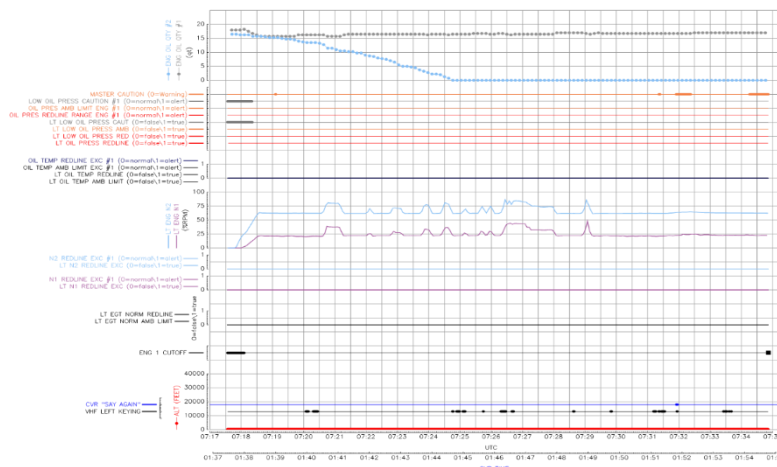
Figure 14 showing the oil quantity drop as per the DFDR downloads during taxi.

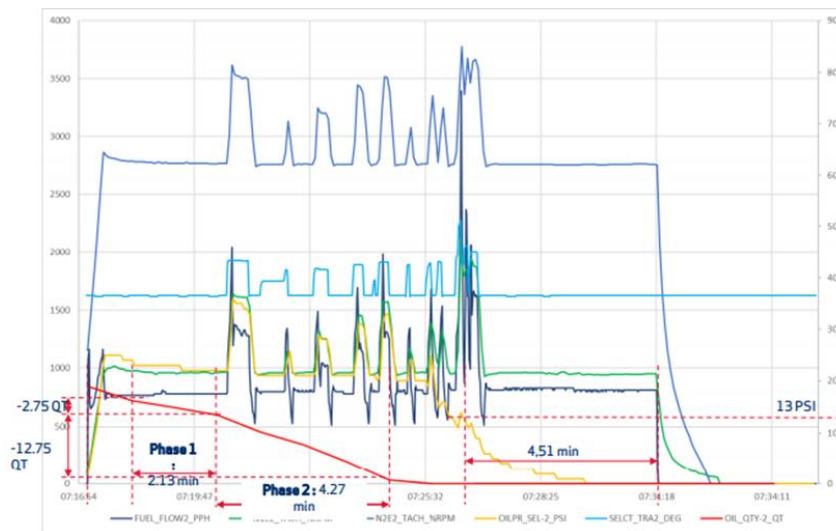
Figure 15 showing the recordings of the downloaded DFDR analysis on oil loss during taxi.

Oil level consumption from DFDR analysis is consistent with oil leakage due to oil system malfunction.

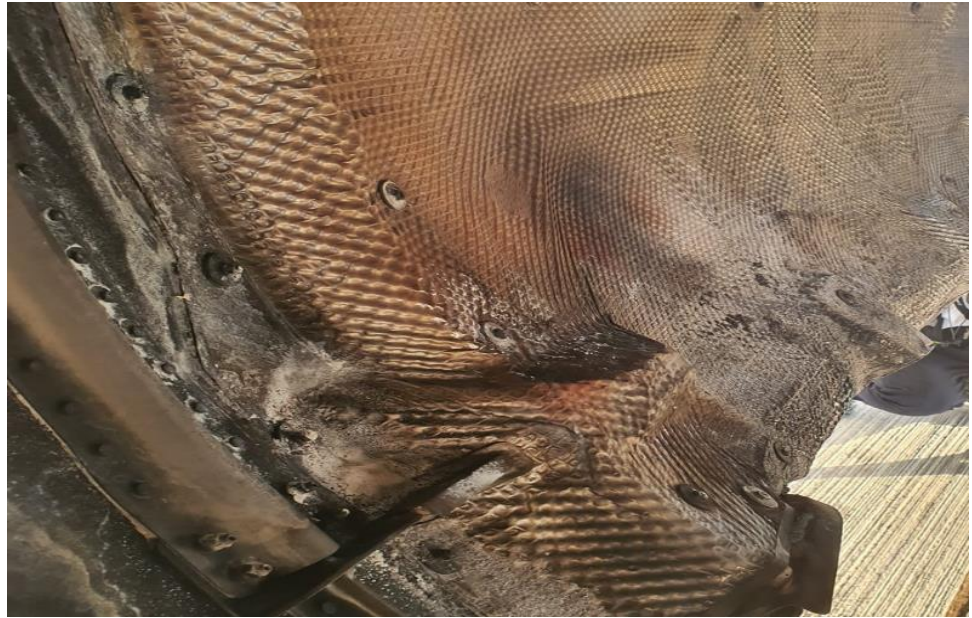
1.12.2 The aircraft sustained damages on engine number 2, exhaust cone heat damage, pylons areas heat damaged, flap fairing heat damaged, bottom wing surfaces signs of after burns effects.

Figure 17 showing the damages to #2 engine thrust reverser thermal blankets

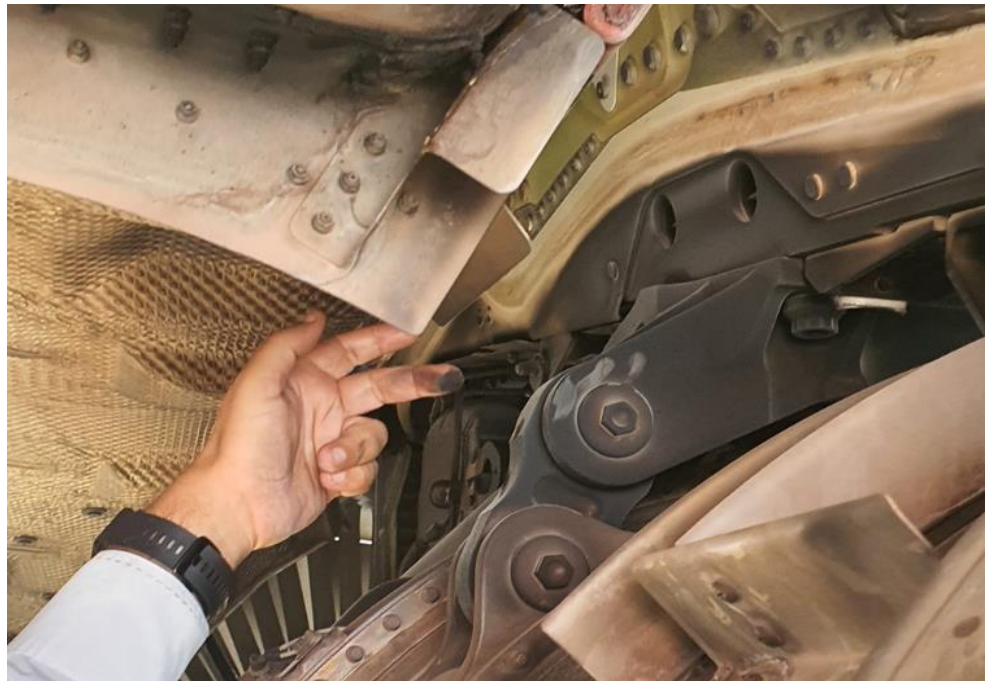
Figure 18 showing damages and soot of the fire

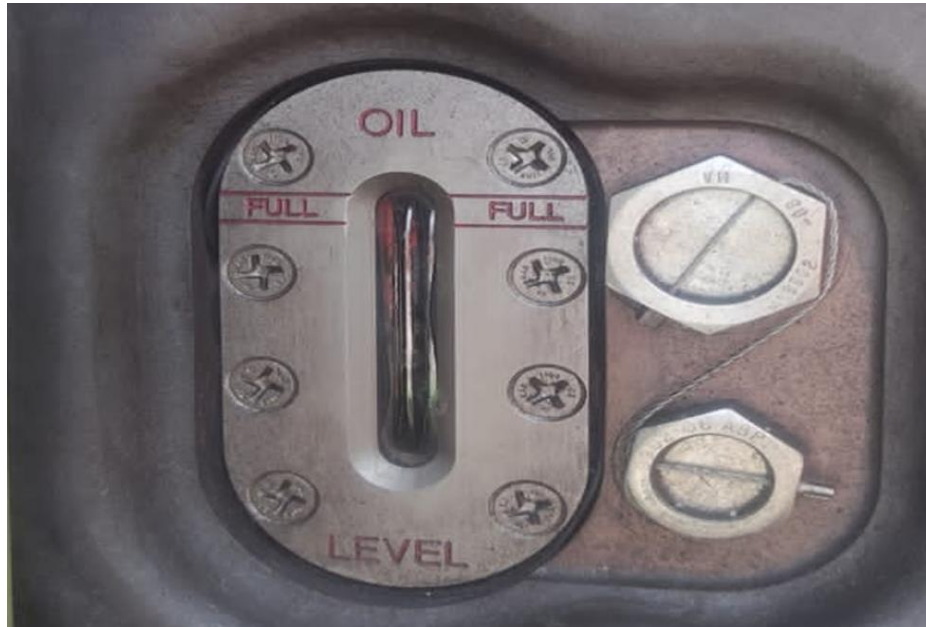
Figure 19 showing the oil level (empty) on the engine 2 sight gauge

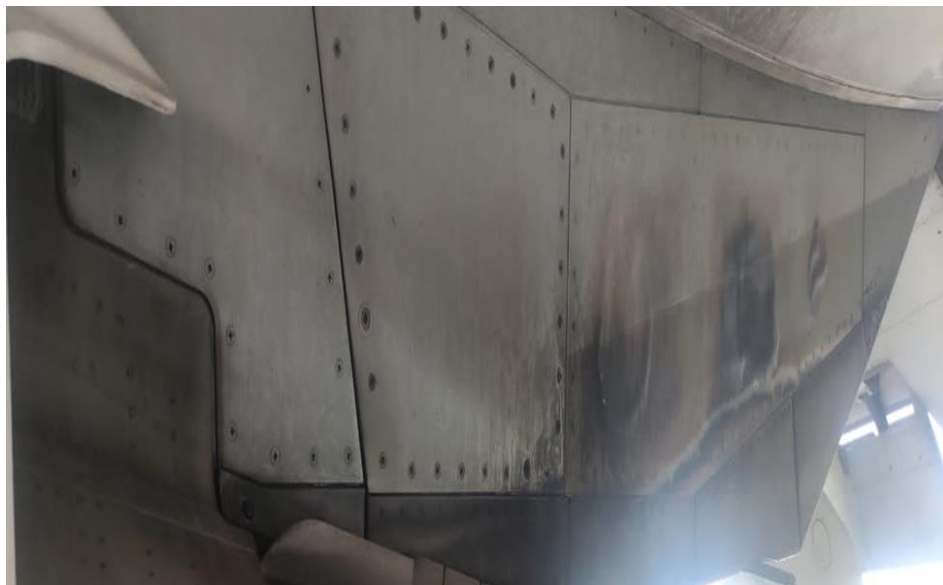
Figure 20. showing the damages to the engine #2 pylon

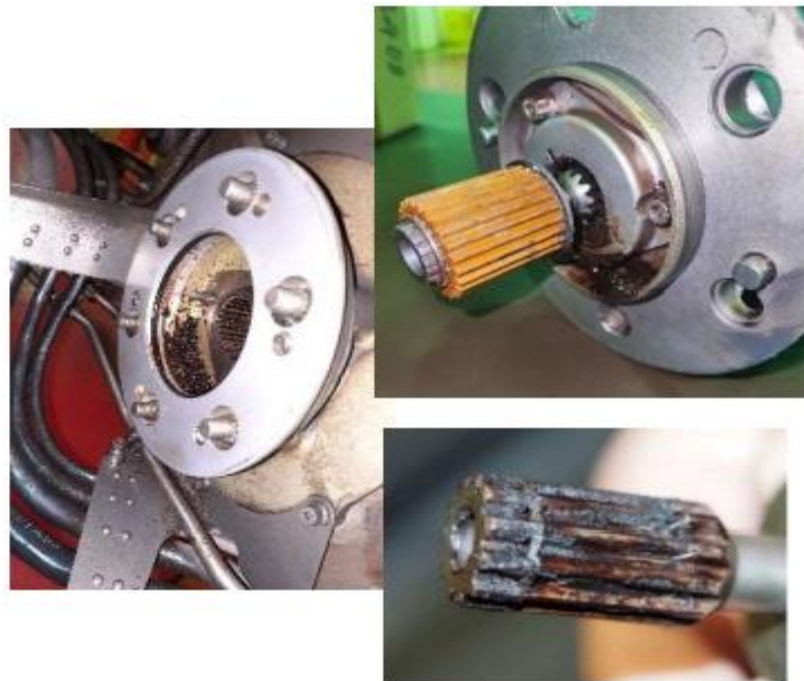
- Evidence of hydraulic fluid exposed to high temperature
- Safety wire in certain areas on the unit was not original- Parker uses safety cable.
- The Compensator Plug had only a remnant of safety cable.
- The pump rotated freely by hand.
- No FOD was observed in the inlet, discharge, or case drain ports
- The Solenoid electrical connector pins were undamaged, but there was minor thread damage to the connector shell.
- Static proof pressure test (52 psi for 5 min): no leakage nor wetting
- Total disassembly: no anomalies (see below figure).

Figure 24 showing black debris and the leak of the skydrol at the base of the EDP

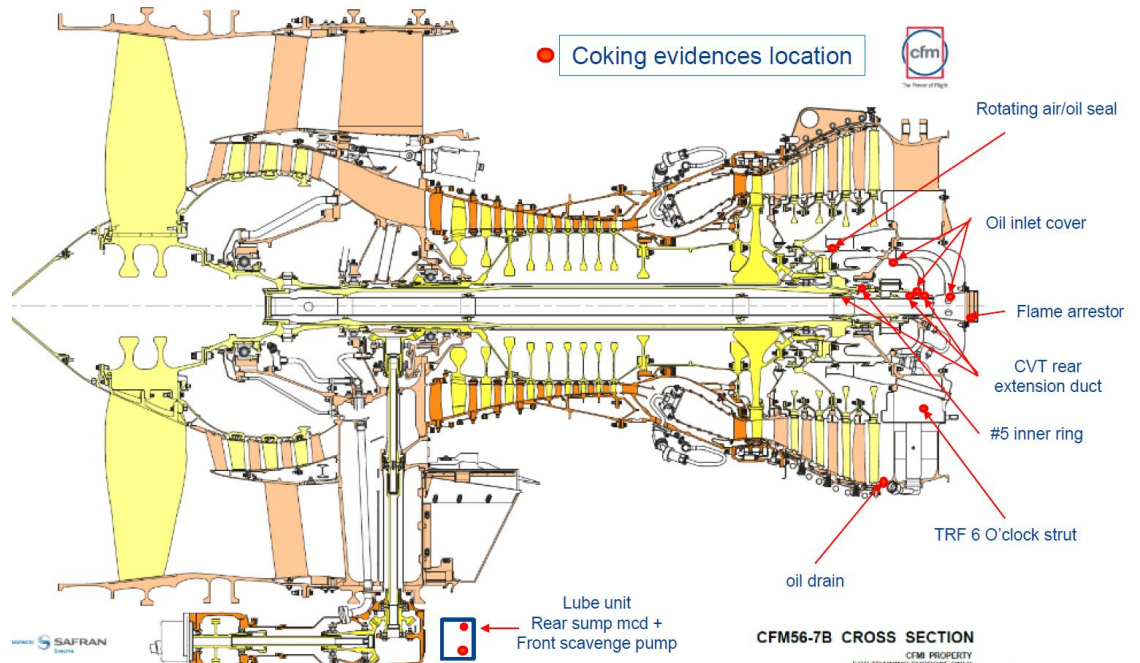
Figure 25. showing coking evidences, locations, #5 inner ring and oil seal, oil inlet cover and flame arrestor (Source; CFM)

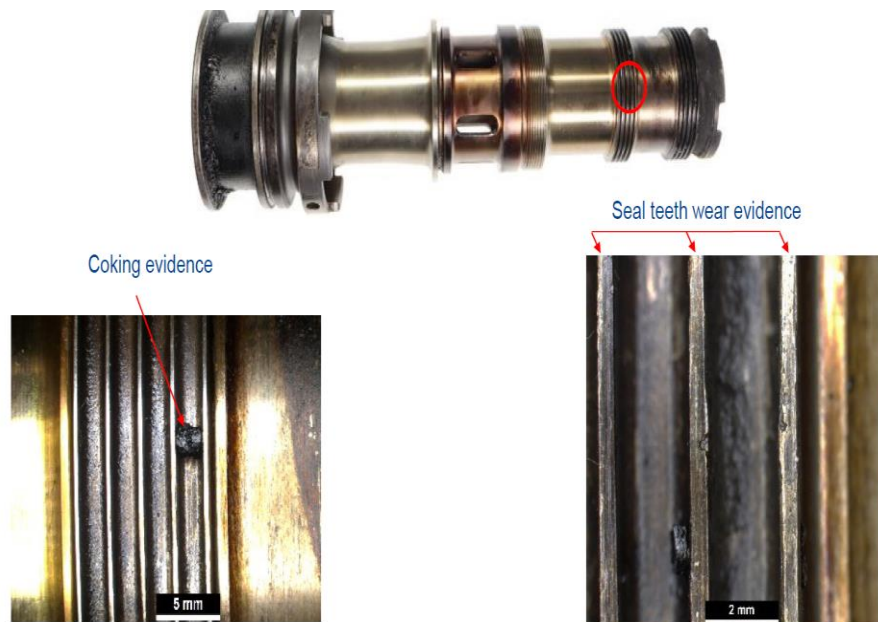
Figure 26. showing abnormal coking at seal teeth location and seal teeth wear

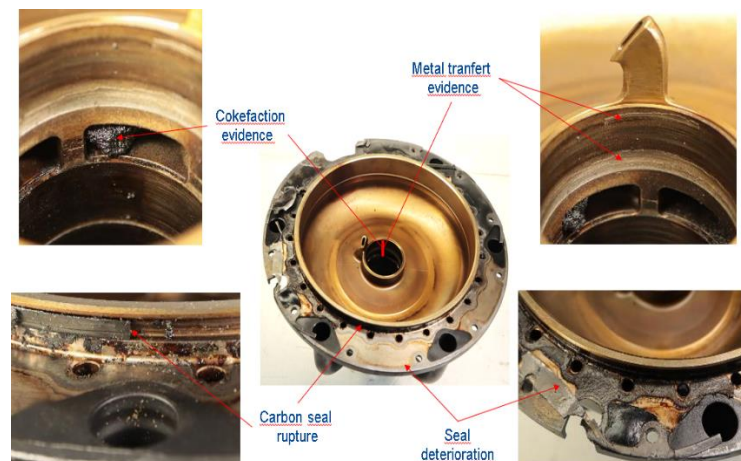
Figure 28. showing damaged seal and evidence of carbon seal rupture

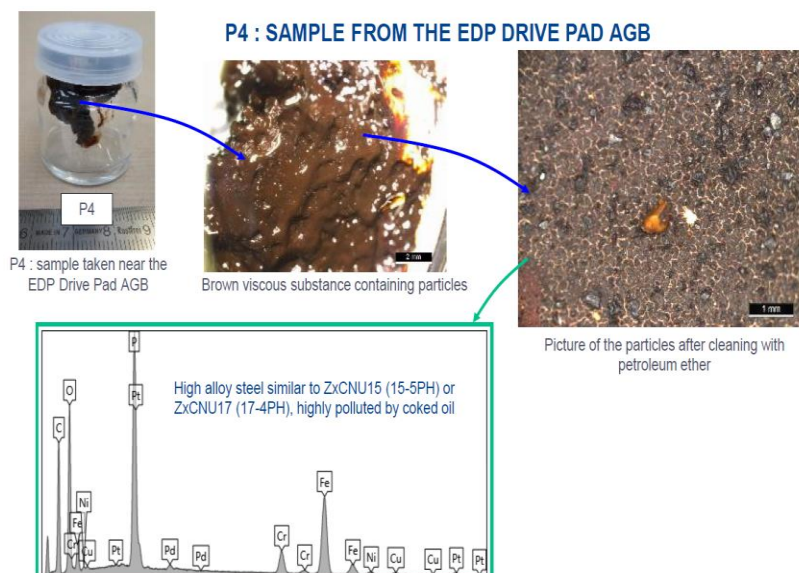
Figure 29. shows a brown viscous substance taken near the EDP Drive pad

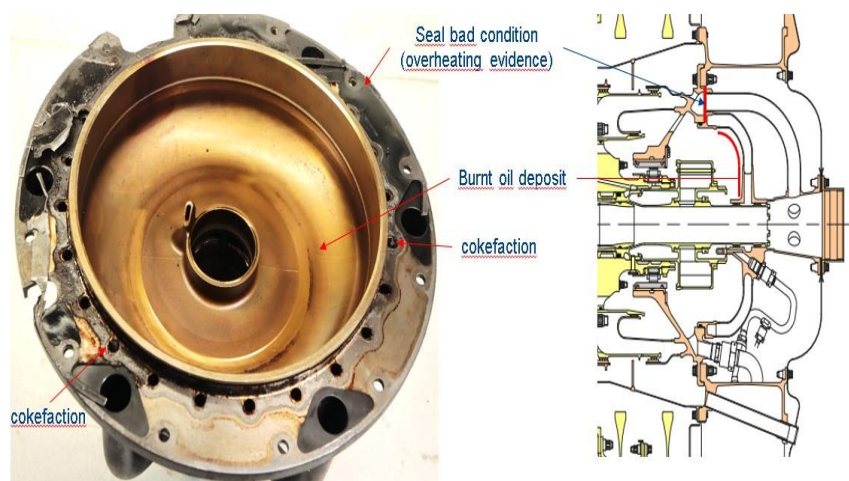
Figure 30. showing a damaged seal conditions and evidence of overheating

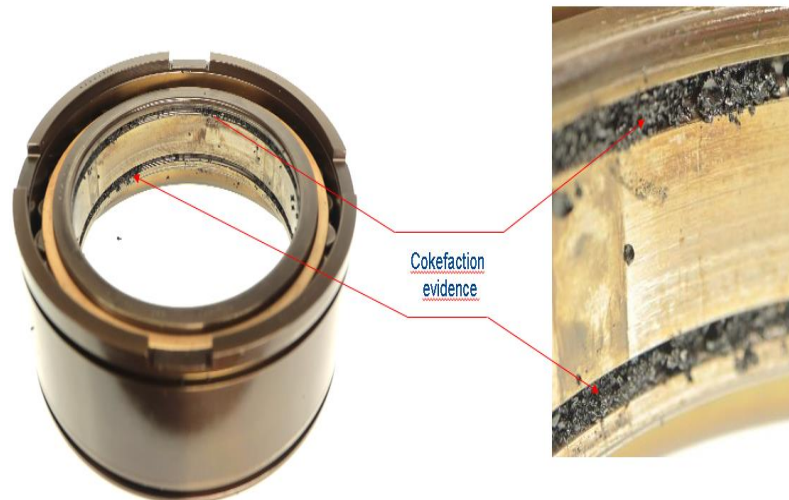
- Large amount of abnormal coking detected in several locations (but where oil is present in normal operation without generating coke), with big pieces up to 11mm, including in scavenge MCD of lube unit.
- Most probably low time of functioning in this condition (should this coke be present on previous flights, other detections or distresses may have occurred).
- Coke generation (linked with specific oil composition): quantity and #5 bearing (BRG) support groove (see figure below) coking most probably come from the soak back phase of previous flights.

Figure 31. showing bearing #5 damages and coke faction evidence on bearing number #5

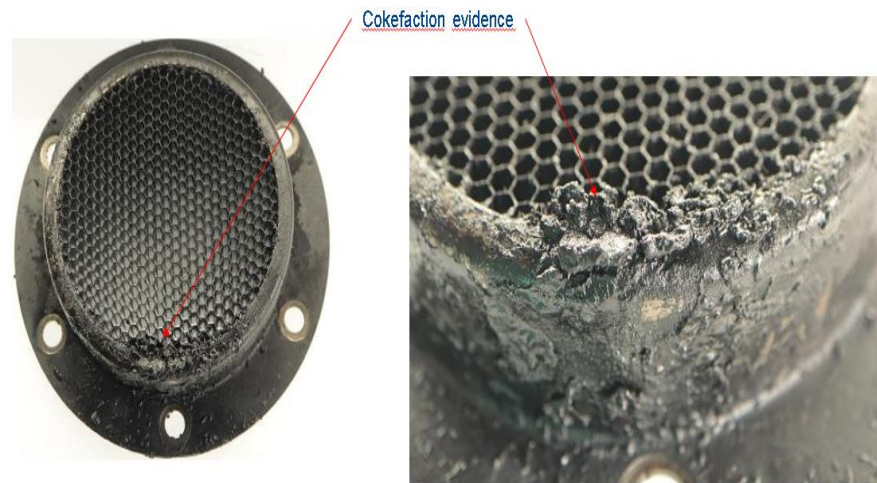
- This abnormal coking (linked with specific oil composition) may block oil flows, could have led to oil scavenge system clogging, generating quick and massive overfill of local sumps, leading to external leakages.
 - Oil was evacuated thru rear sump oil drain and flame arrestor.
- Rear sump seal wear could have contributed to oil evacuation in the exhaust plug.

Figure 32. showing coke faction evidence on the flame arrester

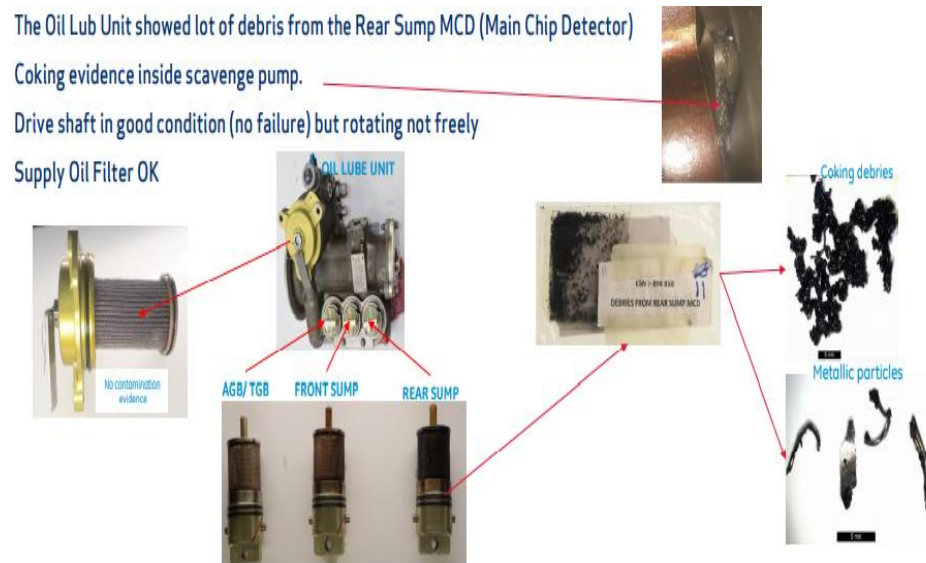
Figure 34. shows oil lubrication unit with debris from the rear sump main chip detector (MCD)

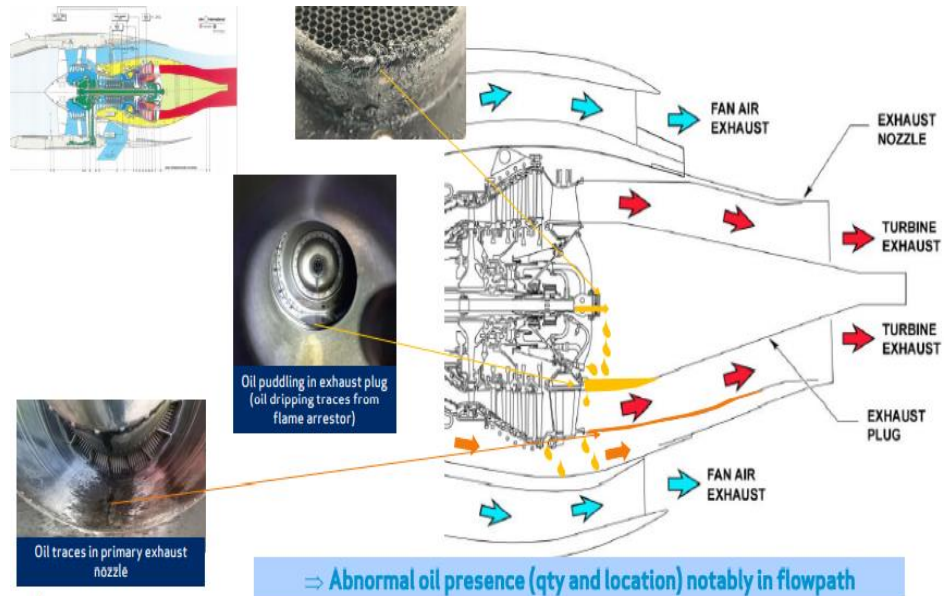
- Oil located in the plug/ exhaust has created the smoke /fire seen during the event. Fire most likely facilitated by abnormal oil composition (unexpected components are excellent fuels).
- Two locations of fire, entertained in spite of permanent airflow (Significant oil leakage) necessary to feed fire, consistent with low oil quantity alarm and remaining oil in flow path and internal to plug (See figure below).

Figure 35. shows traces of oil in primary exhaust nozzle and dripping from flame arrestor

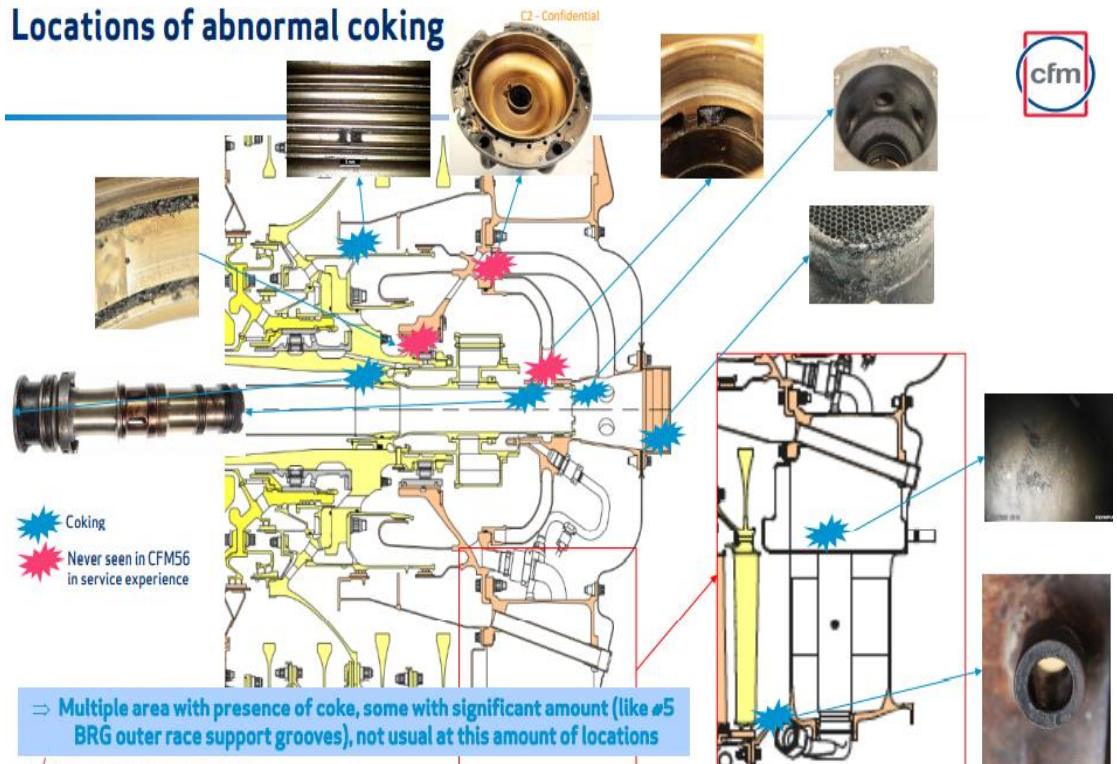
Figure 36. showing locations of affected abnormal coking

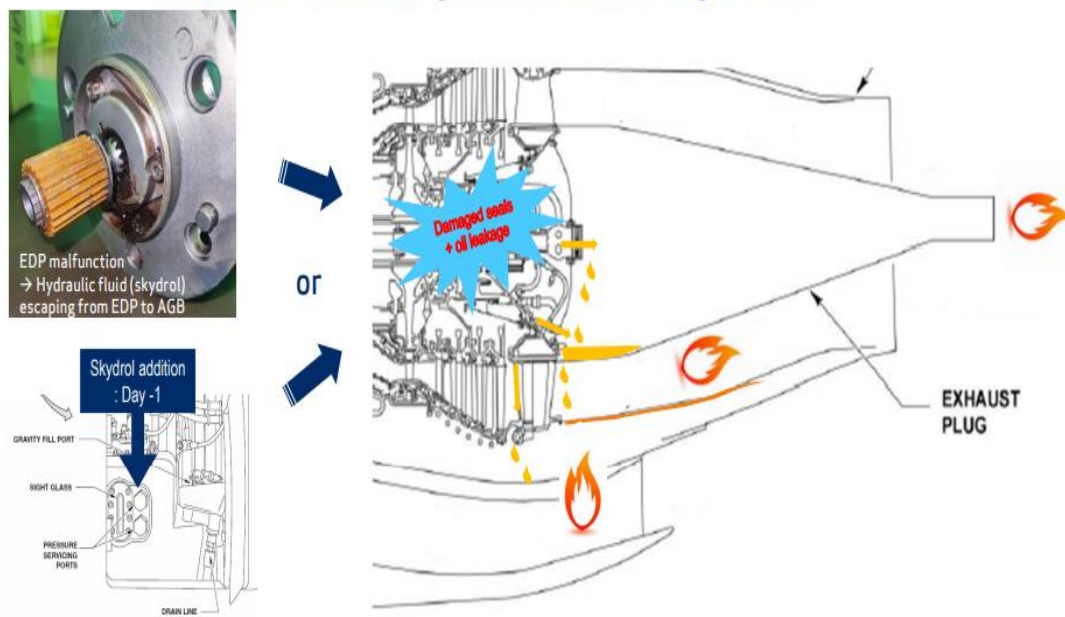
Skydrol in oil → damaged seals → oil leakage → fire

Figure 37. showing hydraulic fluid leaks and escapes from EDP

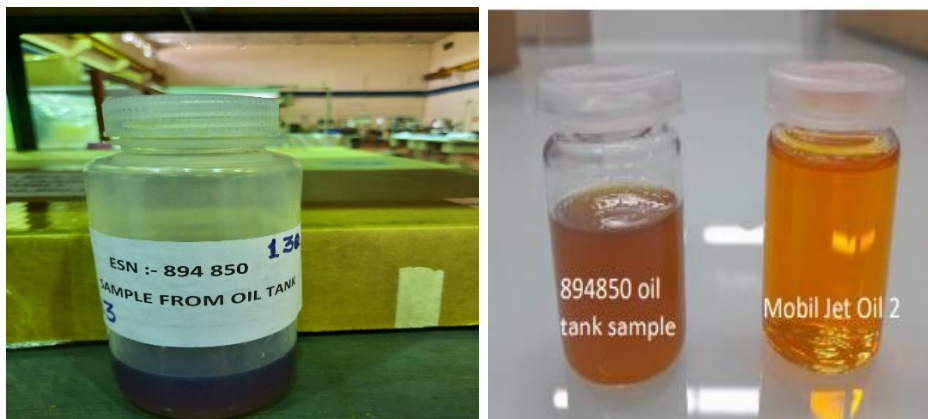
Oil sampling chemical analysis confirmed that the oil is not a typical "Mobil jet 2": unusual aspect, unusual odor and contained foreign product (origin not identified):

- Oil sampling Chemical analysis confirmed non-common Mobil Jet 2 oil: unusual aspect, unusual odor: polysiloxane + 2- pentanone, 4-hydroxy-4-methyl + tributylphosphate
- Unusual coking inside Rear Sump with some coke parts above 11mm + coke locations not in CFM experience
- Last oil servicing (~1l) occurred the night before flight IX443. Distress flight was the 2nd flight of the day.
- Rear sump chip detector contaminated by coke + metallic particles
- Oil inlet cover seal rupture + some seal teeth wear ◇ leakage possible
- Oil consumption (oil tank empty) is consistent with oil leakage due to oil system malfunction
- Remaining oil in plug
- Sister engine #1: oil normal

Figure 38. showing the oil sample from oil tank. Figure 28 showing comparisons of the oil sample from oil tank and the Mobil Jet Oil 2
