Oman Transport Safety Bureau

– Final Report –

OTSB Case File No: IIFN/001/07/2022

TCAS Resolution Advisory between a Saudi Arabian Boeing777 and a Salam Air Airbus320 in the Muscat FIR

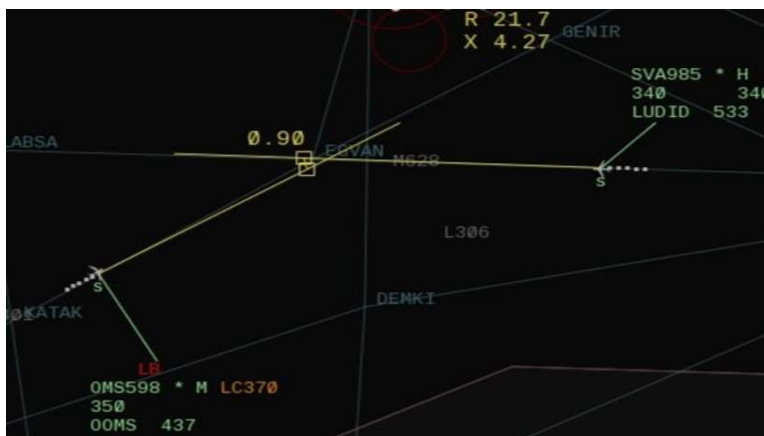
Figure 2- 03:41:46: screenshot from Indra Radar display

7. The OMS598 flight crew understood the ATC clearance "descend to FL350 now" as a need to leave FL370 without delay.
8. At 03:41:46, red LB warning was triggered on the controller's Indra radar display on flight OMS598 as there was a mismatch between the level that flight OMS598 was maintaining FL350 in compliance with the level that was entered by the controller and the level that was entered into the FMS (FL310) as per the following figure: -

9. The red LB is a defensive tool which warned the controller regarding the mismatch of flight levels by appearing red LB on the screen and has an option of an audio sound, which had been switched off by the management.
10. Flight OMS598 descended and maintained FL350. When the flight reached their point of descent at 03:42:20, OMS598 informed ATC that they were descending to FL310.

Therefore, OTSB recommends CAA to consider activating the red LB audible warning for conflicting traffic.

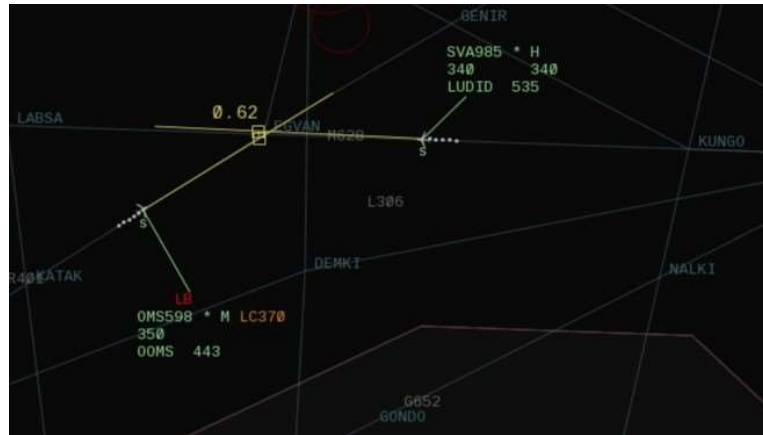
Figure 4- 03:42:26: screenshot from Indra Radar display

11. Flight OMS598 was still showing on the controller's radar screen maintaining FL350, due to the radar antenna which rotated every 10 seconds except for the radar located in Jaalan it rotated every 15 seconds, although actually flight OMS598 had initiated the descent.
12. Flight OMS598 did not inform the controller that FL350 had been vacated and that the flight was already on descent. Instead, OMS598 read back "maintain FL350".
13. At 03:42:26, the controller instructed flight OMS598 to "stop maintain FL350". Flight OMS598 acknowledged, but flight OMS598 had already initiated the descent from FL350 for FL310 descending as per the following figure: -

14. Therefore, there was a gap of 40 seconds from the time the red LB warning (03:41:46) appeared on the radar target from flight OMS598 to the time the controller instructed flight OMS598 to “stop maintain FL350” (03:42:26). During this time, there was silence on the radio frequency and no coordination actions were heard at the controller’s position.

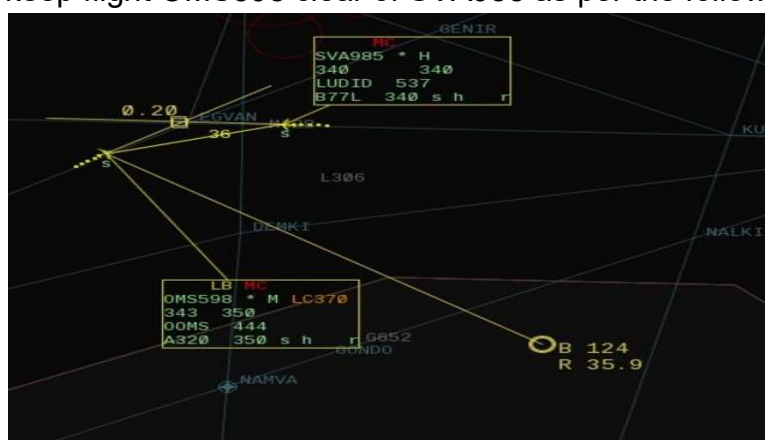
Figure 5:-Screen shot from Indra radar playback

20. Subsequently, the yellow STCA radar warning appeared on radar with the red MC, which indicated that there was a conflict between the two flights (OMS598 and SVA985).

21. For the third time, the controller instructed flight OMS598 to “stop maintain FL350” and the flight crew acknowledged “We are climbing FL350 OMS598”. By that time, flight OMS598 had reached FL341.
22. Flight OMS598 initiated a climb, but the climb rate was very low.
23. During the interview, the flight crew stated that the climb rate was low or almost zero, until they disengaged the auto pilot and flew the aircraft manually. At this time, the flight crew was able to observe the conflicting traffic on TCAS.
24. As the converging distance between flight OMS598 and flight SVA985 was 16 NM closing, the controller issued an avoiding heading of 190 degrees to flight OMS598 in order to keep flight OMS598 clear of SVA985 as per the following figure: -

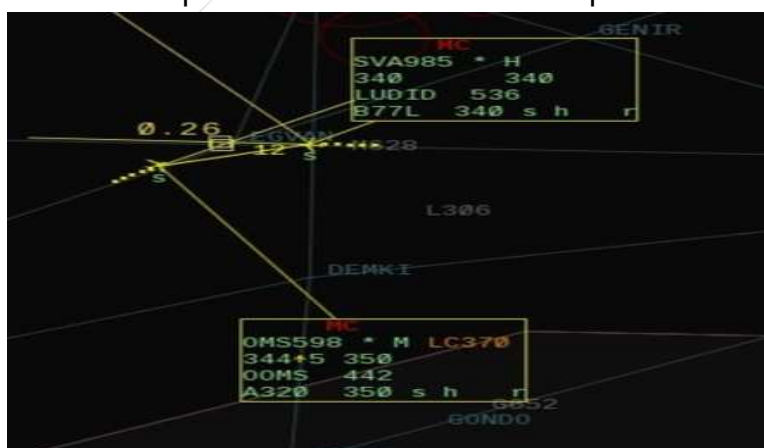
Figure 6:-Screen shot from Indra radar playback

25. Thereafter, the controller issued an avoiding heading of 320 degrees to flight SVA985, but flight SVA985 reported at the same time a TCAS TR. The controller instructed the crew to report once clear of conflict as per the following figure: -
