# Oman Transport Safety Bureau (OTSB)

## - Final Report -

OTSB Case File No: AIFN/001/03/2025

### TCAS Resolution Advisory between Fly Vaayu - Airbus 320-232 and Qatar Airways - Airbus A330-302 in the Muscat FIR

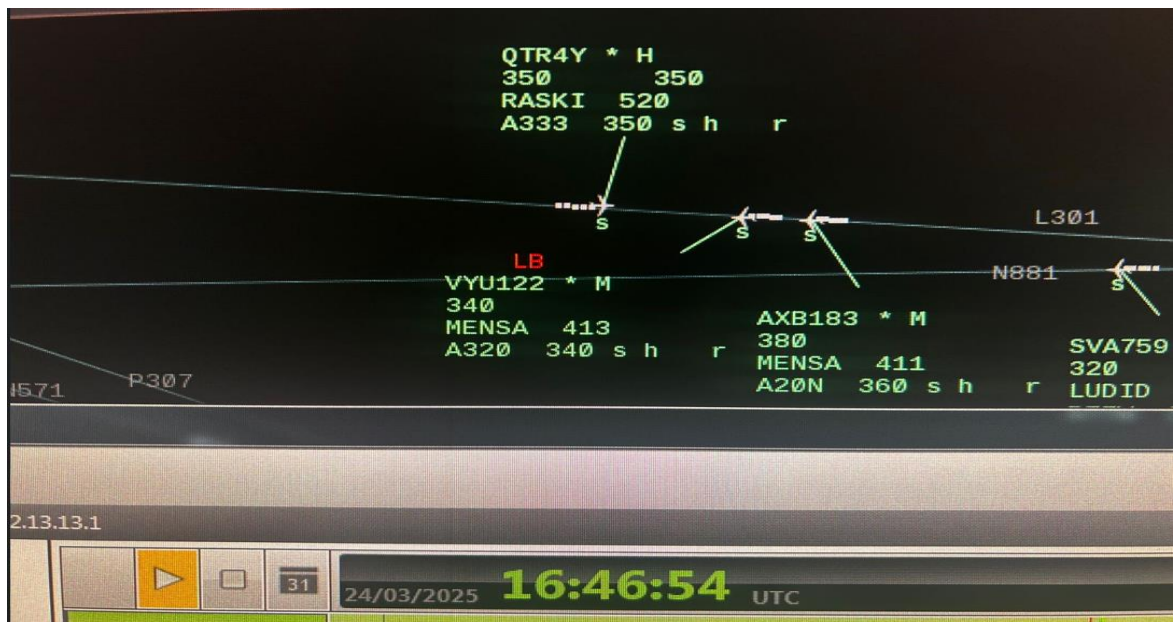
- 1.1.9 At the time 16:46:54, although the radar display screen was indicating aircraft VYU122 maintaining FL340 but the “Level Burst (LB) radar warning (indicating a level bust) was activated on aircraft VYU122”, as shown below in figure 1.

Figure. 1 ATC radar indicating LB activated without any indication of ROC and FL340 on aircraft VYU122 (Source: DGAN)

- 1.1.10 At the time 16:46:56, it was observed on radar the ATCO pointing the cursor on VYU122 label with the LB warning, but since aircraft VYU122 was still maintaining FL340, the ATCO did not take any action.
- 1.1.11 At the time 16:47:06, aircraft VYU122 was observed on the RDR display leaving FL340, climbing at a rate of 600 Feet Per Minute (FPM), while opposite direction traffic, aircraft QTR4Y, was flying on the same route (L301) and maintaining FL350.

2.2.4.6 As per the FDA, the aircraft VYU122 left FL340 at the time 16:46:53, however, according to the RDR display, at the time 16:46:54 the aircraft VYU122 was observed with Red LB maintaining FL340. In the RDR display it was observed climbing at 16:47:06. At time 16:47:08 the ATCO instructed the flight crew of VYU122 to maintain FL340, which was 2 seconds after it was observed climbing. The FDA and RDR time difference of the aircraft VYU122 leaving FL340 could be explained as a result of the RDR rotating with approximately time lag of 5-12 seconds.

4.2.2.2 The ATCO did observe on the radar Red LB displayed on VYU122, but the ATCO assumed that the Red LB on the aircraft VYU122 was from the FMS as a future climb and did not confirm with the flight crew of VYU122, OTSB recommends that DGAN to provide mechanism to ATCOs: **treat LB (red label) as actionable** until confirmed otherwise ask for immediate clarification (“Confirm you are climbing?”) rather than assuming FMS plan in order to achieve positive control.

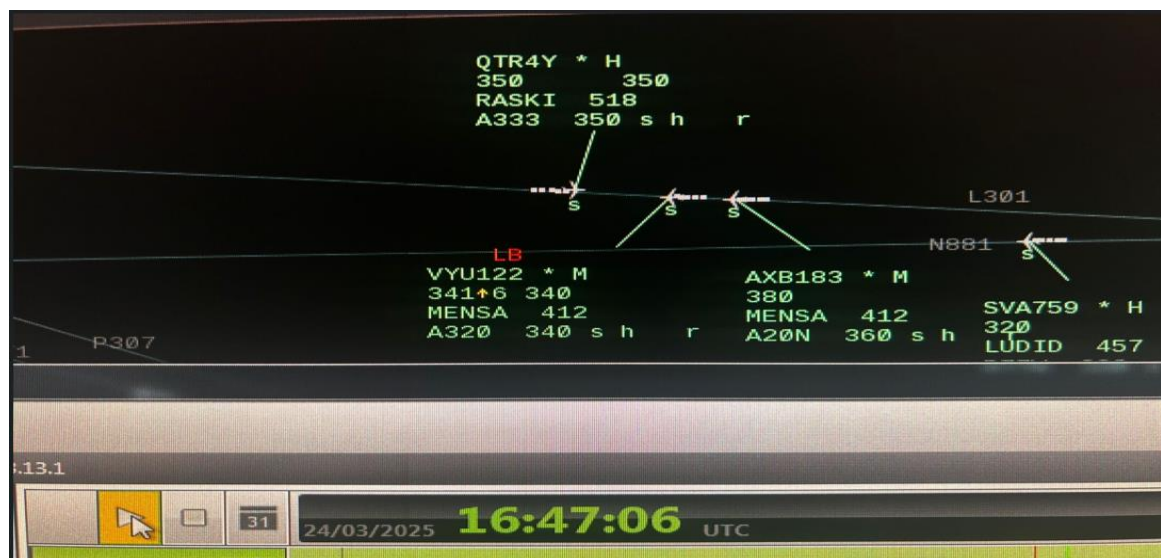
Figure. 2 ATC RDR indicating aircraft VYU122 climbing through FL341 at a ROC of 600FPM (Source: DGAN)

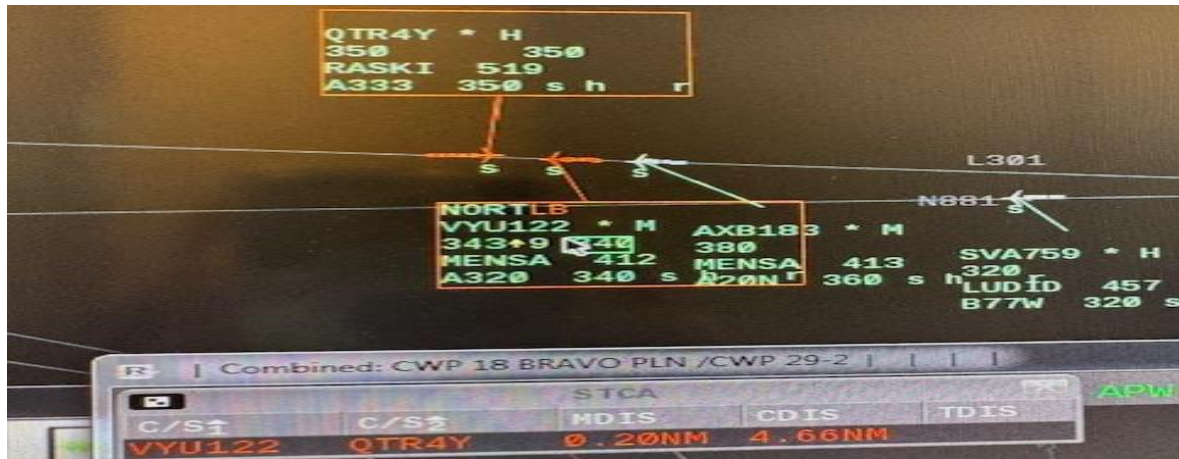
- 1.1.13 At the time 16:47:18, the Red Short-Term Conflict Alert (STCA) warning was triggered between aircraft VYU122 on climb passing through FL343, ROC 900FPM and an opposite direction aircraft QTR4Y maintaining FL350 with a separation distance of 4.66 NM closing between the two aircraft as shown in figure 3.

Figure. 3 ATC RDR indicating Red STCA warning between aircraft VYU122 climbing through FL343, ROC of 900FPM and an opposite direction aircraft QTR4Y maintaining FL350 with a distance of 4.66NM closing between the two aircraft (Source: DGAN)

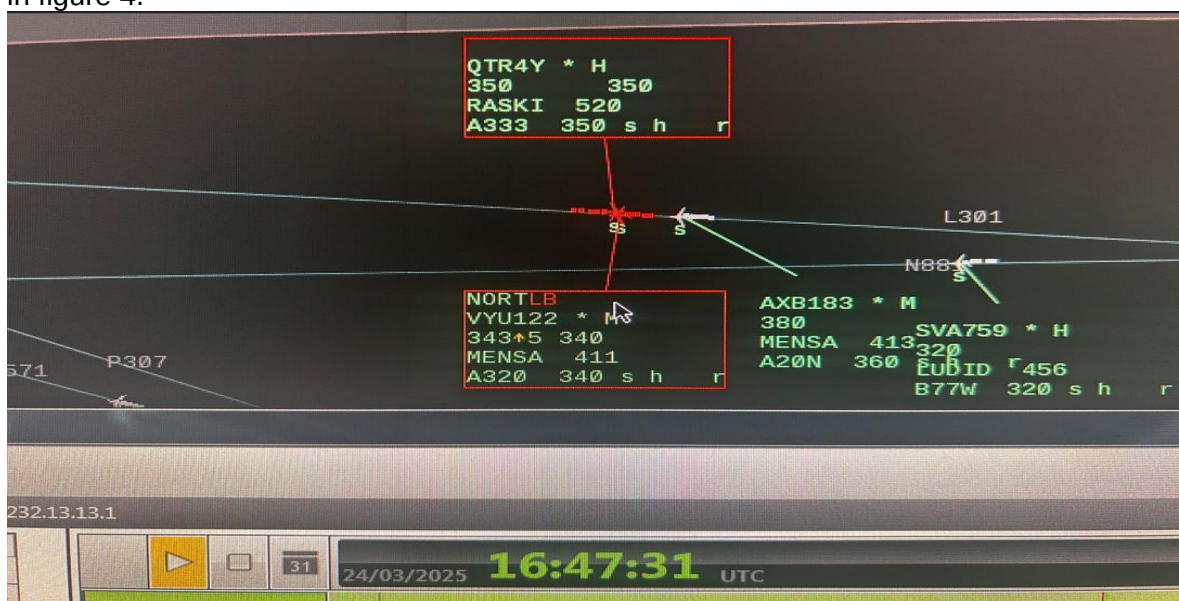
- 1.1.14 At the time 16:47:19 The flight crew of VYU122 apologized by stating “Sorry for that VYU122”. At the time 16:47:24, ATCO informed the flight crew of QTR4Y “the traffic is descending now”. At the time 16:47:27, the flight crew of QTR4Y reported “QTR4Y TCAS RA” however the flight crew of VYU122 did not report TCAS RA.
- 1.1.15 At the time 16:47:31, during radar playback aircraft VYU122 was observed on climb passing through FL343, ROC of 500FPM and aircraft QTR4Y was observed on opposite direction maintaining FL350 with a separation distance of 1.53 NM between the two aircraft as shown in figure 4.

Figure. 4 Aircraft VYU122 observed on ATC RDR on climb passing through FL343 ROC of 500FPM and aircraft QTR4Y on opposite direction maintaining FL350 with a separation distance of 1.53 NM between the two aircraft (Source: DGAN)

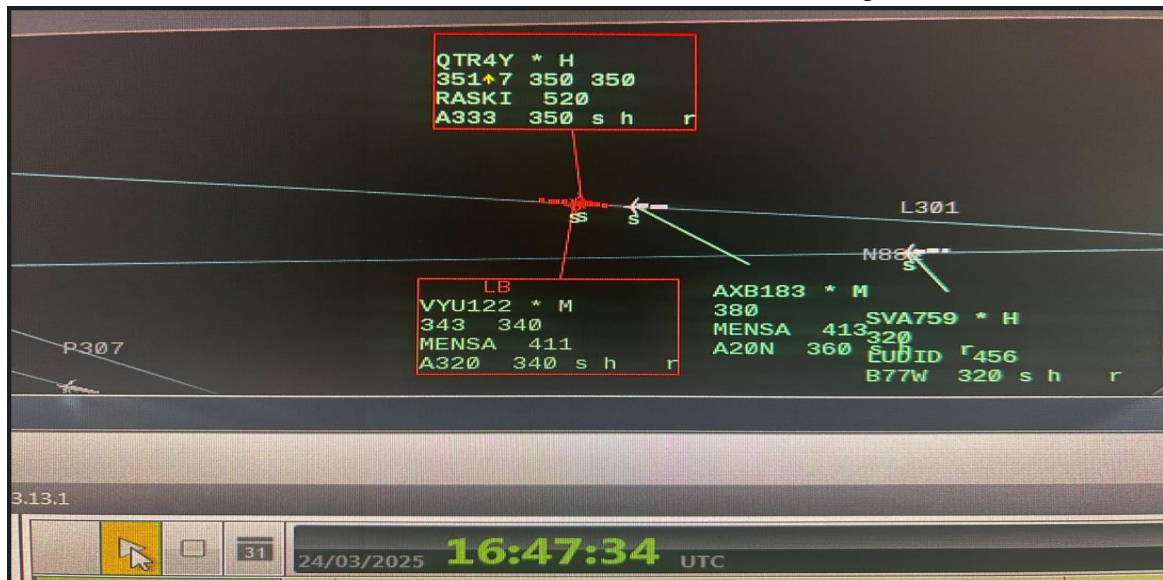
- 1.1.16 At the time 16:47:34, RDR showed aircraft QTR4Y leaving FL350 climbing through FL351 at a ROC of 700FPM, while the opposite direction aircraft VYU122 was maintaining FL343. The distance between the two aircraft was 0.39 NM as shown in figure 5.

Figure.5 ATC RDR indicating aircraft QTR4Y on climb passing through FL351 at ROC of 700FPM and opposite direction aircraft VYU122 was maintaining FL343 (Source: DGAN)

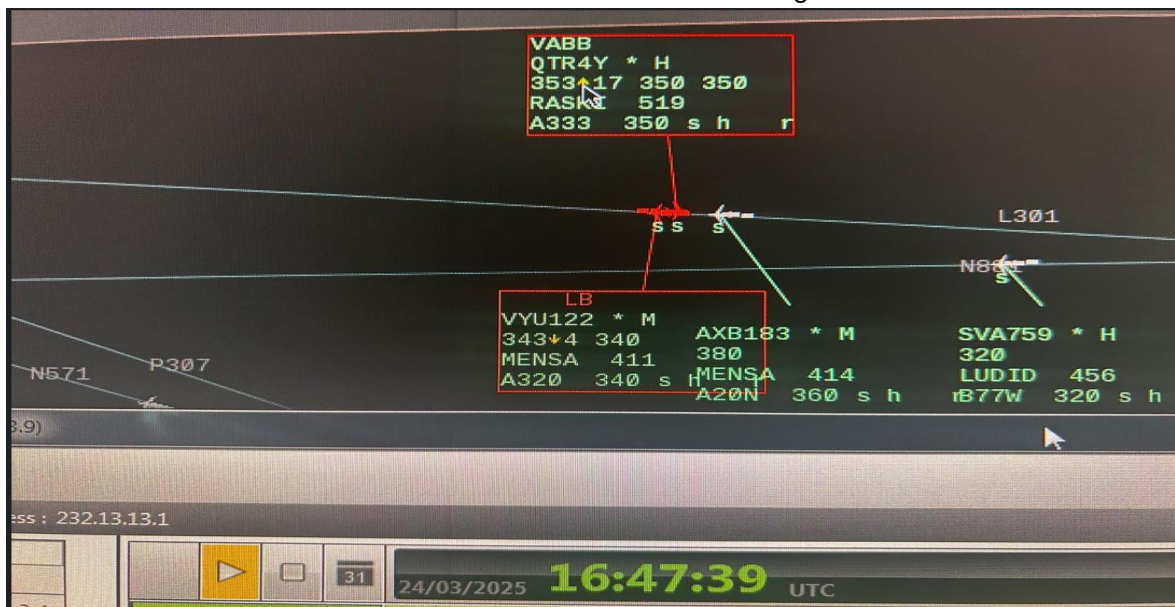
- 1.1.17 At the time 16:47:39, a 1,000 feet (FT) separation was attained between aircraft VYU122 and aircraft QTR4Y whilst aircraft QTR4Y was on climb passing through FL353 at ROC of 1700FPM, and aircraft VYU122 on descent passing through FL343 ROD of 400FPM. The distance between the two aircraft was 0.66 NM as shown in figure 6.

Figure.6 ATC RDR indicating aircraft QTR4Y climbing through FL353 at ROC of 1700FPM and opposite direction aircraft VYU122 was on descent passing through FL343, ROD of 400FPM the distance between was 0.66 NM (Source: DGAN)

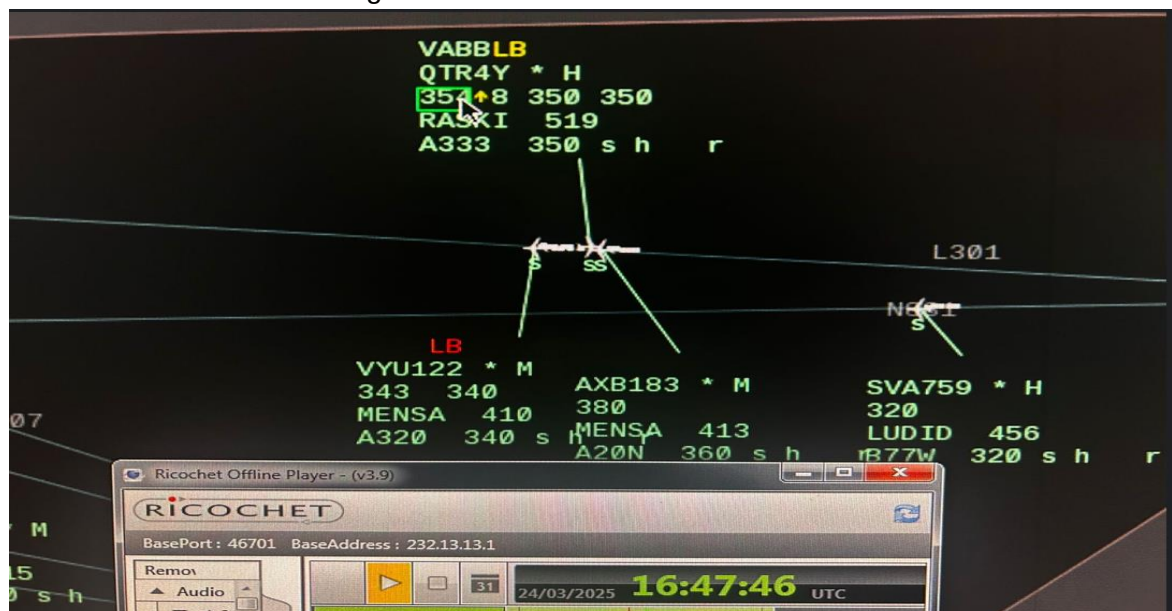
- 1.1.18 At the time 16:47:46, the red STCA on the radar screen was deactivated between aircraft VYU122 while maintaining FL343 and opposite traffic aircraft QTR4Y climbing through FL354 with ROC of 800FPM. The distance between both traffic after passing each other was 1.67 NM as shown in figure 7.

Figure.7 RDR Indicating red STCA deactivated between aircraft VYU122 still maintaining FL343 and aircraft QTR4Y climbing through FL354, ROC of 800FPM (Source: DGAN)

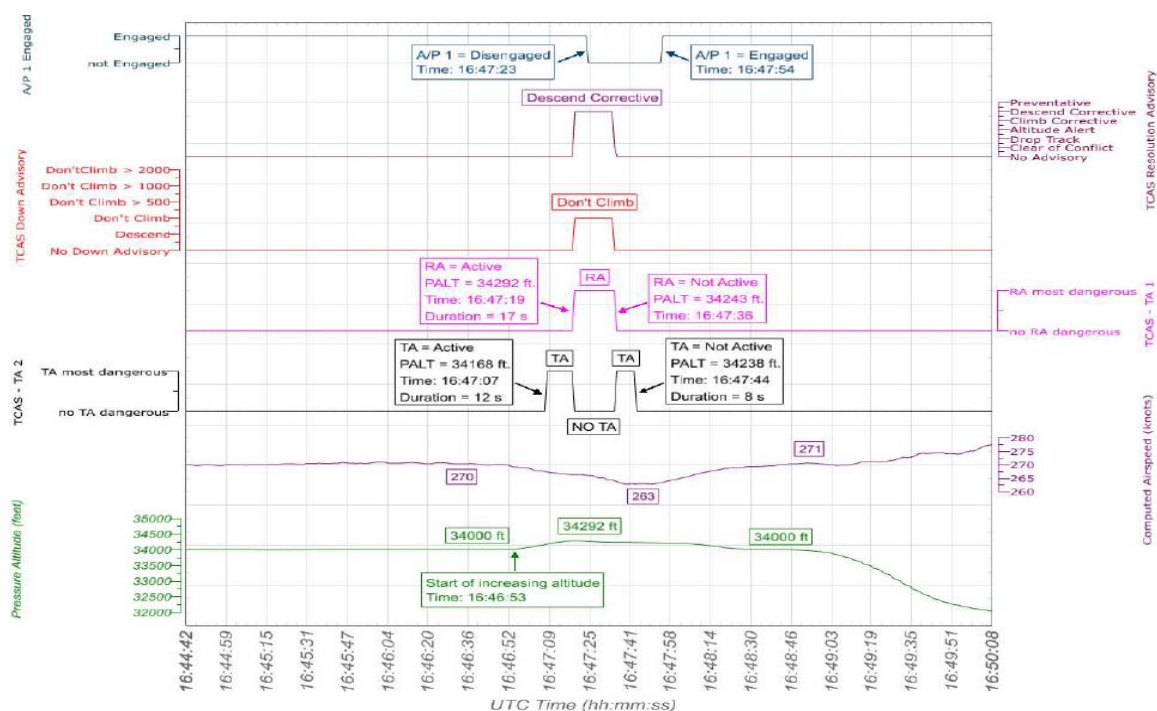
- 1.1.22 According to the Flight Data Analysis (FDA), at the time 16:46:53, aircraft VYU122 left FL340 and reached 34292FT and at the time 16:48:30 aircraft VYU122 was back to FL340 as per figure 8 below:

Figure. 8 shows all TCAS Advisory parameters including TCAS RA duration which lasted for 17 seconds for flight VYU122 (Source: Fly Vaayu – Flight Data Analysis - FDA)

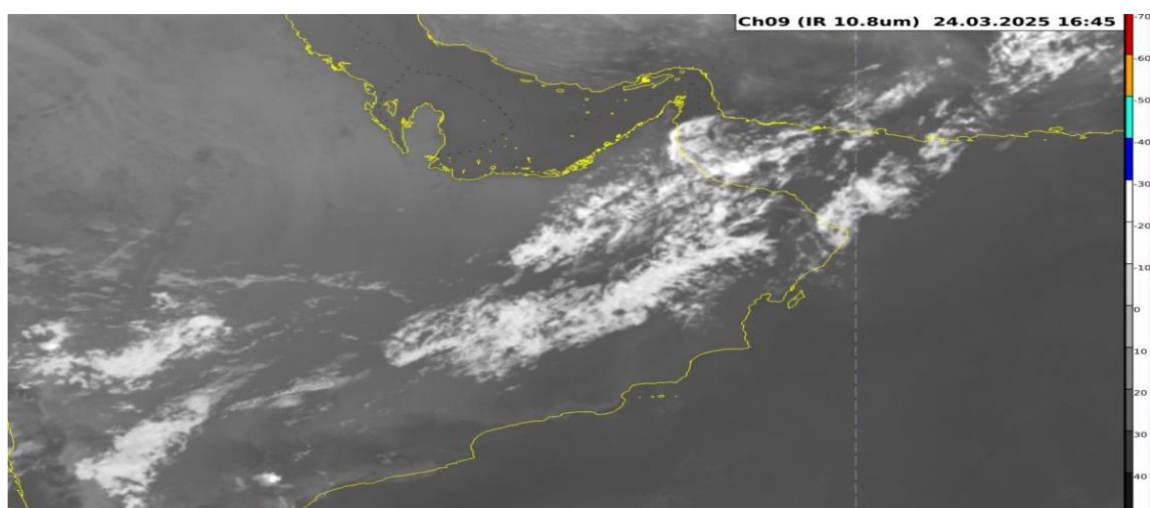
Figure. 9 Showing cloud conditions at the time and date of the serious incident (Source: DGMET)

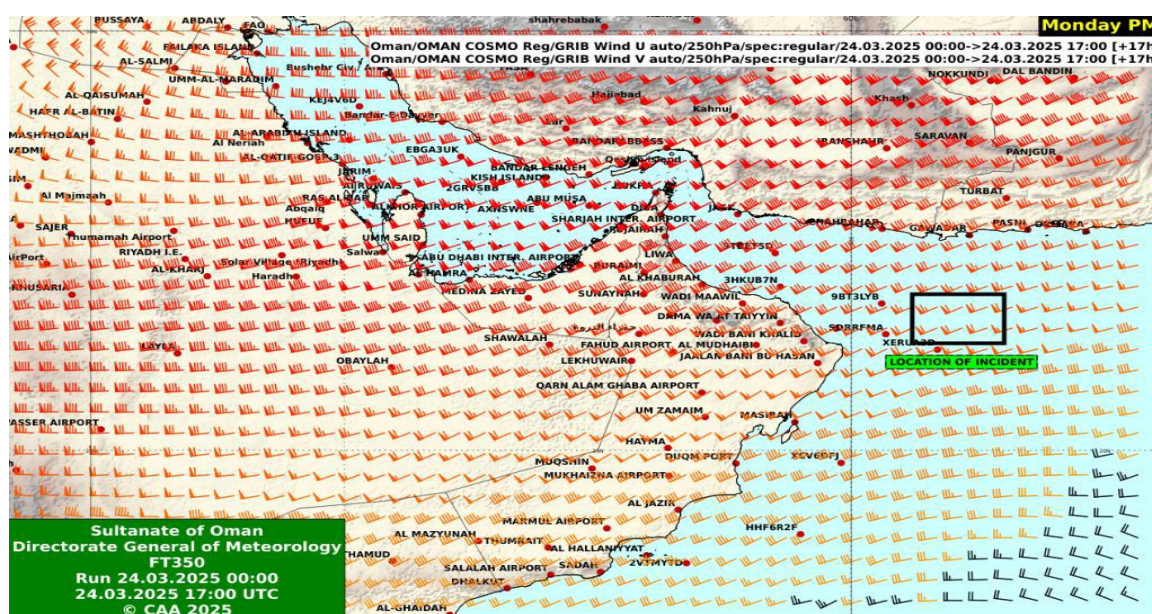
to 27065kt) from FL320 to FL360 in the upper air, maybe Jetstream was associated as it indicated in Figure (10). Also, forecasting, no weather condition as shown in the Muscat TAF and no pilot reports were received. Therefore, no warning was issued over the area of the serious incident. The weather information below is from the Meteorological Routine Aerodrome Report (METAR):

Figure. 10 showing the weather conditions at the time and date of the serious incident (Source: DGMET)
