Oman Transport Safety Bureau

Preliminary Report

OTSB Case File No: AIFN-003/05/2024

TCAS Resolution between Two Salam Air Aircraft Airbus A320-200, A4O-OXD and Airbus A320-200, A4O-OXB in the Muscat FIR Next to OOMS

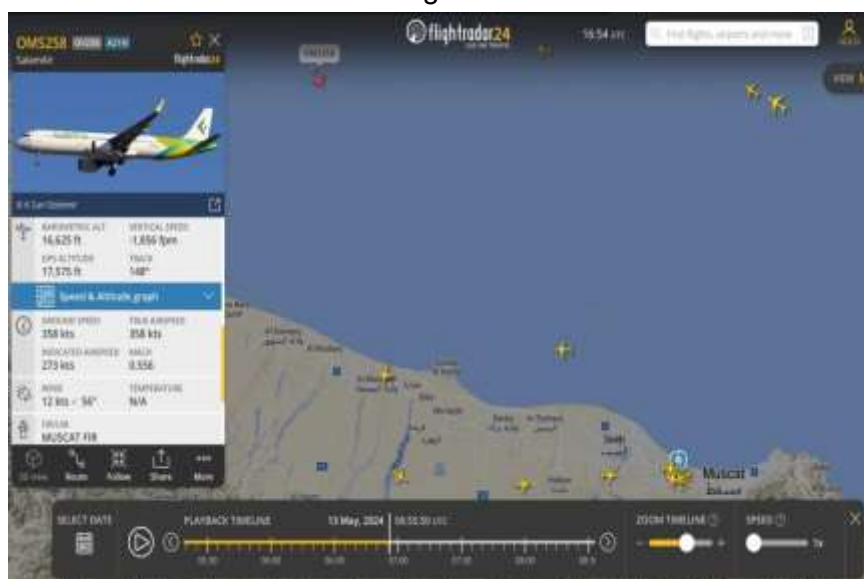
Figure 1 showing aircraft OMS258 34nm from north west (NW) of MCT (Source: Flight radar 24)

- 1.1.2. At 06:55:50, aircraft OMS258 reported to Muscat radar controller that they were routing to MCT VOR at flight level (FL)160. The radar controller then contacted Muscat approach controller and handed over aircraft OMS258 who reported the QNH1008 and cleared it to descend to altitude 13000 ft direct to MUSANAH. At 06:56:05, ATCO contacted the crew of OMS258 and corrected the destination from MUSANAH to MCT and to expect vectors for ILS RWY 08L. The crew of OMS258 read back and acknowledged.

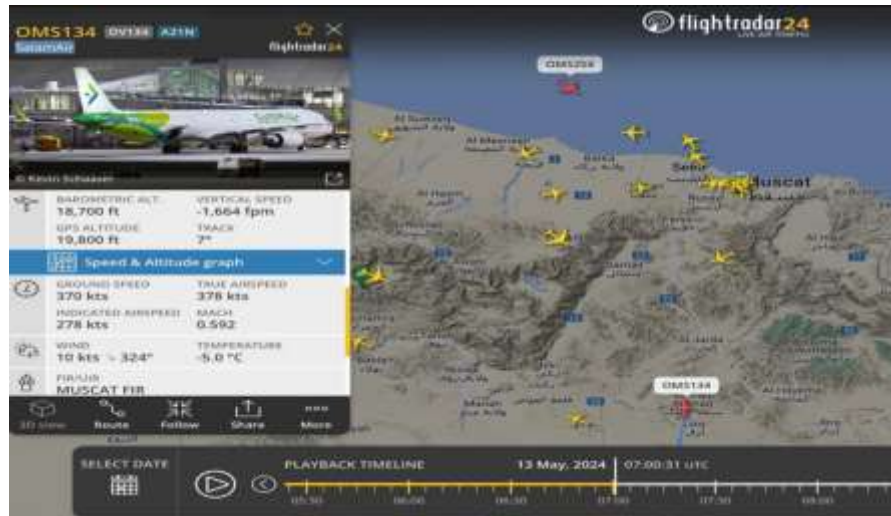
Figure 2 showing aircraft OMS134 was approaching MCT from the South
(Source: Flight radar 24)

- 1.1.3 Aircraft OMS134 was flying to MCT from the South. At 07:00:31, the crew of OMS134 contacted MCT Approach who cleared the crew of OMS134 to descend to FL160. At this time aircraft OMS134 was 50nm from MCT descending to FL160 and aircraft OMS258 was 34nm from MCT maintaining altitude of 13000ft.

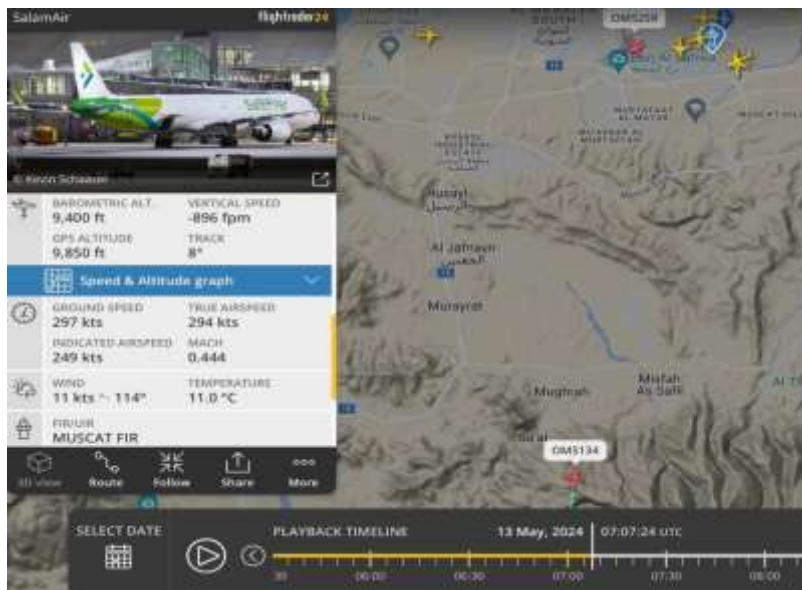
Figure 6 showing aircraft OMS258 overhead MCT at 9800ft descending to 7000ft and aircraft OMS134 9nm South of MCT at 9300ft descending to 8000ft

1.1.12 At 07:07:24, aircraft OMS258 was overhead MCT VOR at track 155. Aircraft OMS134 was 9nm south of MCT VOR.

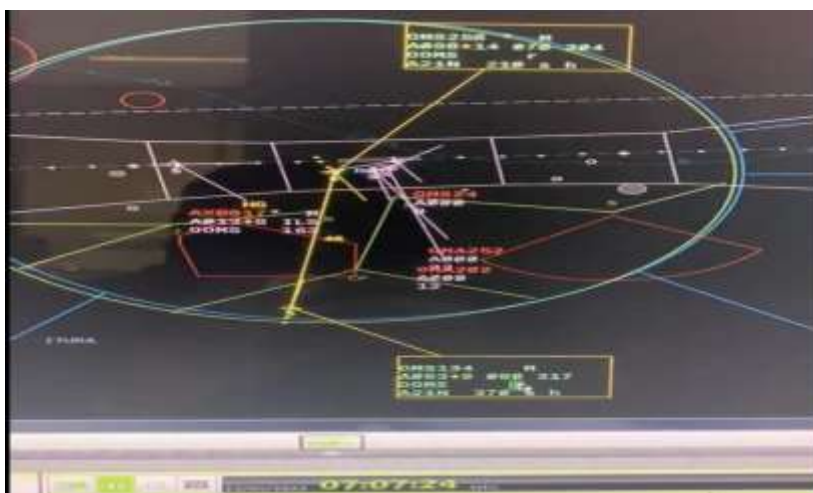
Figure 7 showing both aircraft OMS258 and aircraft OMS134 descending with distance and time between was 9nm and 46 seconds

1.1.13 At 07:07:24, as shown below, aircraft OMS258 was at 9800ft descending at rate of descent 1400ft/min and aircraft OMS134 at 9300ft descending at rate of descent 900ft/min. Both at indicated speed of 250kt. The distance in time between the two aircraft is 46 seconds and in distance and 9nm. OMS258 maintained its heading for 8 seconds and then commenced a right turn aiming for heading 290. At the same time, called ATCO to confirm the direction of the turn.

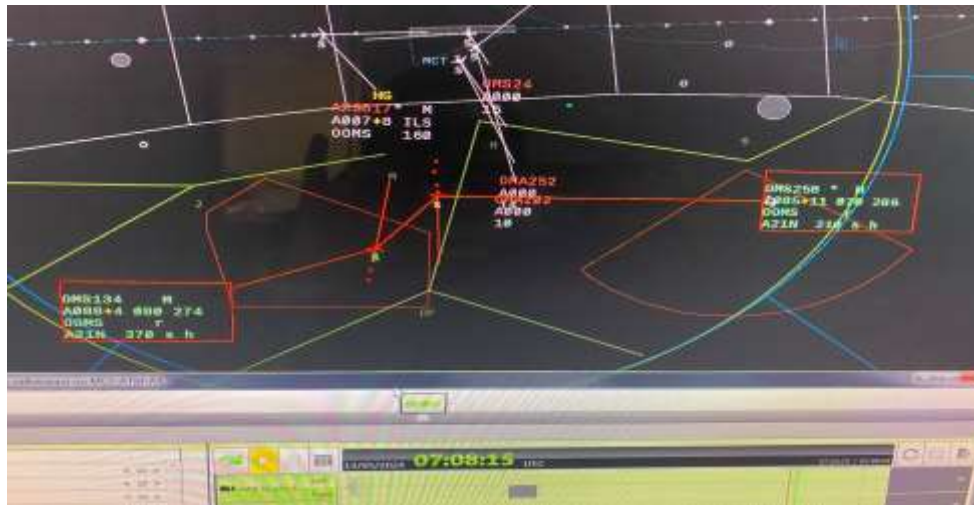
Figure 11 showing the RED STCA activated between OMS134 and OMS258 while descending

- 1.1.17 At 07:08:12, aircraft OMS258 was observed on radar screen turning left. At 07:08:14, OMS134 reported they were clear of TCAS conflict.
- 1.1.18 The red STCA was activated for 36 seconds from 07:08:14 to 07:08:50. When deactivated OMS134 was descending through altitude 8300 ft with rate of descend of 400 ft/min and OMS258 descending through altitude 7700ft with rate of descend of 1100 ft/min.

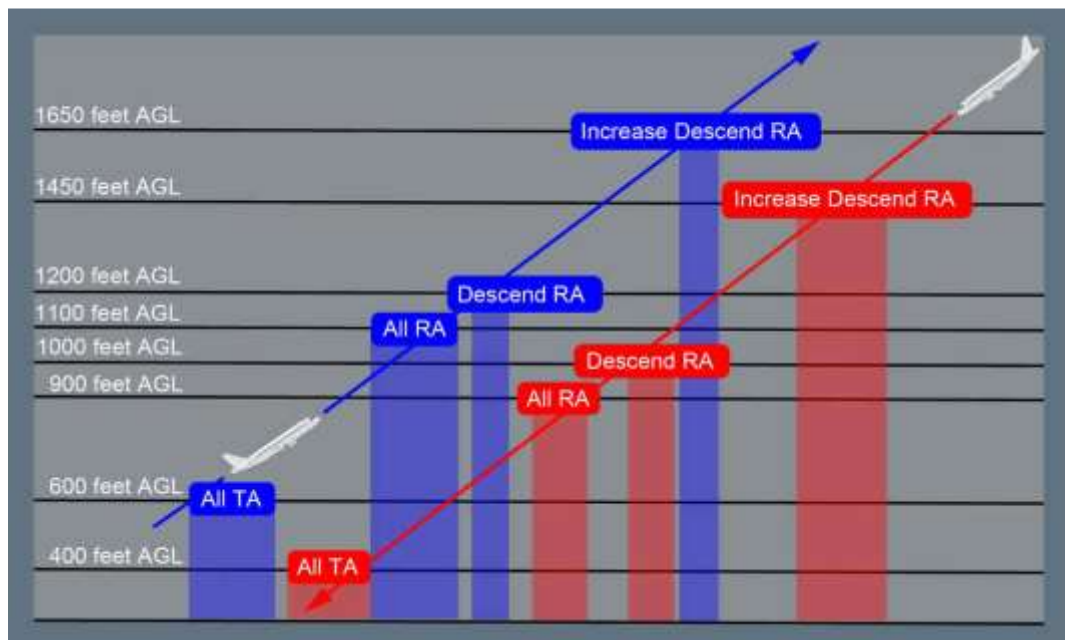
- It triggers the "CLEAR OF CONFLICT" aural alert.
 - In most of the cases, the AP/FD TCAS mode automatically reverts to V/S mode: The vertical speed target leads the aircraft toward the FCU selected altitude.
- If the altitude capture conditions are met at the clear of conflict, the AP/FD TCAS mode can revert to an altitude acquire, or an altitude hold mode. Refer to DSC-22_30-40-100 Normal Operations - When a RA is triggered - Consequence on AP/FD Vertical Mode.

Figure 19 showing when a RA is triggered - Consequence on AP/FD Vertical Mode.
