# Oman Transport Safety Bureau (OTSB)

## Final Report

### TCAS Resolution Advisory between Etihad Airways - Airbus 320-232 and Boeing 787-9 Dreamliner in Muscat FIR

**OTSB Case File No: AIFN001.02.2026**

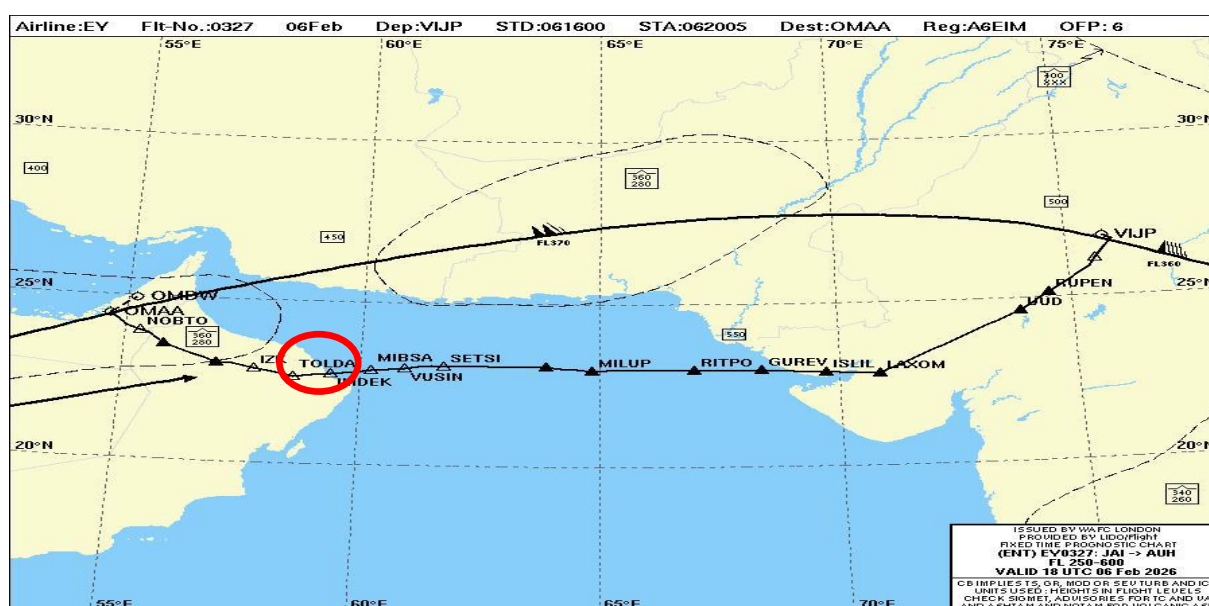
1.7.1 According to Oman Directorate General of Meteorology (DGMET) office, satellite image was observed with no Significant weather condition over MCT FIR. Medium and high clouds were observed during the time (1645UTC), close to the time of the serious incident. Strong wind was expected southwest to west (25055kt to 27065kt) from FL320 to FL360 in the upper air, maybe Jetstream was associated. Also, forecasting, no weather condition as shown in the Muscat Terminal Area Forecast (TAF) and no pilot reports were received. Therefore, no warning was issued over the area of the serious incident. The flight plan of the ETD7AN did not show any significant weather conditions. Figure13 shows weather conditions at the location of serious incident location.

Figure 13. shows weather image of the weather at the location of the serious incident (Source: DGMET).
