Oman Transport Safety Bureau (OTSB)

Final Report

OTSB Case File No: AIFN-006/10/2024

Salam Air A321-251N Ground Proximity Warning System (GPWS) Serious Incident

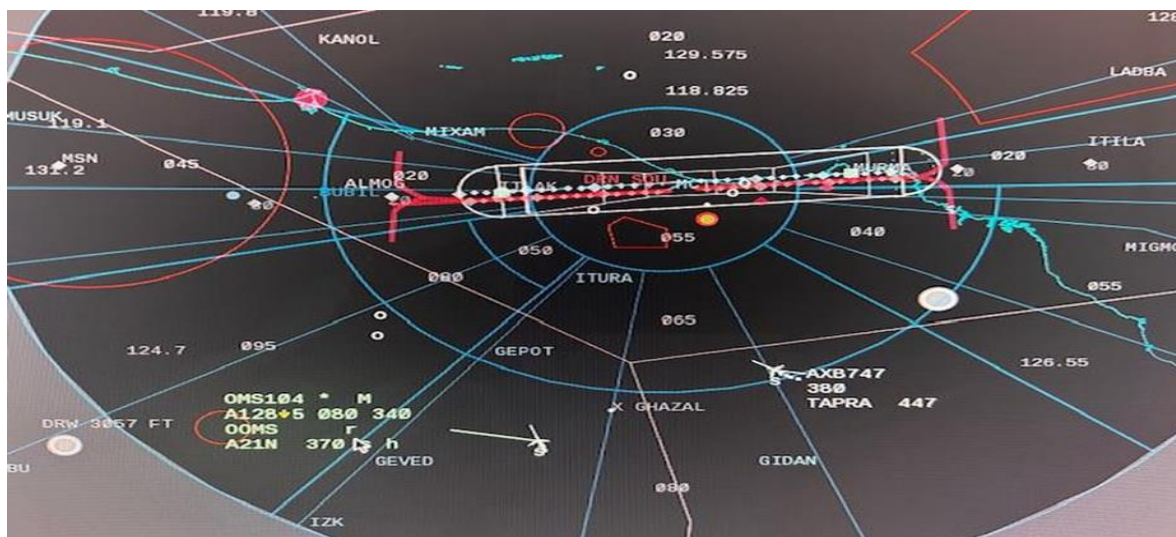
Figure 1: showing aircraft OMS104 observed on radar passing through 12800FT descending to 8000 FT at ROD 500 feet per minute (FPM) (Source: DGAN)

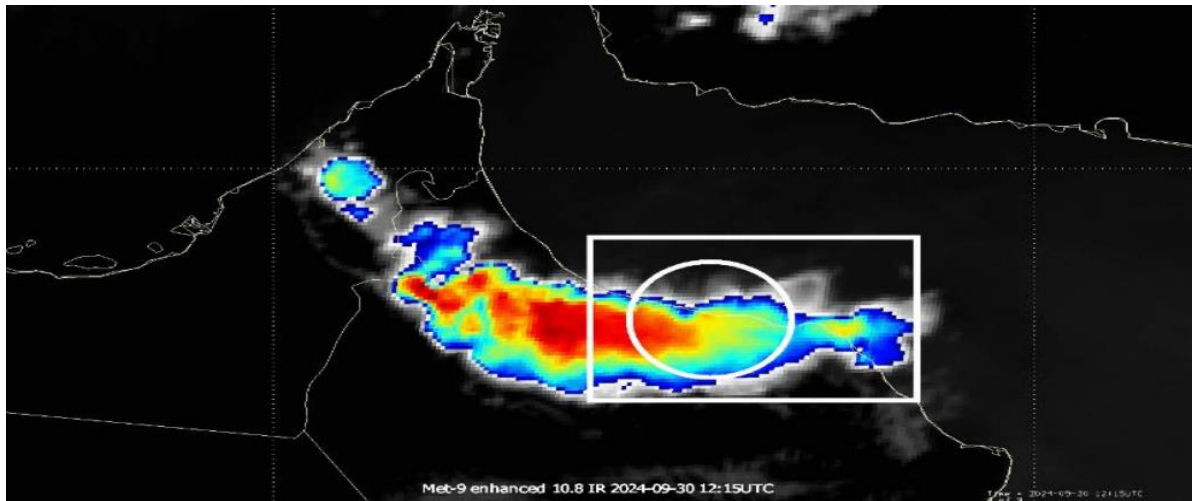
Satellite show convective cloud over area may be CB cloud as showed in figures 9 and 10. Expected low cloud and convective cloud over the area and during time of incident Figure 7. Convective cloud can be found CB extend up to 39000FT associated with Thundershower rain, downdraft wind, wind shear and turbulence.

Figure 9: showing satellite image at the time 1200Z on the 30th September 2024 (Source: DGMET)

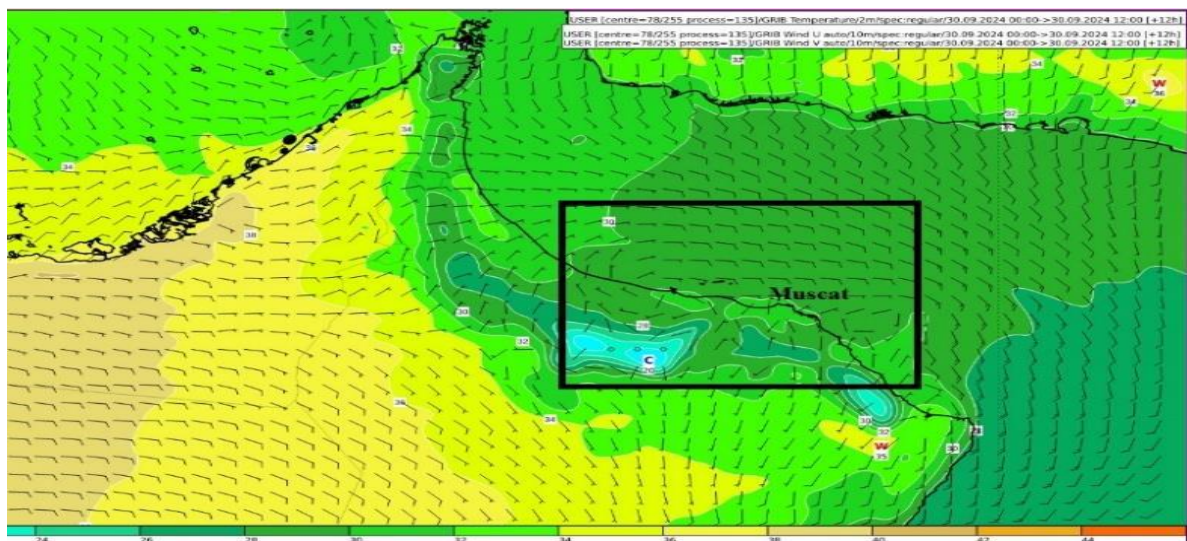
Figure 10: showing temperature and winds at the time 1200Z on the 30th September 2024 (Source: DGMET)

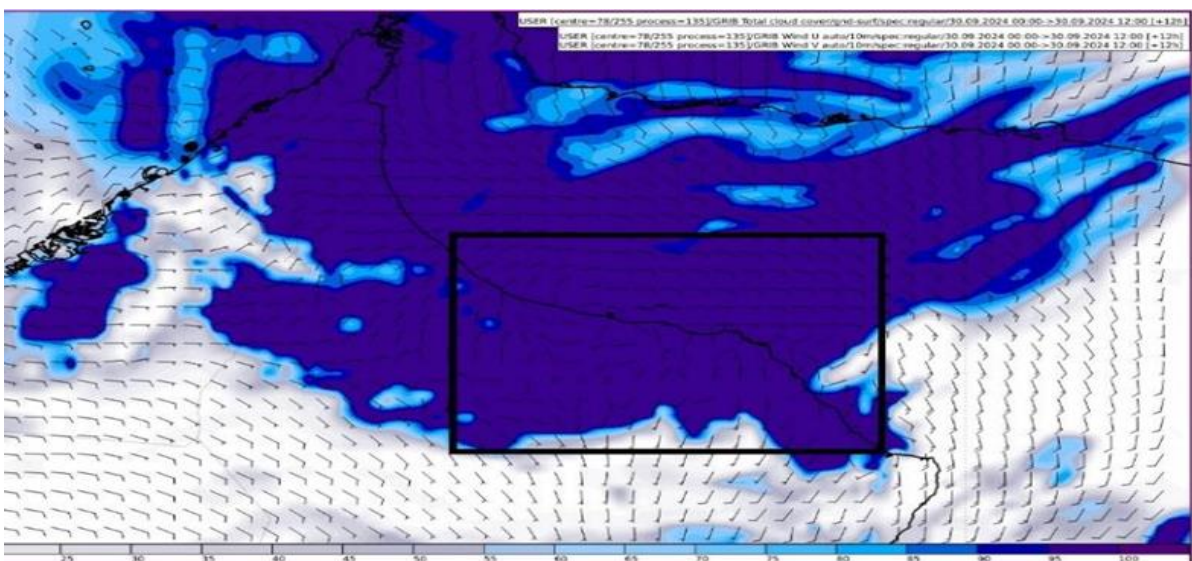
Figure 11: showing clouds with wind at the time 1200Z on the 30th September 2024 (Source: DGMET)

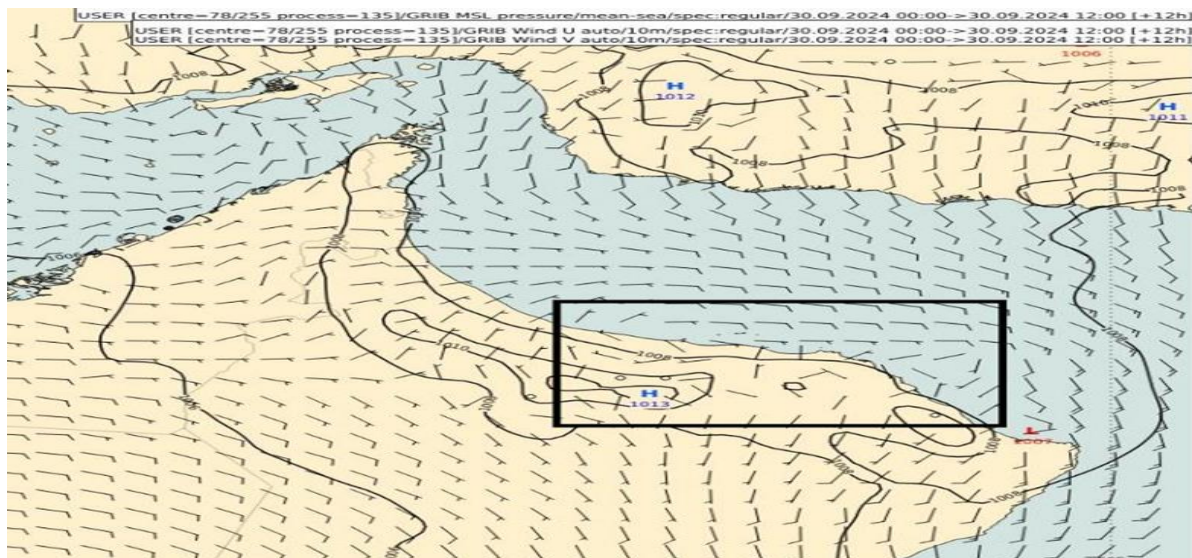
Figure 12: showing pressure with wind at the time 1200Z on the 30th September 2024 (Source: DGMET)

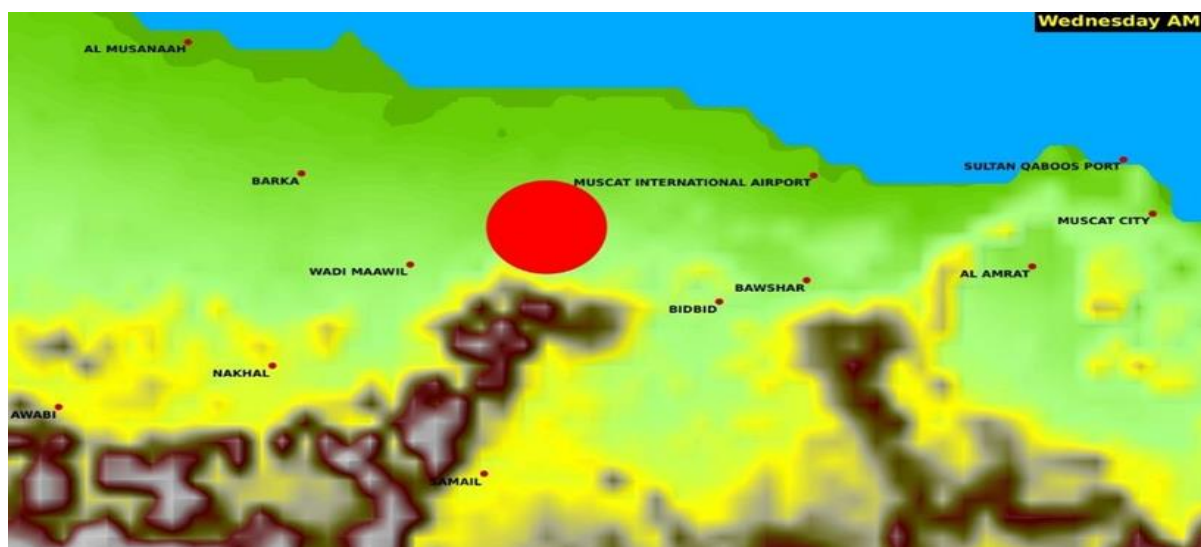
Figure 13: showing position of incident 23.415395N 057.992873 E-see red circle (Source: DGMET)

1.7.4. Significant weather condition was observed from the satellite image during the time of the incident over Oman FIR especially over Alhajar mountain at time (1215UTC) and covering the position of the serious incident. There was convective cloud around in the location of the serious incident and expected type of CB clouds which was extended up to 12000m (39000FT) approximately and associated thundershower rain, hail, downdraft, strong variable winds, strong wind shear, lighting and air turbulence.

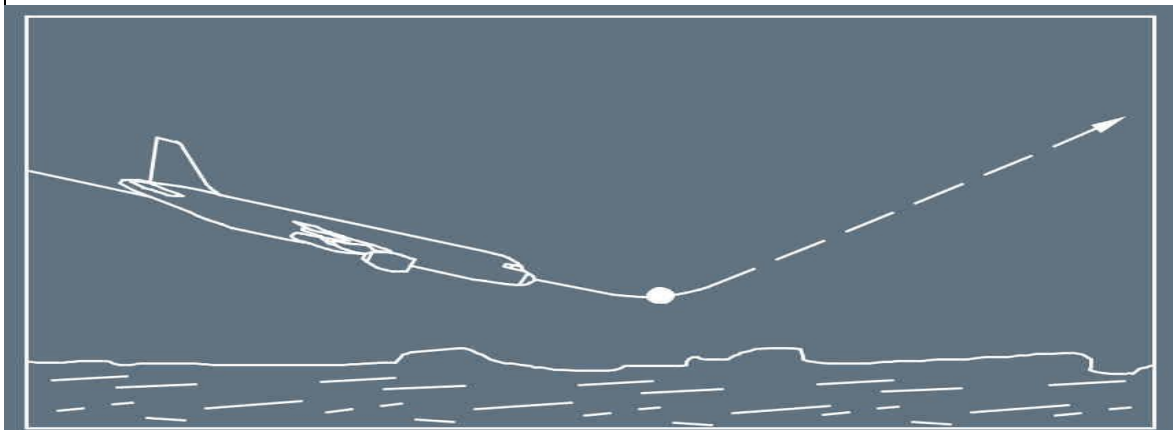
Figure 17 showing Mode 1 excessive rate of descent (Source: Salam Air FOM)

Mode 1 triggers aural and visual alerts about excessive rates of descent, based on the radio height, and the rate of descent of the aircraft.

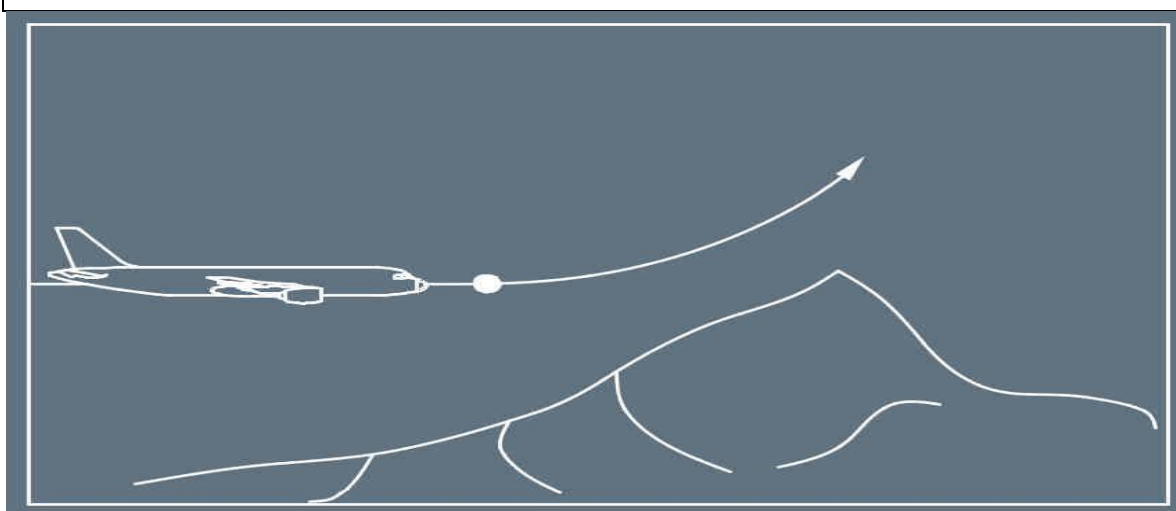
Figure 18 showing Mode 2 excessive terrain closure rate (Source: Salam Air FOM)

Mode 2 triggers aural and visual alerts, based on the landing gear/flaps configuration of the aircraft, the radio height, and the RA rate of change.

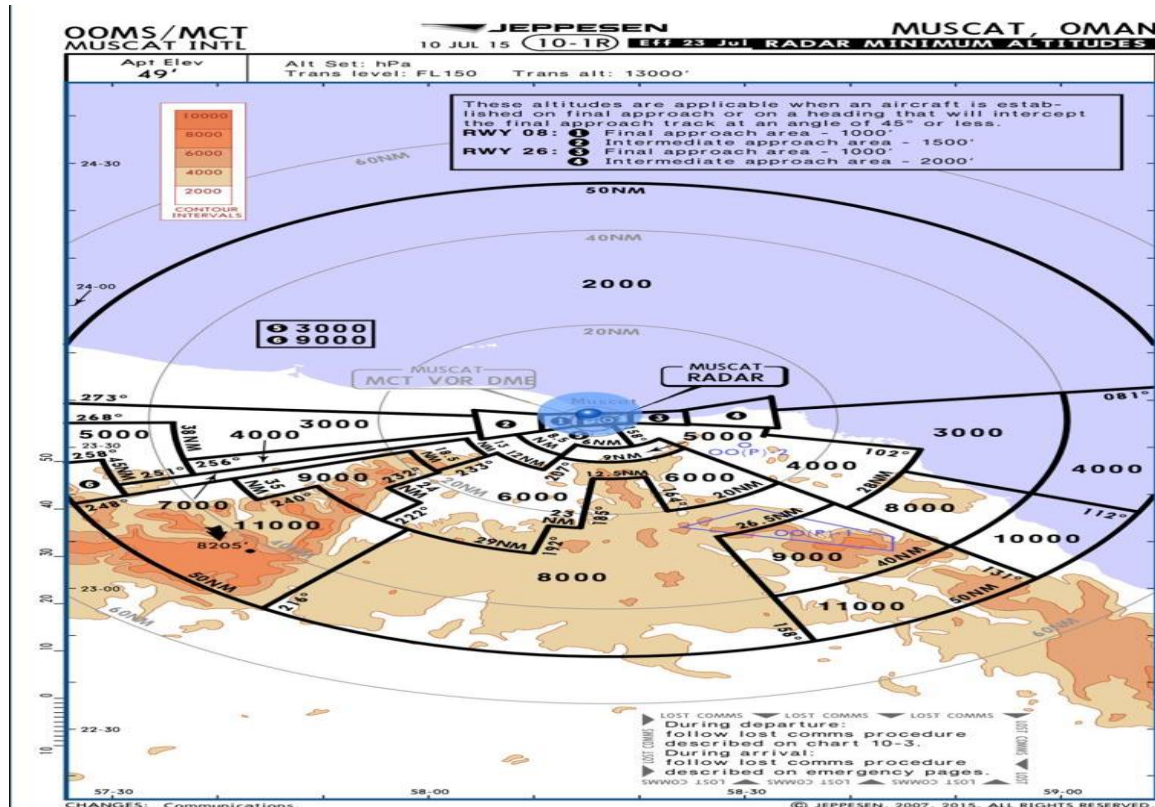
Figure 19 indicates Jeppesen Chart Minimum Safety Altitude (MSA) 6000FT/8000FT for OOMS
